## ASSIGNMENT (Office)

SFM 7739S

BMW 316i

## VEHICLE DAMAGE INSPECTION REPORT

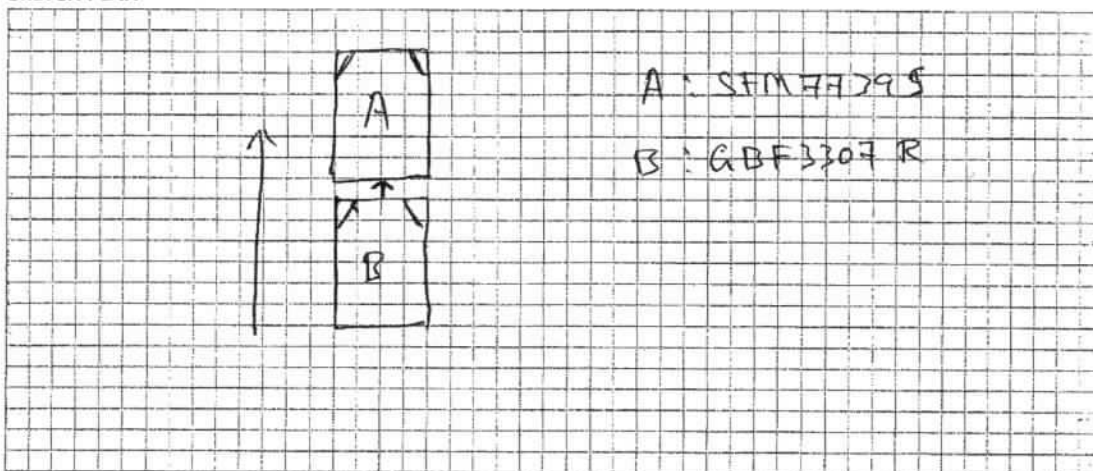
SKETCH PLAN

I am travelling to office through Upper Bukit Timah Road passing through Rail mall. The road condition was dry & had heavy traffic. My car was stationary in the traffic suddenly the Van behind my vehicle hit my rear bumper.
