Pre repair inspection request - SLR9660Z V5 SLG2914X (OI) DOA: 17/01/2019

Vehicle : SLR 9660 Z
Chassis No : AGH300040850
Make : Toyota ALPHARD
Year : 2016

VEHICLE DAMAGE INSPECTION REPORT

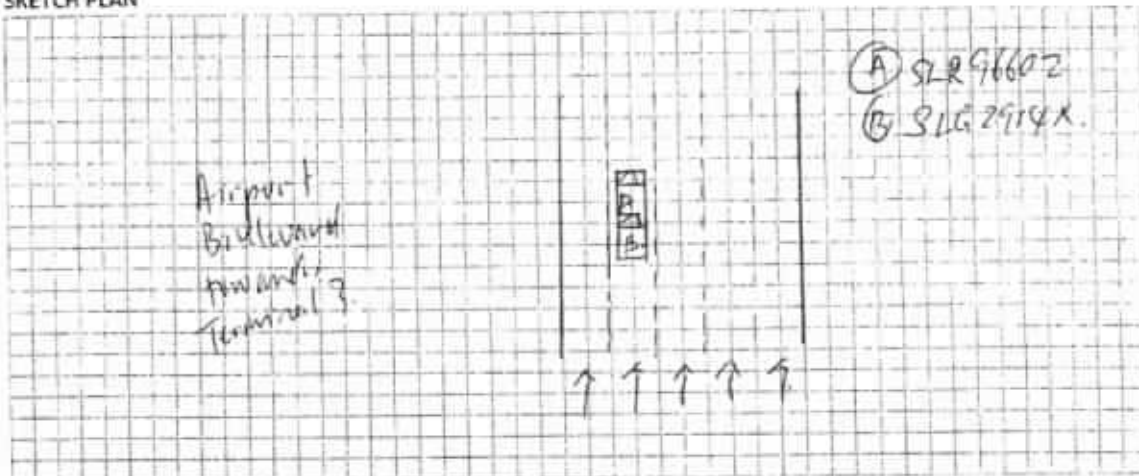
SKETCH PLAN

I was travelling along Airport Boulevard towards Terminal 3 on the 4th lane of 5 lanes road. In front of me a taxi stopped so I managed to slow down and stopped. About 5 seconds a ~~Vehicle~~ Vehicle SLG 2914X collided against the rear of my vehicle.
