ASSIGNMENT (Office)

To Inspect Vehicle No: SKC 1774Y Insured: XE 3033Aat Workshop m/s Zoom Autowerks Tel: 94507920of 15 Kaki Bukit Rd 4 # 01-53Policy No: 28967616 MEC Claim No: 582770

## VEHICLE DAMAGE INSPECTION REPORT

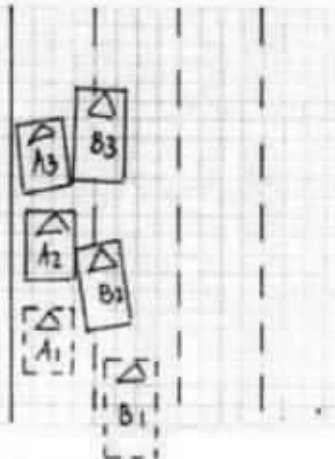
# Accident Sketch Plan

VEHICLE A: SKC 1774Y

VEHICLE B: YE 3033A / TPD 442611.

Vehicle B, before impact, entered from the right

On the stated date & time, I, vehicle 'A', SKC 1774Y, was travelling straight along the stated venue. Suddenly, vehicle 'B', YE 3033A, cut into my lane and collided onto my vehicle's right portion. He then continued to further went on for a couple of metres.
