**- PRE-REPAIR INSPECTION - ACCIDENT INVOLVING OUR INSURE...**

**PRE-REPAIR SURVEY**

**ACCIDENT INVOLVING SLU2949Y & SLL4774T & OTHERS ON 19<sup>TH</sup> JANUARY 2019 AT ABOUT 1345HRS**

## VEHICLE DAMAGE INSPECTION REPORT

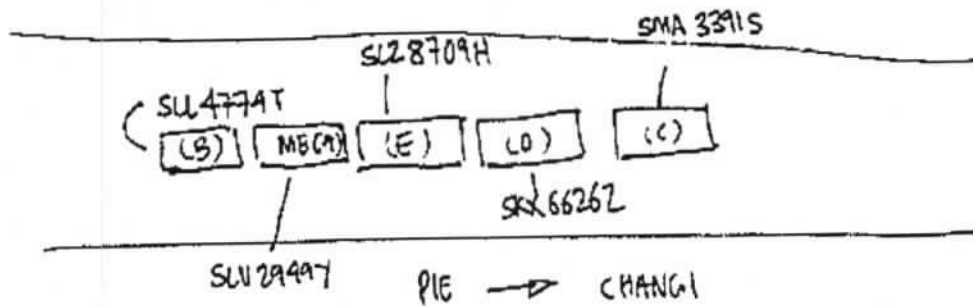
## SKETCH PLAN

ON THE 19 JAN 2019 I WAS DRIVING ON THE PIE (CHANGI). THE CAR IN FRONT OF ME SL28709H SUDDENTLY BRAKED SO I JAM BRAKED IN REACTION TO THIS. THE CAR BEHIND ME (SLU4774T) ALSO JAM BRAKED BUT HE KNOCKED INTO ME AND I KNOCKED THE CAR IN FRONT OF ME (SL28709H). ROUGH TIME OF ACCIDENT: 13.5 HRS.
