**Preliminary Advice**

Insured Vehicle No	: SLC9774H	Accident Date	: 18/01/2019
TP Vehicle No	: GBC5110T	Assignment Date	: 22/01/2019
Make	: NISSAN NV200	Est. Duration of Repair	: 5.00
Date of Inspection	: 23/01/2019		
Inspection At	: CARZ AUTO SERVICES PTE LTD - WOODLANDS (HQ) NO 61, WOODLANDS INDUSTRIAL PARK E9, #04-04 E9 PREMIUM SINGAPORE 757047 SINGAPORE 757047

## VEHICLE DAMAGE INSPECTION REPORT

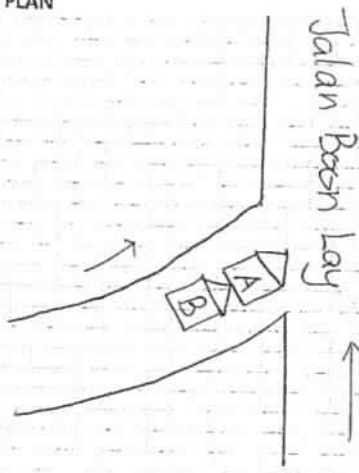
SKETCH PLAN

Vehicle A: GBC5110T.

Vehicle B: SLC9774H

On 18/1/2019 at about 9:15a.m. I was travelling to Jalan Boon Lay Road. I was stop when waiting all the vehicle drive along Jalan Boon Lay Road. Suddenly, I heard a loud bang from behind. When I realised, there was Vehicle B collided my vehicle.
