VEHICLE DAMAGE INSPECTION REPORT

Our File No: CS/CTI19001516/JSD3E2

Handling Insurer:	China Taiping Insurance (Singapore) Pte. Ltd.	Policy No:	DMCVSN30003819044
Claimant Vehicle No :	SLG1095R	Insured Vehicle No :	YL3090K
Date of Loss:	18/01/2019	Nature of Claim:	TP
		Claim No:	YL3090K

Reg No:	SLG1095R	Engine No:	LEB5908152
Make & Model:	HONDA VEZEL, 1.5 HYBRID (A)	Chassis No:	RU31208141
Reg. Date:	21/09/2016 (Man. Year: 2016)	Odometer:	159615 km
Colour:	Black		
Engine Capacity:	1496 cc		
Market Value/New Car Price:	N/A		
Sum Insured (S\$):	Market Value/New Car Price

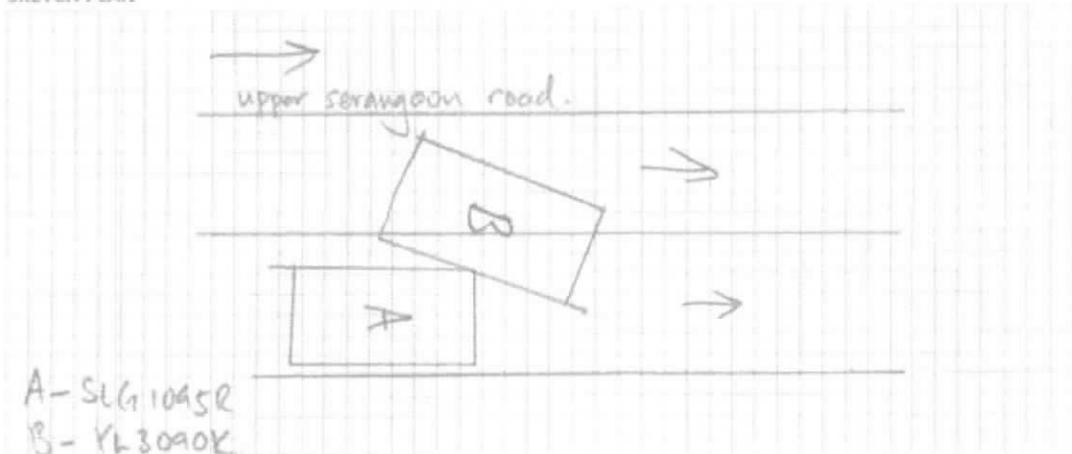
SKETCH PLAN

DESCRIBE CIRCUMSTANCES OF THE ACCIDENT

On 18 Jan 2019, at approximately 1040hrs, I was driving vehicle A, SLG 1045R, on upper serangoon Road where I was involved in a hit & run accident with vehicle B, YL3090K.

While travelling along upper Serangoon Road heading down south towards Woodleigh station, I was on the right lane when vehicle B filtered into my lane without signalling his intentions. I sounded my horn to warn him of my presence, but it fell on deaf ears and the incident occurred.
