**MOTOR SURVEY ASSIGNMENT**

**PRE-REPAIR INSPECTION REPORT**

Ref: CS3/FCI19001539/Ucd3s2

Make & Model	PORSCHE 718 CAYMAN S-A	c.c	1988
Engine No.	HIDDEN	Year of Reg.	2017
Chassis No.	WP0ZZZ98ZJK250680	Colour	BLUE
Odometer	23583 KM	Steering	IN ORDER
Brakes	IN ORDER	Modification	SPORTS RIM
General	GOOD

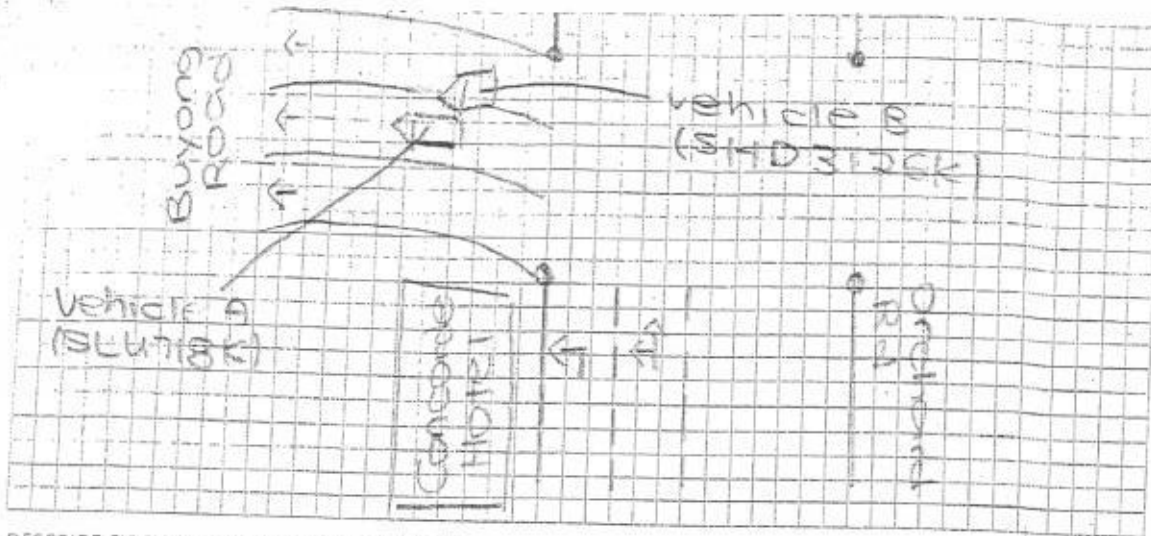
## Sketch Plan #2 Pg. 1

I was driving along Buyong Rd. Suddenly, vehicle B cut into my lane resulting in hitting onto the rear right hand fender and rim of my vehicle.
