To Inspect Vehicle No: SH7099C Insured: GBG 481SD

## SINGAPORE ACCIDENT STATEMENT

**REPAIR ESTIMATE**

## VEHICLE DAMAGE INSPECTION REPORT

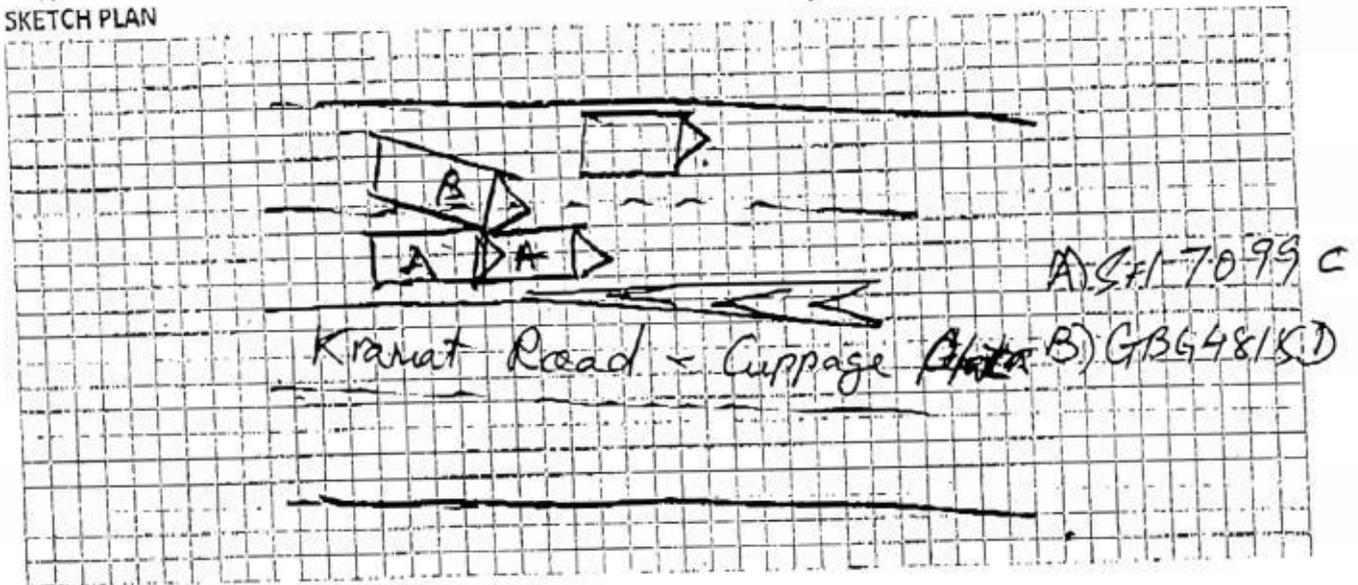
SKETCH PLAN

On 19/1/19 at about 23.00 hrs while in I Veh A was driving straight ahead on the right lane Veh B from the left lane suddenly filtered to my lane after noticing a parked vehicle ahead of his vehicle along his left lane and collided on the whole portion of my moving vehicle.
