VEHICLE DAMAGE INSPECTION REPORT

Our File No: CS/CT19001622/DSD3N2

Handling Insurer:	China Taiping Insurance (Singapore) Pte. Ltd.	Policy No:	DMCVSN30313618022
Claimant Vehicle No :	SHB3355B	Insured Vehicle No :	GY4730K
Date of Loss:	22/01/2019	Nature of Claim:	TP
		Claim No:	SNM19D200421C02

Reg No:	SHB3355B	Engine No:	D4FDEU411153
Make & Model:	HYUNDAI I40, 1.7 L CRDI AT ABS AIRBAG 4DR (A)	Chassis No:	KMHLB41UMEU061635
Reg. Date:	30/10/2014 (Man. Year: 2014)	Odometer:	643021 km
Colour:	Yellow		
Engine Capacity:	1685 cc		
Market Value/New Car Price:	N/A		
Sum Insured (\$\$):	Market Value/New Car Price

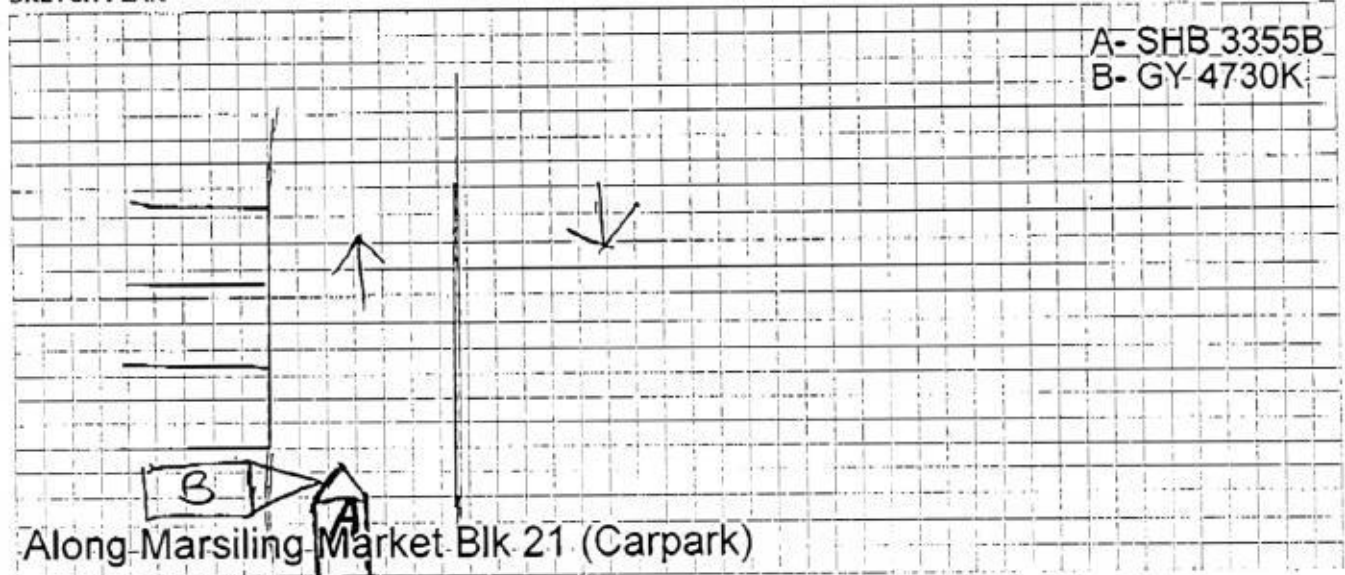
SKETCH PLAN

On 22.01.2019 @ 0145HRS I was travelling along Marsiling Market Blk 21 Carpark with 1 male and 1 female passenger onboard .

As I was entering the carpark veh (B) GY 4730K suddenly dashed out from my front left and hit onto my vehicle front left portion.
