ACCIDENT INVOLVING SMA9103T & SHC8221R AT THE JUNCTION OF STEVENS ROAD AND BUKIT TIMAH ROAD ON 9TH OCTOBER 2018 AT ABOUT 0235 HOURS

Vehicle Inspection Report

Report No: AAS/2018/432

Registration no: SMA9103T
Make/Model: Toyota C-HR Hybrid (A)
Year of registration: 2018
Colour: Metallic Yellow

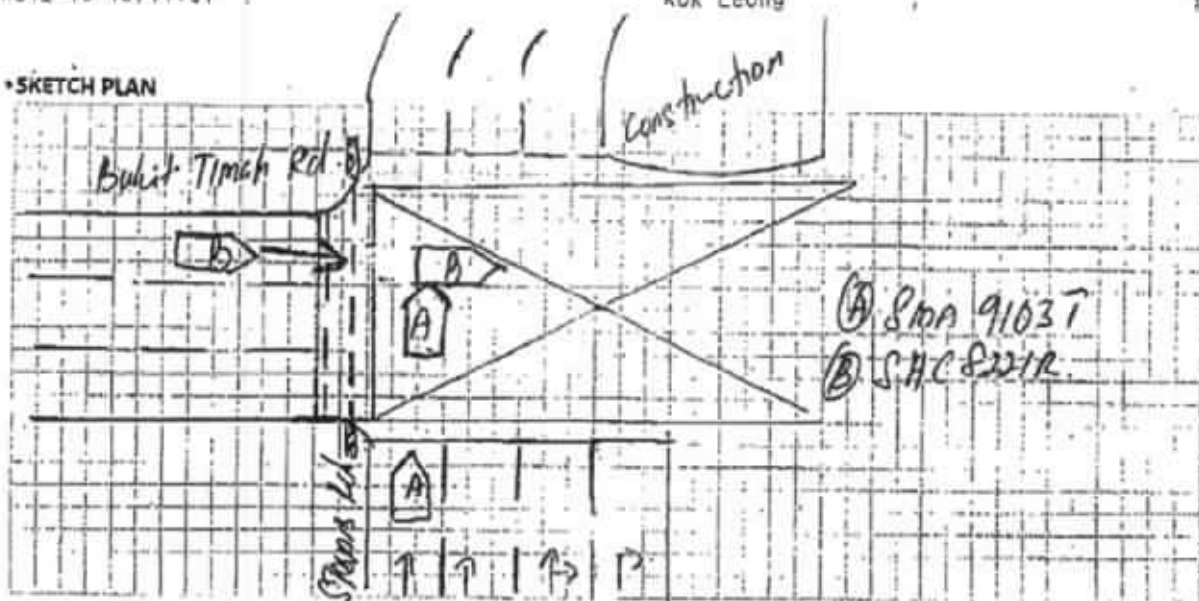
• SKETCH PLAN

Traffic light was green and I proceeded to drive. Suddenly a taxi, white mercedes drove straight and hit my vehicle going against the red light. No one was injured. I am filing this report for insurance claims.

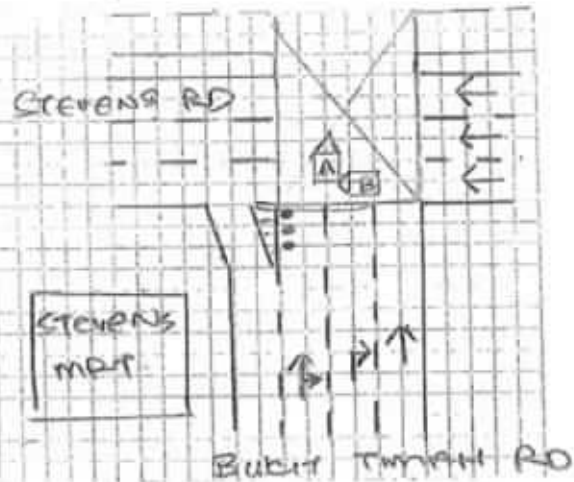
SKETCH PLAN

A = SHC 8221R
B = SMA 910BT
