MOTOR SURVEY ASSIGNMENT

INITIAL INSPECTION REPORT OF VEHICLE NO. SLW 2334K .

ADJUSTMENT ON REPAIR COST FOR VEHICLE NO. SLW 2334K

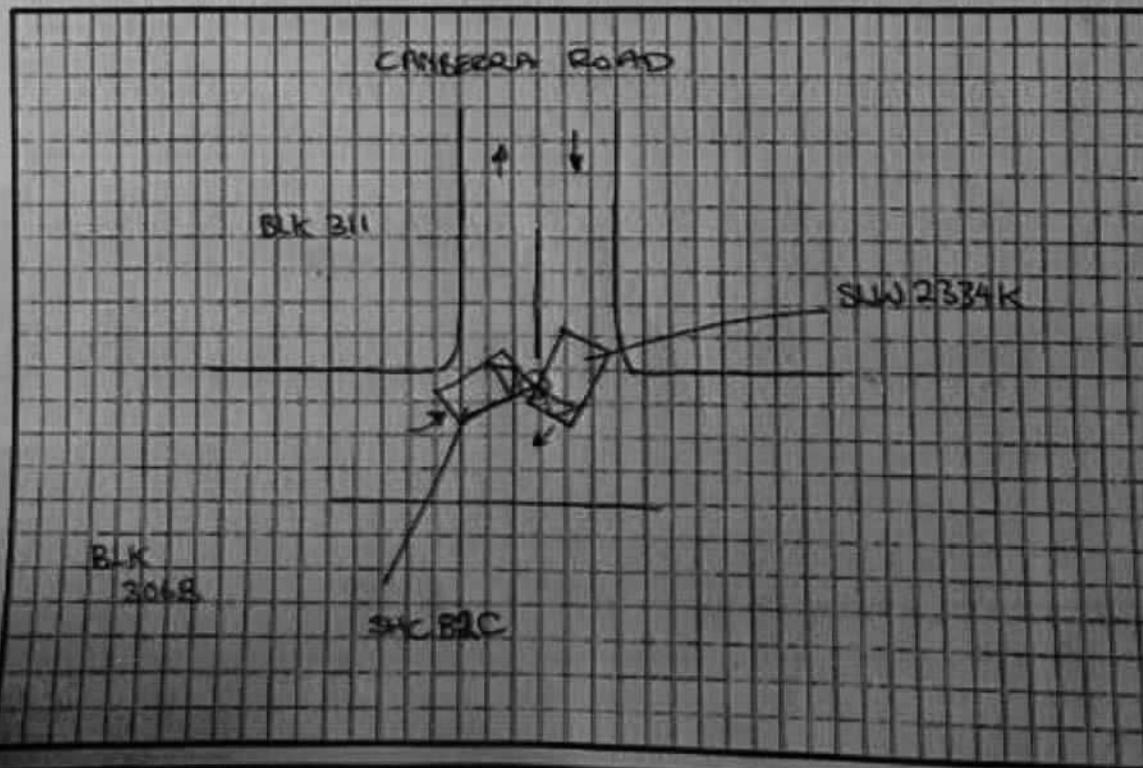
Sketch Plan

I was coming back home from my office , after a left turn from Canberra Road to the service road to Blk 311 Canberra road , there is a T junction . I was turning right from the T junction to reach Blk 311 , a taxi turned from my right to his left to go out to the main road Canberra road ... In a fraction of second , the taxi SHC82C banged on my SLW2334K right front door edge during both cars were moving their direction. No injuries involved.
