Preliminary Advice

: SHB8003J

: HYUNDAI 130 GDH

VEHICLE DAMAGE INSPECTION REPORT

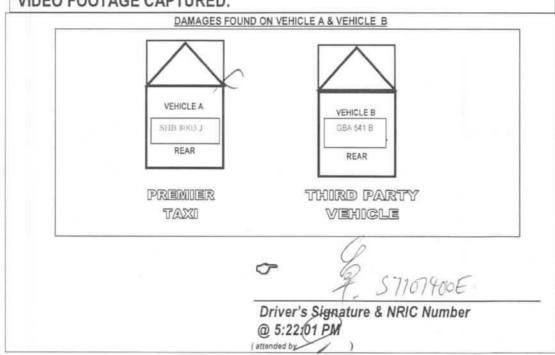
WHILE MOVING AHEAD, VEHICLE B (GBA 541 B – LORRY) WHICH WAS FROM LANE 2 – ENCROACHED ONTO MY PATH ON RIGHT ABRUPTLY & COLLIDED ONTO THE RIGHT WING MIRROR OF MY TAXI.

DUE TO THE IMPACT, MY TAXI HAD DAMAGES ON THE RIGHT WING MIRROR AND NO DAMAGES TO VEHICLE B.
