Veh No: **WC1325T** Yr Regn: **2002 OG**
Type: M.Car / M.Cycle / Bus / Van / Lorry / Taxi / Prime Mover /
Truck / Trailer or: **CEMENT TRUCK**
Make: **ISUZU CYH52S** C.C: **1568l**
Colour: **WHITE** A/C: Insured / Std / NI / NA
Sp. Reading: **263901** T/Radio: Insured / Std / NI / NA
Eng/No: _____
C/No: **3AL CYH 52S 77000650**
Gen. Cond: Good / Fair / Poor / Burnt
Steering: In order / Jammed / Leaked / Burnt or
Brake: In order / Jammed / Leaked / Burnt or
Mod: NI / S/Rim / STD A/Rim or
Tyre Size: F: **295/80R22.5**
R: _____

Subject: PRI WC1325T VS SJJ5R DOA 26/01/19

4. Description of Damages				
THE VEHICLE SUSTAINED DAMAGES AT THE REAR N/S PORTION. DAMAGES SEE DETAILS.				
5. General Information				
Accident Date	26/01/2019	Inspection Date	30/01/2019	
Survey held at	WOODLANDS TRANSPORT SERVICE PTE. LTD. 8 GUL CIRCLE SINGAPORE 629564			
5a. Remarks				
A)THE INSPECTION WAS CONDUCTED ON A"WITHOUT PREJUDICE" BASIS. B)IN ACCORDANCE TO YOUR INSTRUCTIONS, WE HAVE NOT AUTHORISED REPAIRS.				
5b. Estimate Days of Repair				
ESTIMATED NORMAL PERIOD FOR REPAIR:		5 Working Days

ADJUSTMENT ON REPAIR COST FOR VEHICLE NO. WC 1325T

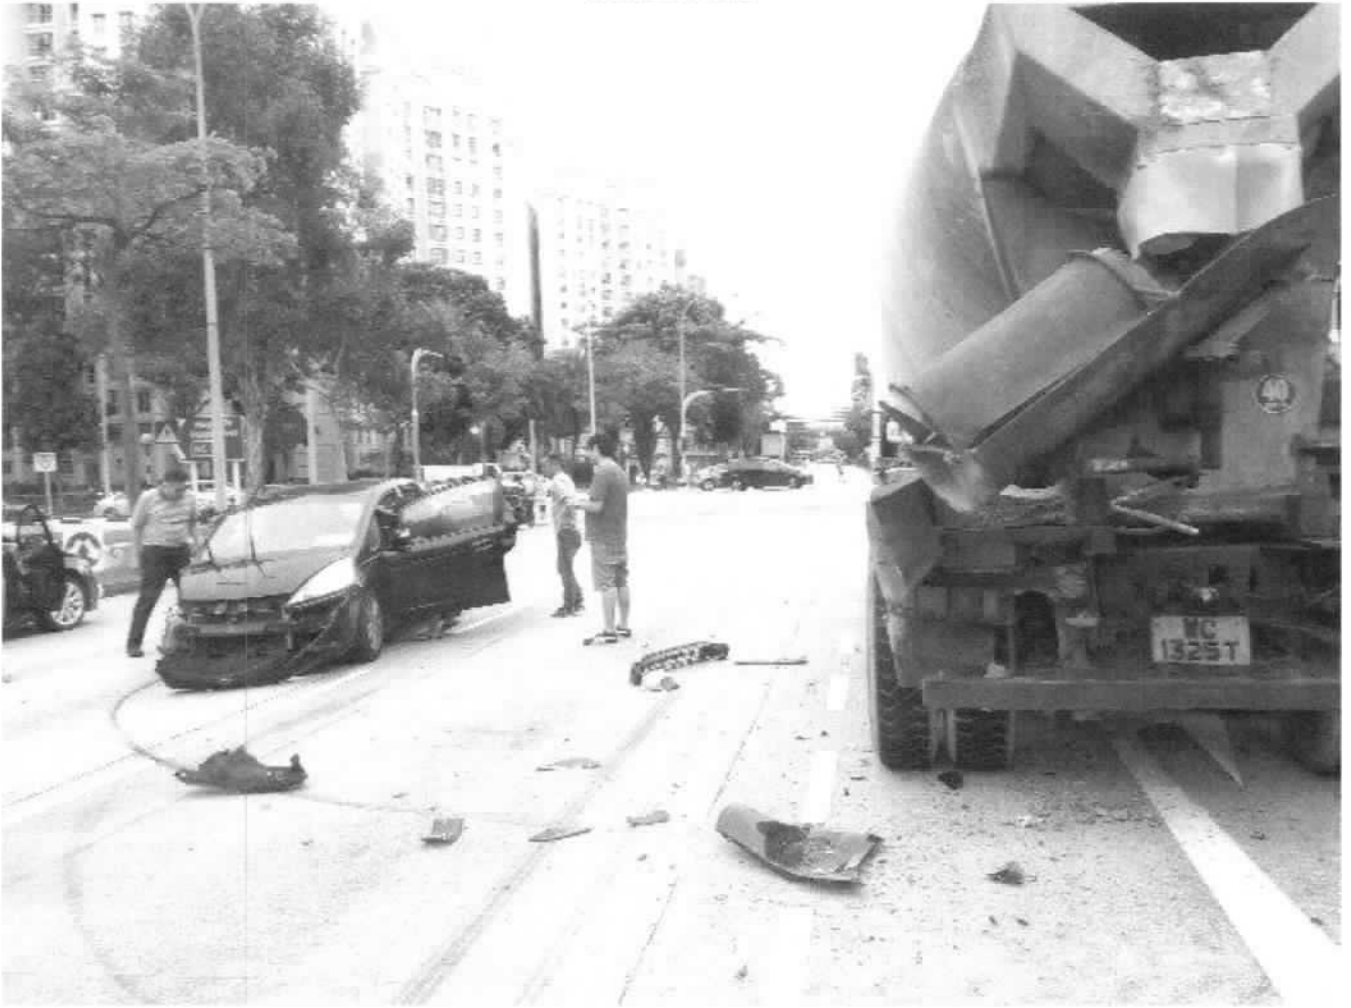
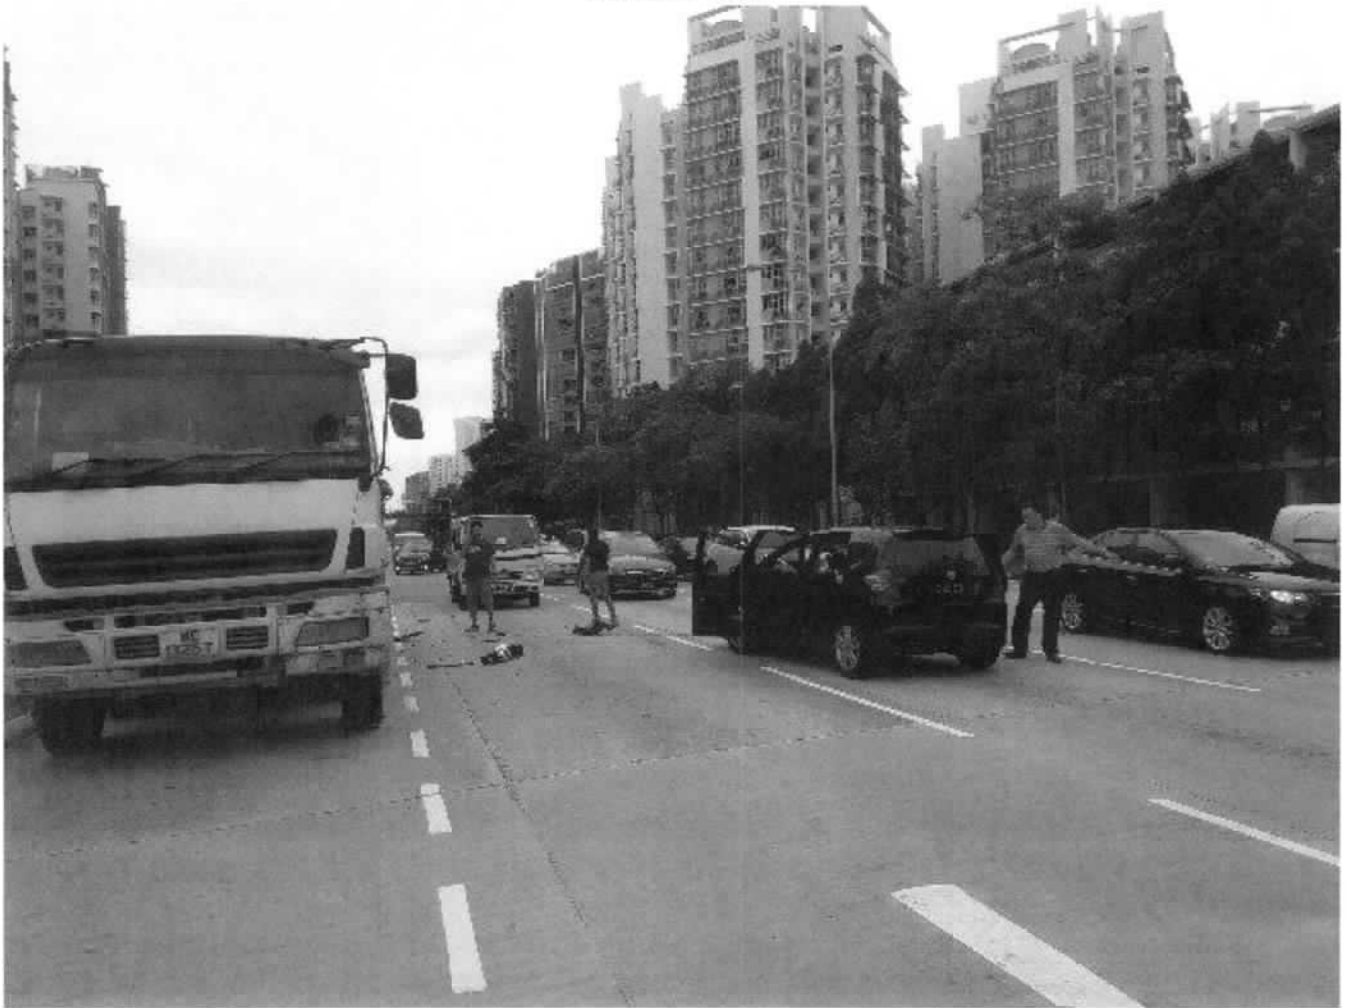
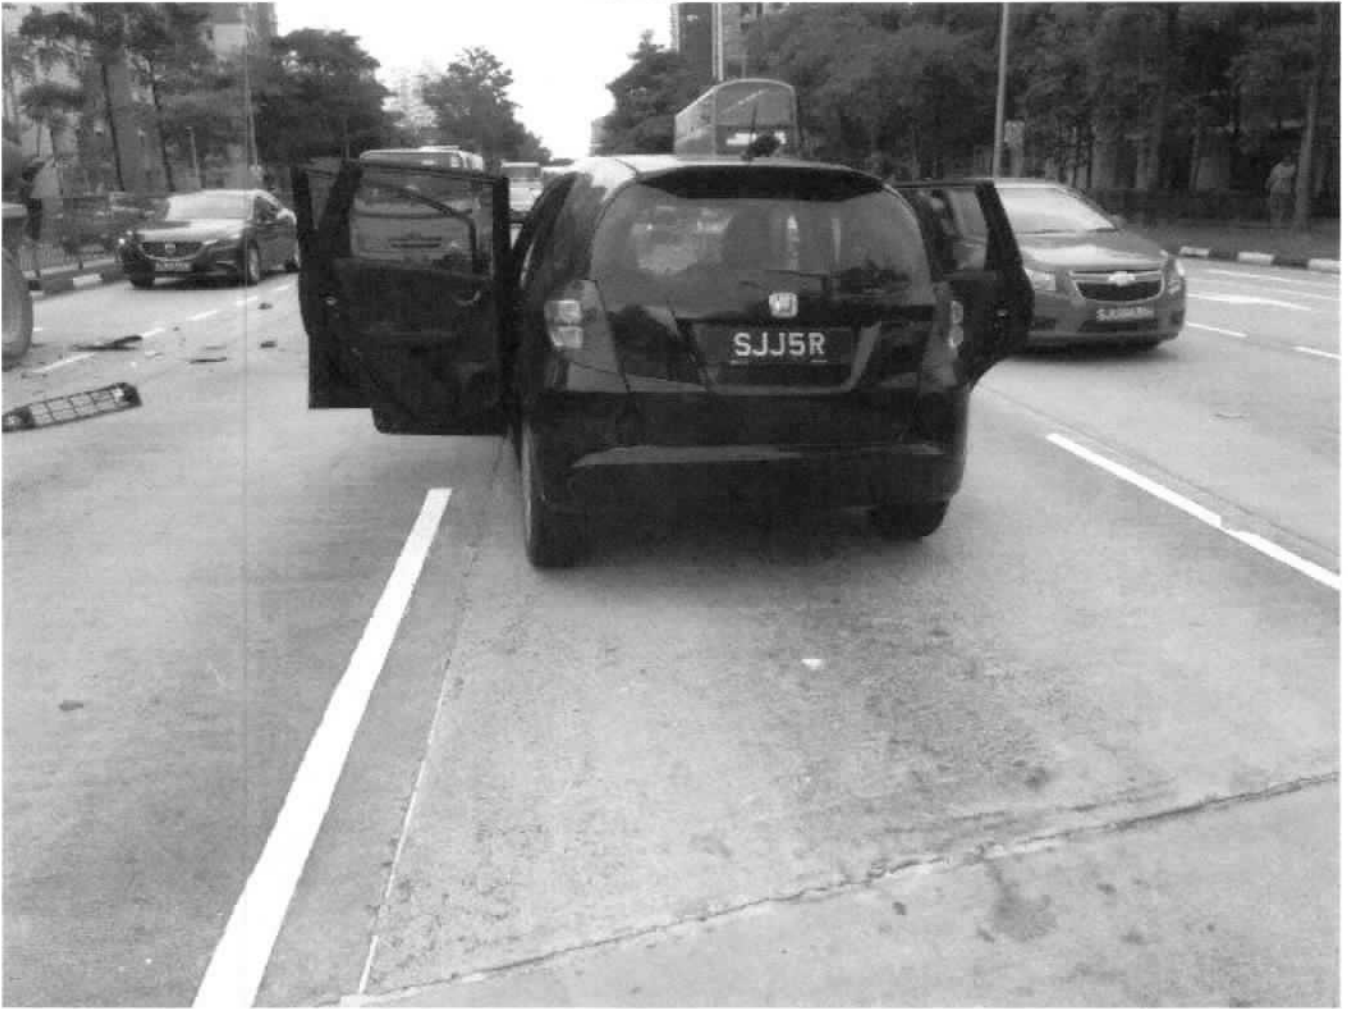
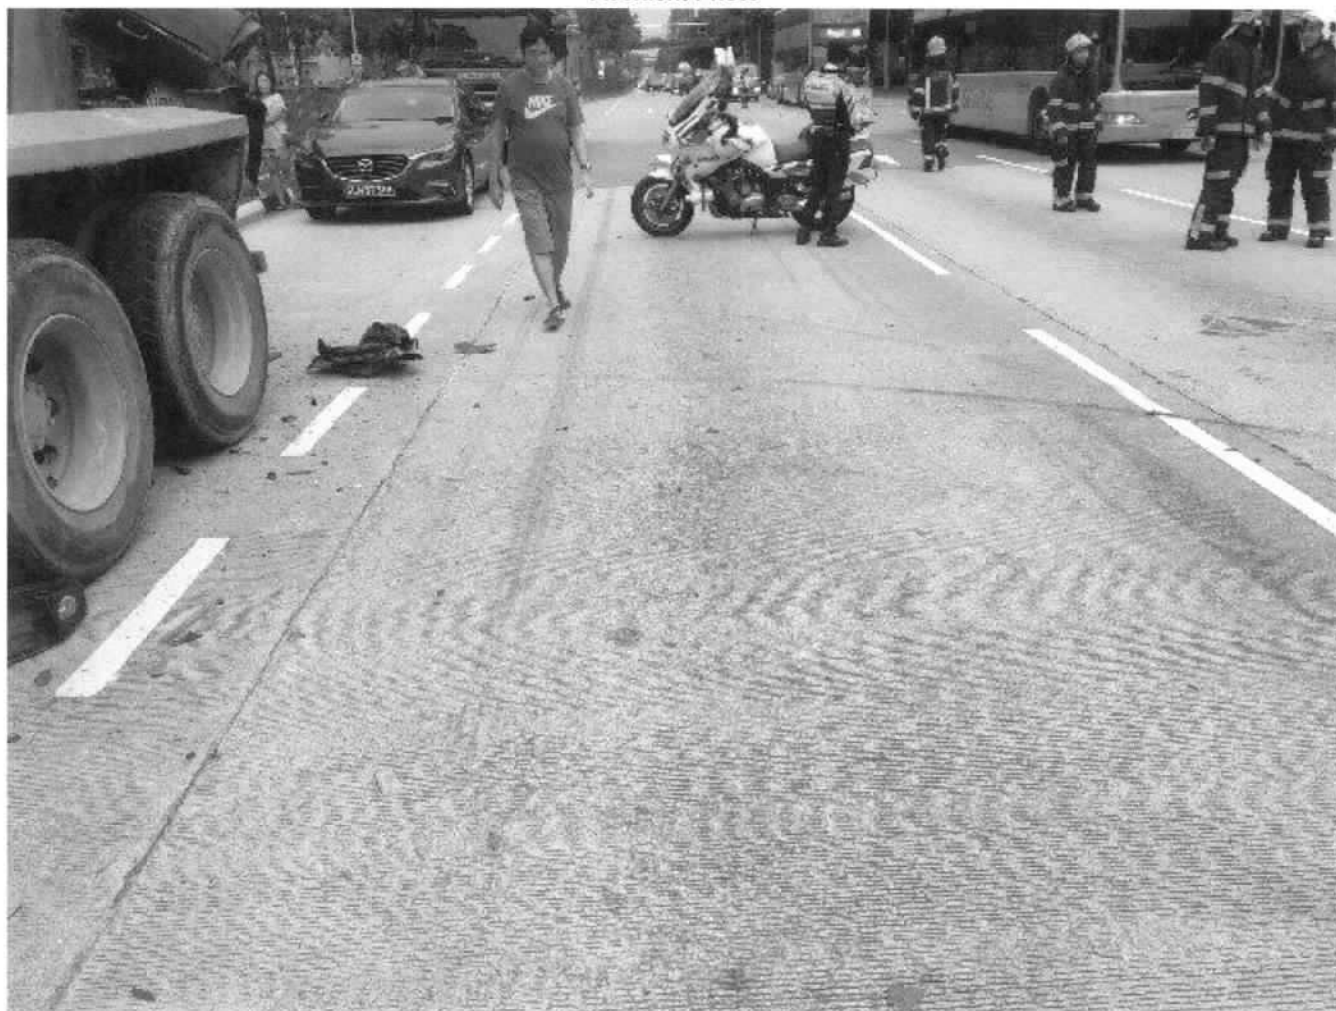
Accident Photo

The U/C / Chassis frame / Body Structure affected due to collision.

RECOMMENDED COST OF LUMP SUM REPAIRS (TO ITS PRE-ACCIDENT CONDITION)			2,900.00
---	--	--	-----------------
