ESTIMATE TO REPAIR TOYOTA PRIUS HYBRID - SMG8826R

VEHICLE DAMAGE INSPECTION REPORT

Our File No: CS/CTI19001934/KQD3N2

Handling Insurer:	China Taiping Insurance (Singapore) Pte. Ltd.	Policy No:	NA
Claimant Vehicle No :	SMG8826R	Insured Vehicle No :	SKN3732Y
Date of Loss:	27/01/2019	Nature of Claim:	TP
		Claim No:	SNM19D200508

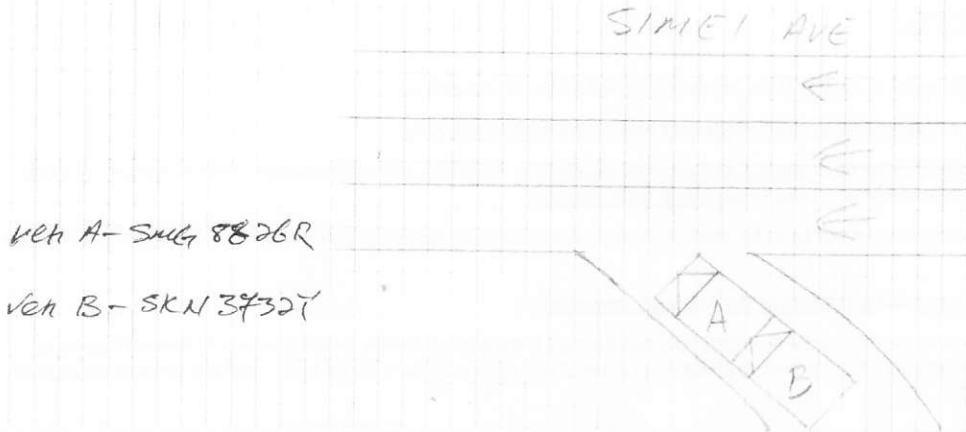
SKETCH PLAN

On 27/01/2019, 13:10 hrs, I vehicle A (SMG 8826R), was travelling along upper changi road toward Simei Ave. While on the slip road toward Simei Ave waiting for the car to clear on the right side, suddenly vehicle B (SKN 3732Y) collided onto the rear portion of my vehicle.
