From: Claims Dept of CTI <claimsdept@sg.cntaiping.com>
Sent: Thursday, 31 January 2019 10:25 AM
To: admin@mycar.sg; assignments@lkkauto.com; SUR
Cc: Ong Chin Kiat; Alfred Toh; Chee So Chow
Subject: OUR REF: SKV2945R YOUR REF: SKE7590K PRE-REPAIR INSPECTION FOR SKV2945P
- SNM19D200540C02/0
Attachments: GIA Report.pdf

**PRE-REPAIR INSPECTION FOR SKV2945P
ACCIDENT INVOLVING SKV2945P AND SKE7590R**

VEHICLE DAMAGE INSPECTION REPORT

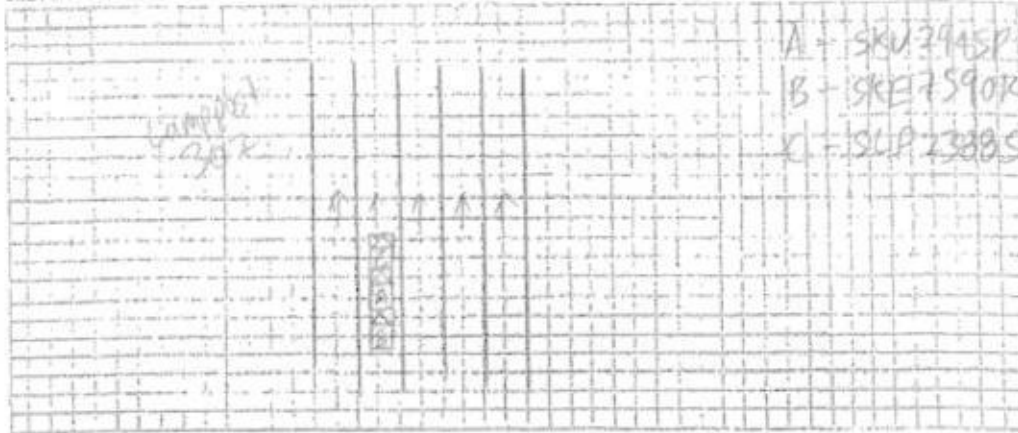
Sketch Plan #2

On 26/01/2019, at about 15:40, I was travelling in my vehicle (SKV 2945P) on CTE towards SLE at lampost 302 on the 4th lane. I came to a complete stop as there was a massive jam in front. Suddenly, I felt a huge impact from the back of my vehicle. This caused my vehicle to move forward and touch the vehicle (SLP 2388S) in front of me. I went down and saw that vehicle (SKE 7590K) had collided into the rear of my vehicle. This left my vehicle badly damaged. We exchanged our particulars with all parties and left the scene.
