REF: CS/QBE 19062426/TISd3⁹

To inspect Vehicle No: SLS125G

Make: BMW 730 SR. 1998

INITIAL INSPECTION REPORT OF VEHICLE NO. SLS 125G

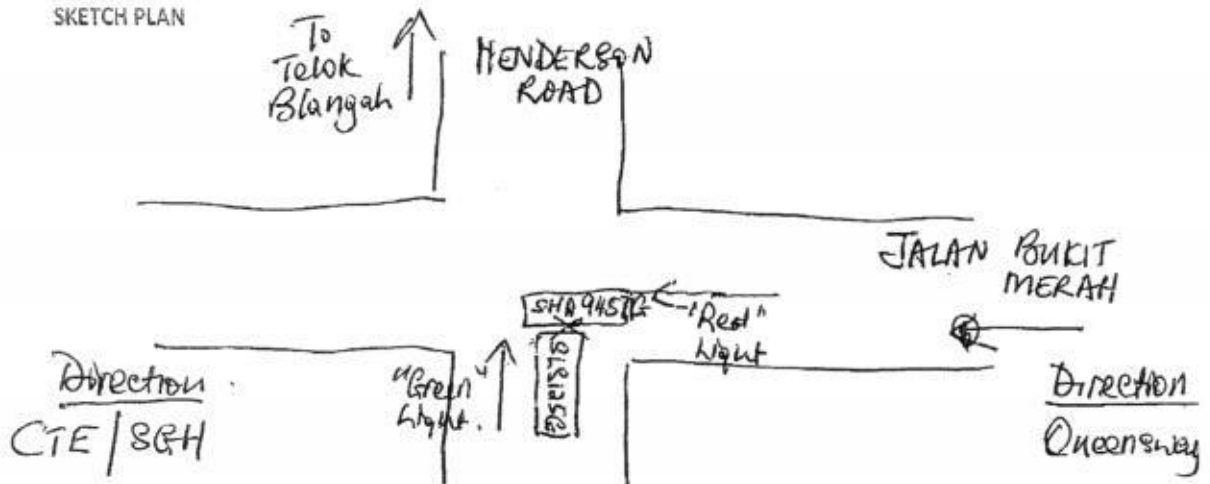
SKETCH PLAN

I was driving along Henderson Road in the direction of Telok Blangah. The traffic light at the junction of Henderson Road + Jalan Bukit Merah was showing "green" for me so I proceeded on. Suddenly a Comfort Taxi SHA 9457G appeared from the Jalan Bukit Merah side, even though I had the "green" light + right of way. I tried to brake, but it was too late and my car collided with the taxi. Subsequently I was told by the driver that he had made a mistake and was not concentrating + assumed the road was green in his favor. He apologized for his mistake.
