ASSIGNMENT

Vehicle No	: SLS2279H	Accident Date	: 10/02/2019
Make	: AUDI A3	Policy No.	: 1700050102
Assignment Date	: 18/02/2019	Excess	: S\$0.00
Date of Inspection	: 15/02/2019	Est. Duration of Repair	: 14.00
Inspection At	: PREMIUM AUTOMOBILES PTE LTD (UBI) 55 UBI ROAD 1 SINGAPORE 408699

VEHICLE DAMAGE INSPECTION REPORT

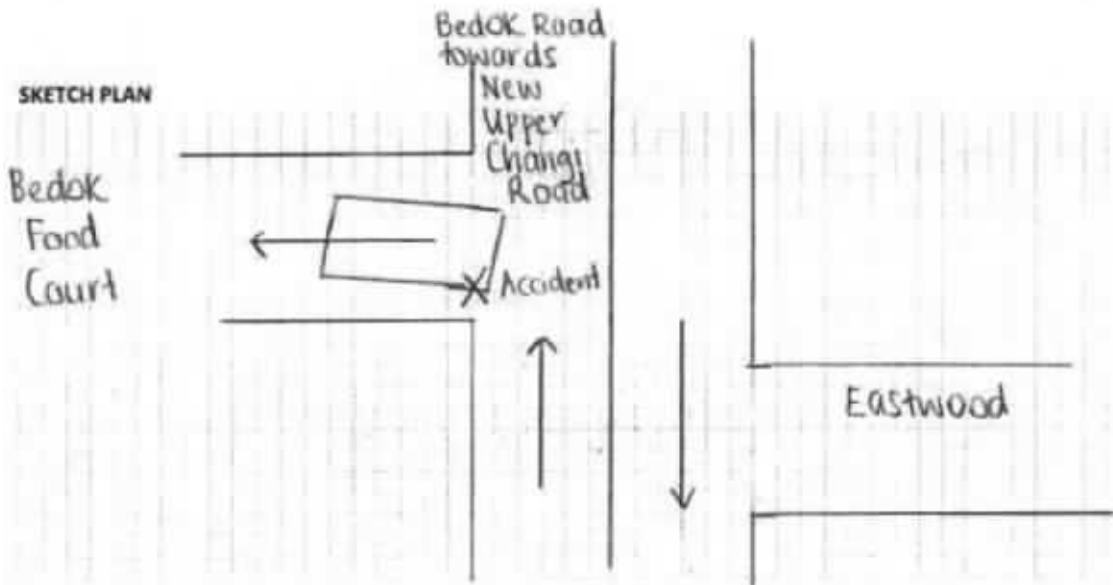
Sketch Plan #2

On 10/02/2019 at about 1715hrs along Bedok Road towards New Upper Changi Road, I was travelling in my vehicle SLS2279H and was turning left into the carpark of Bedok Food Centre. I slowed down before the turn and signalled early before making the turn. After making the turn into the carpark entrance and while waiting for the barrier to open in 3-5 seconds, I heard a bang on the left rear of my vehicle. I then stepped out to check and saw a male rider of motorcycle PBD 9221A on the ground. The road was clear and the road conditions were dry with light traffic.

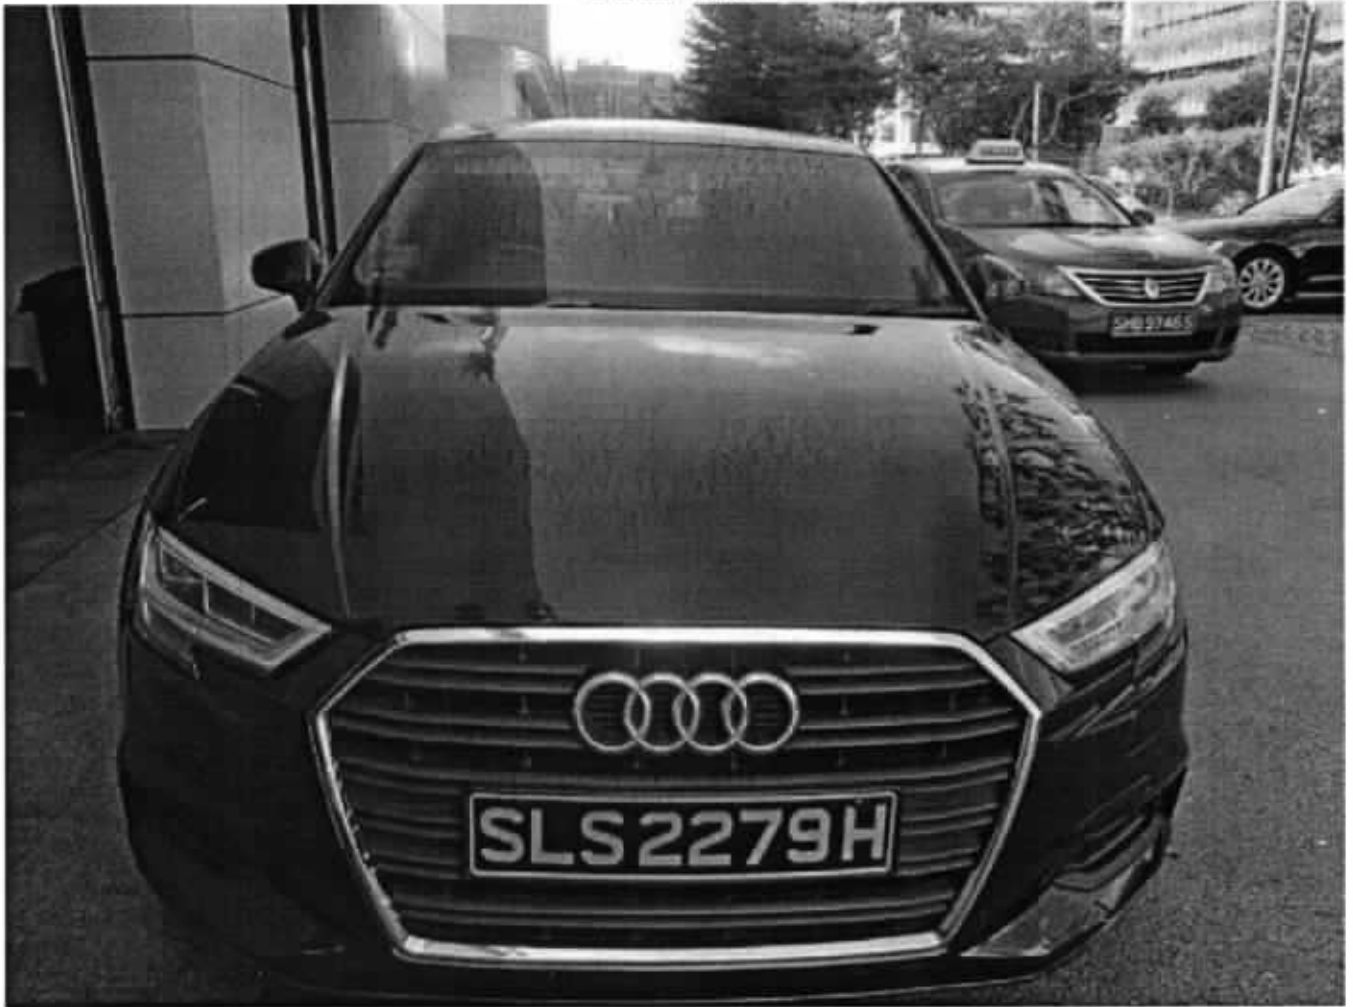
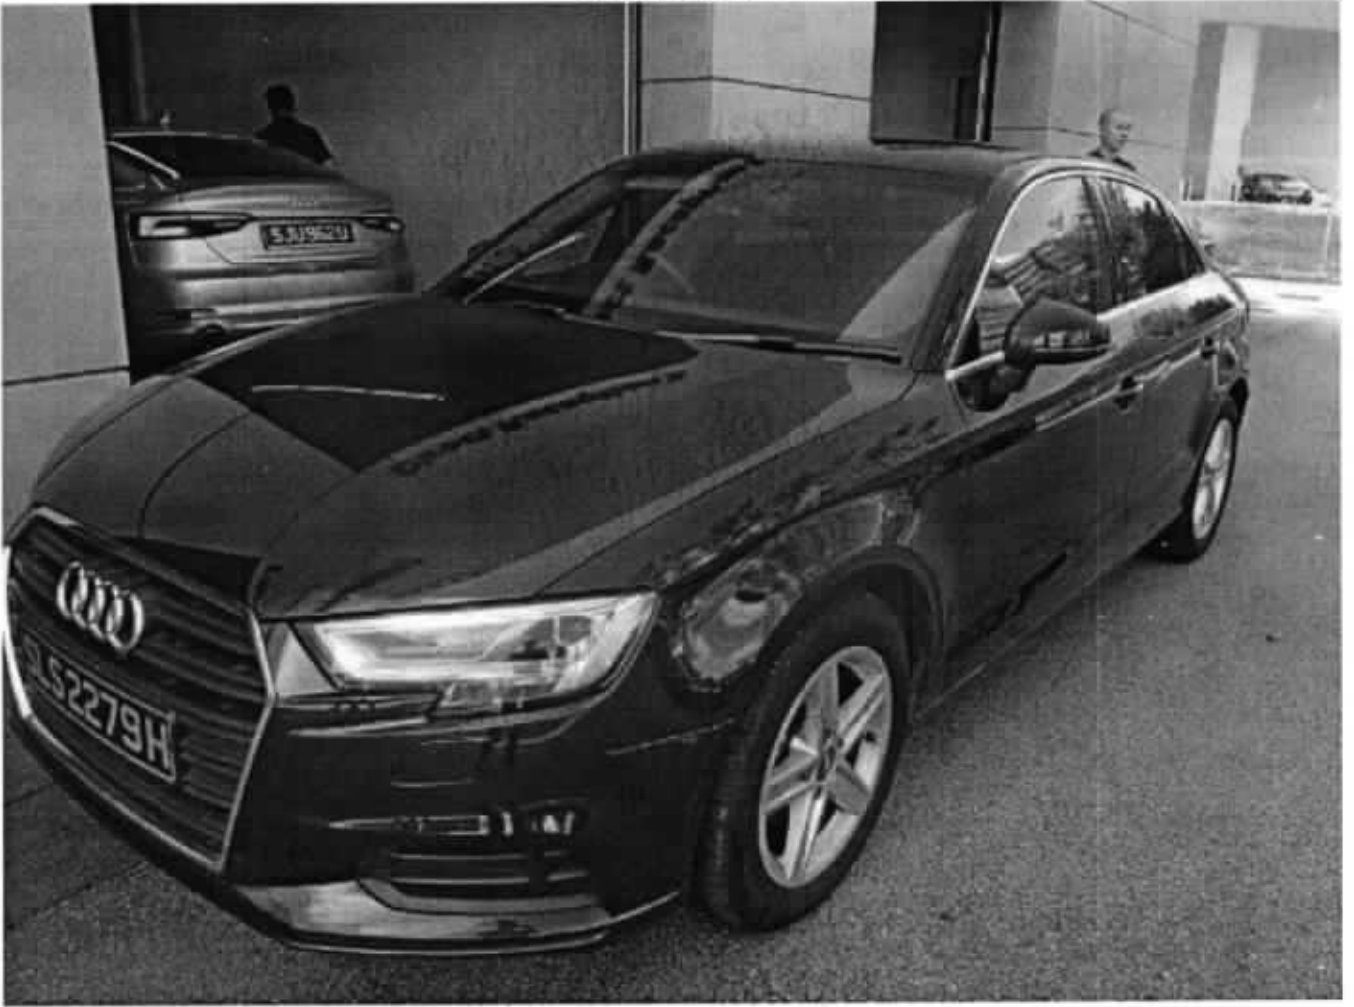
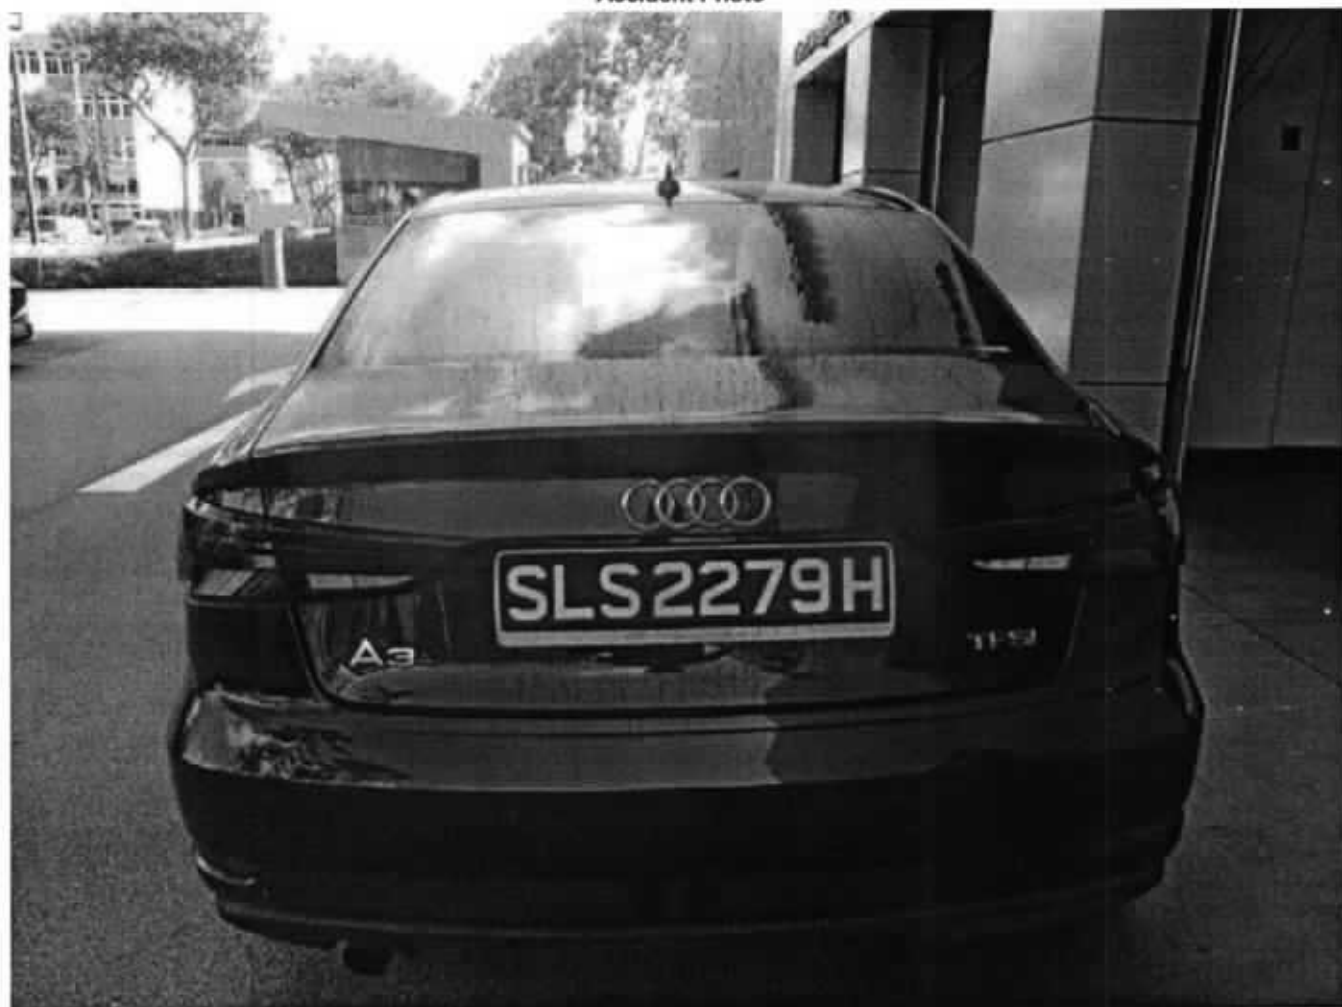
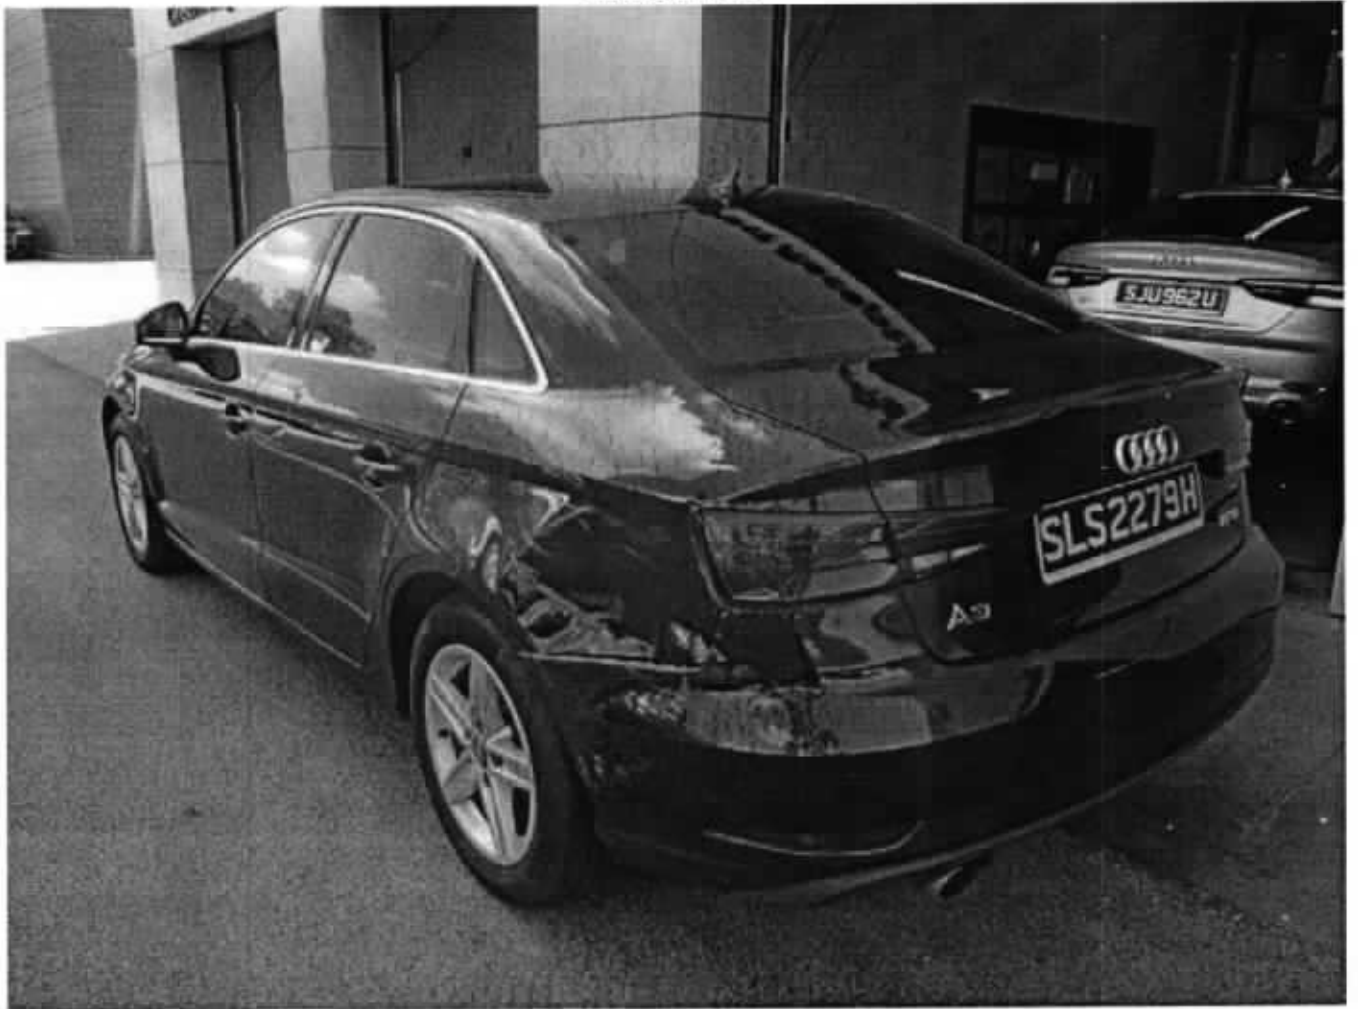
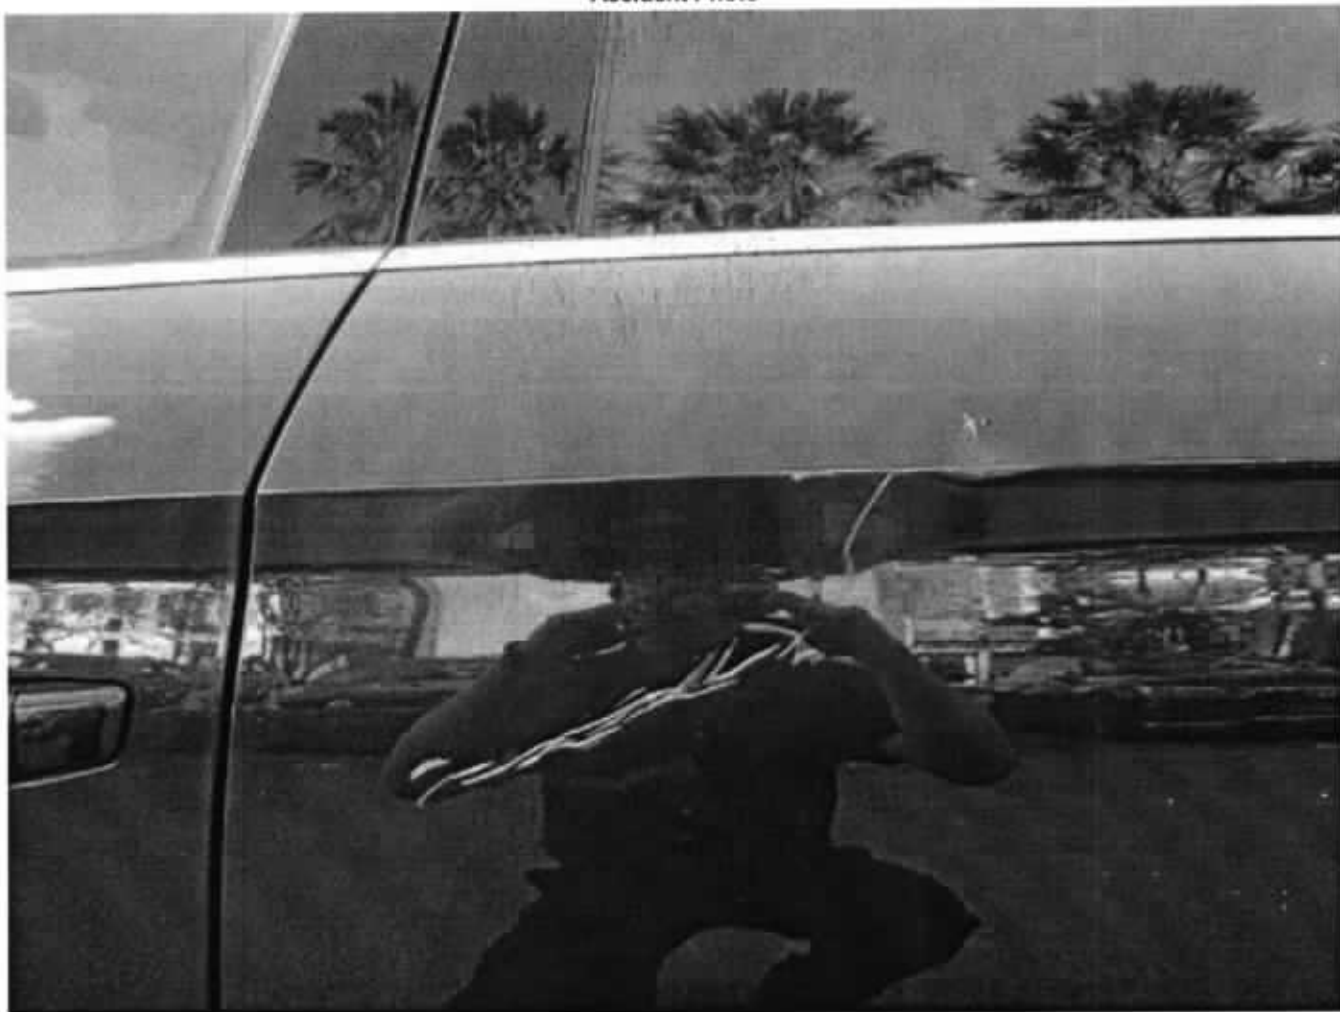
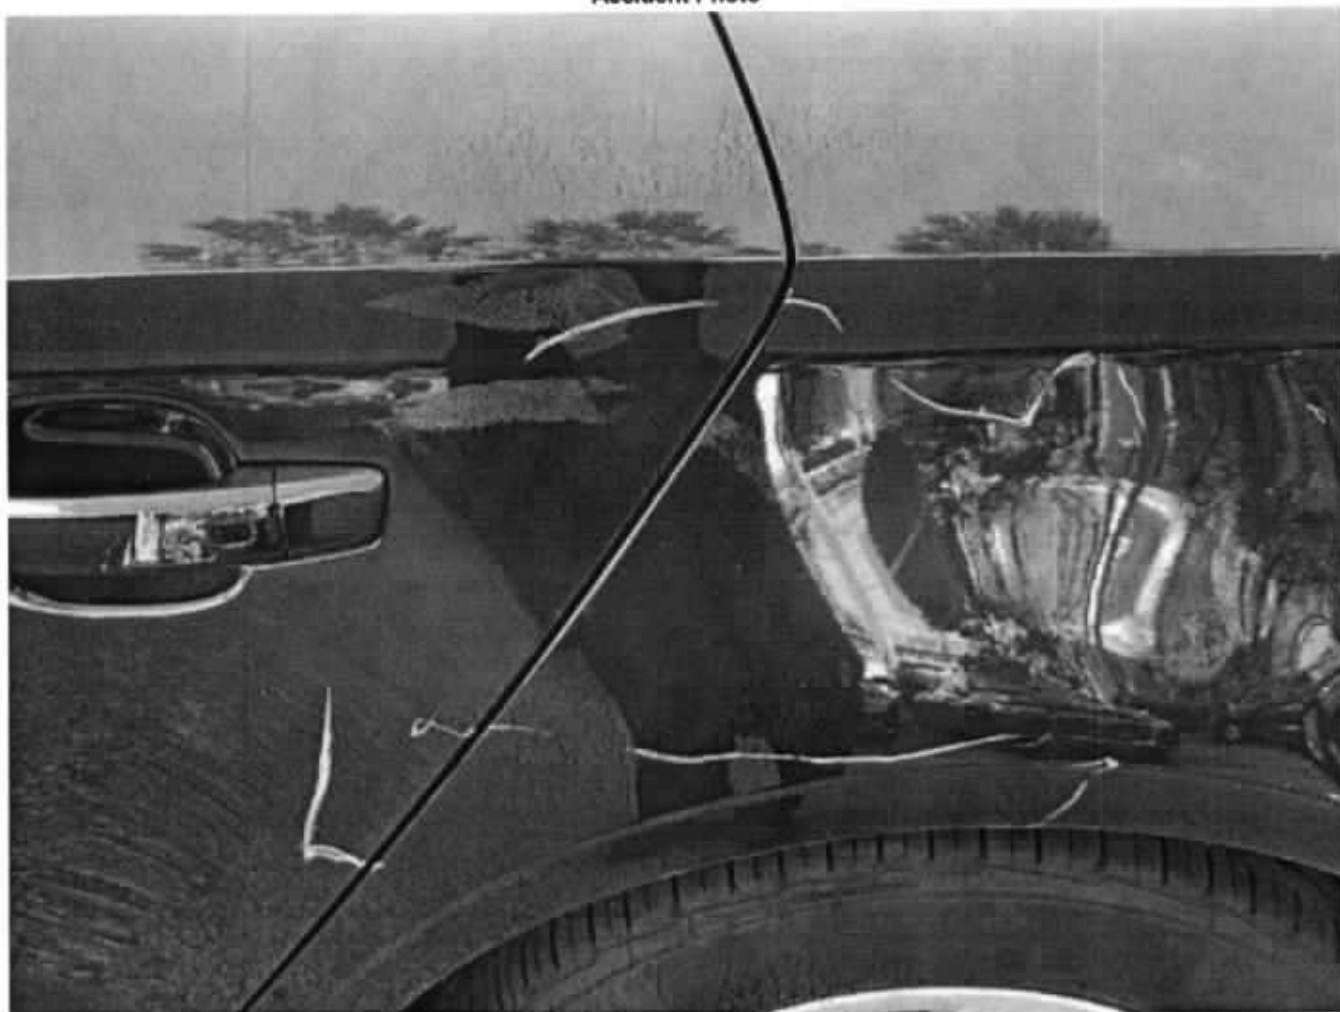
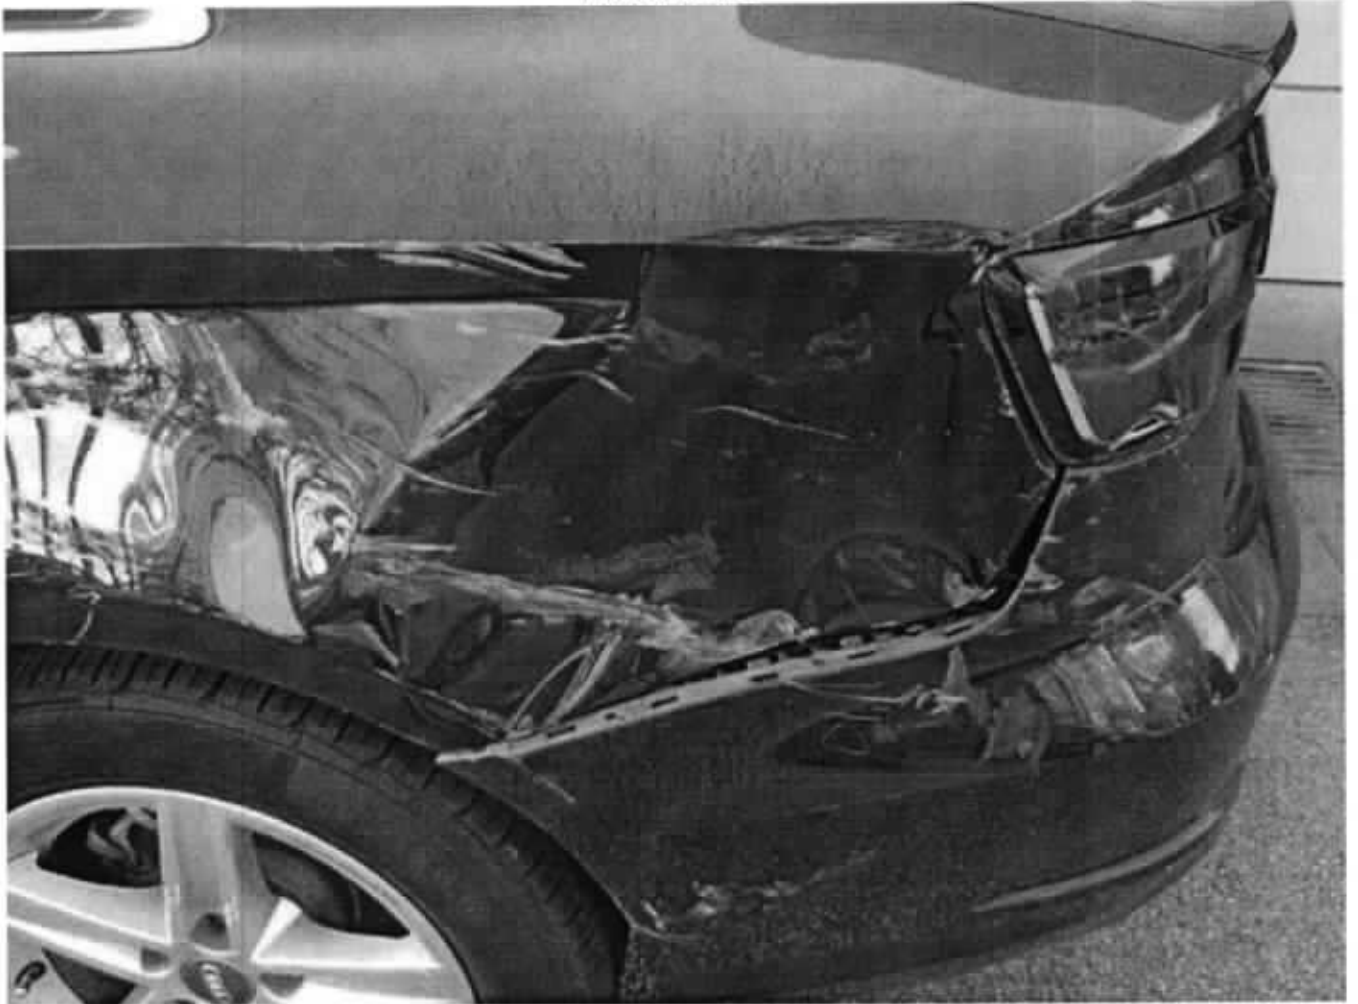
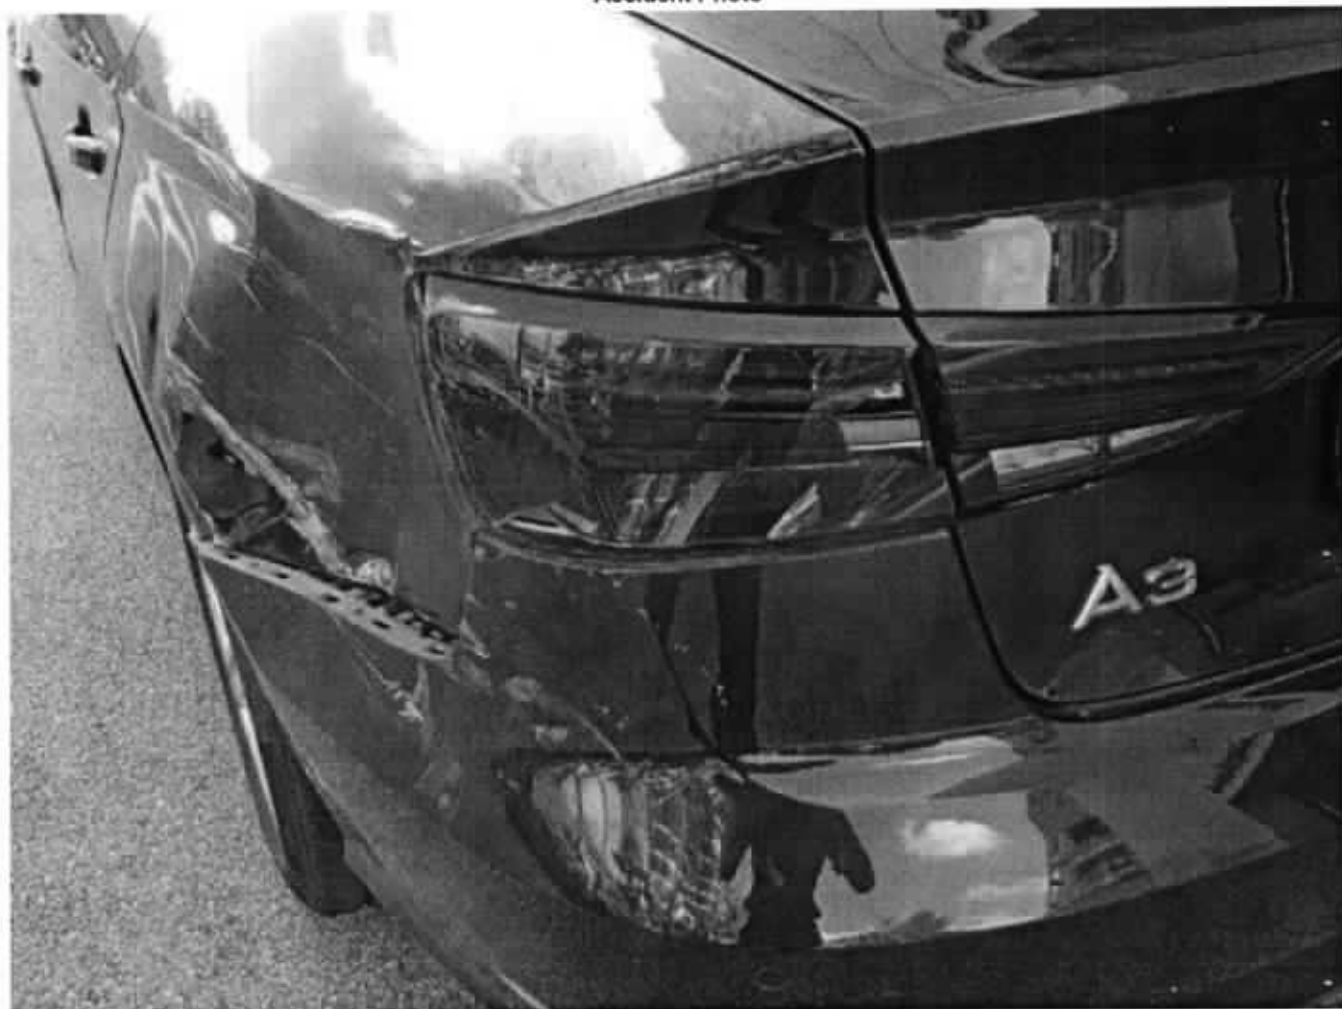
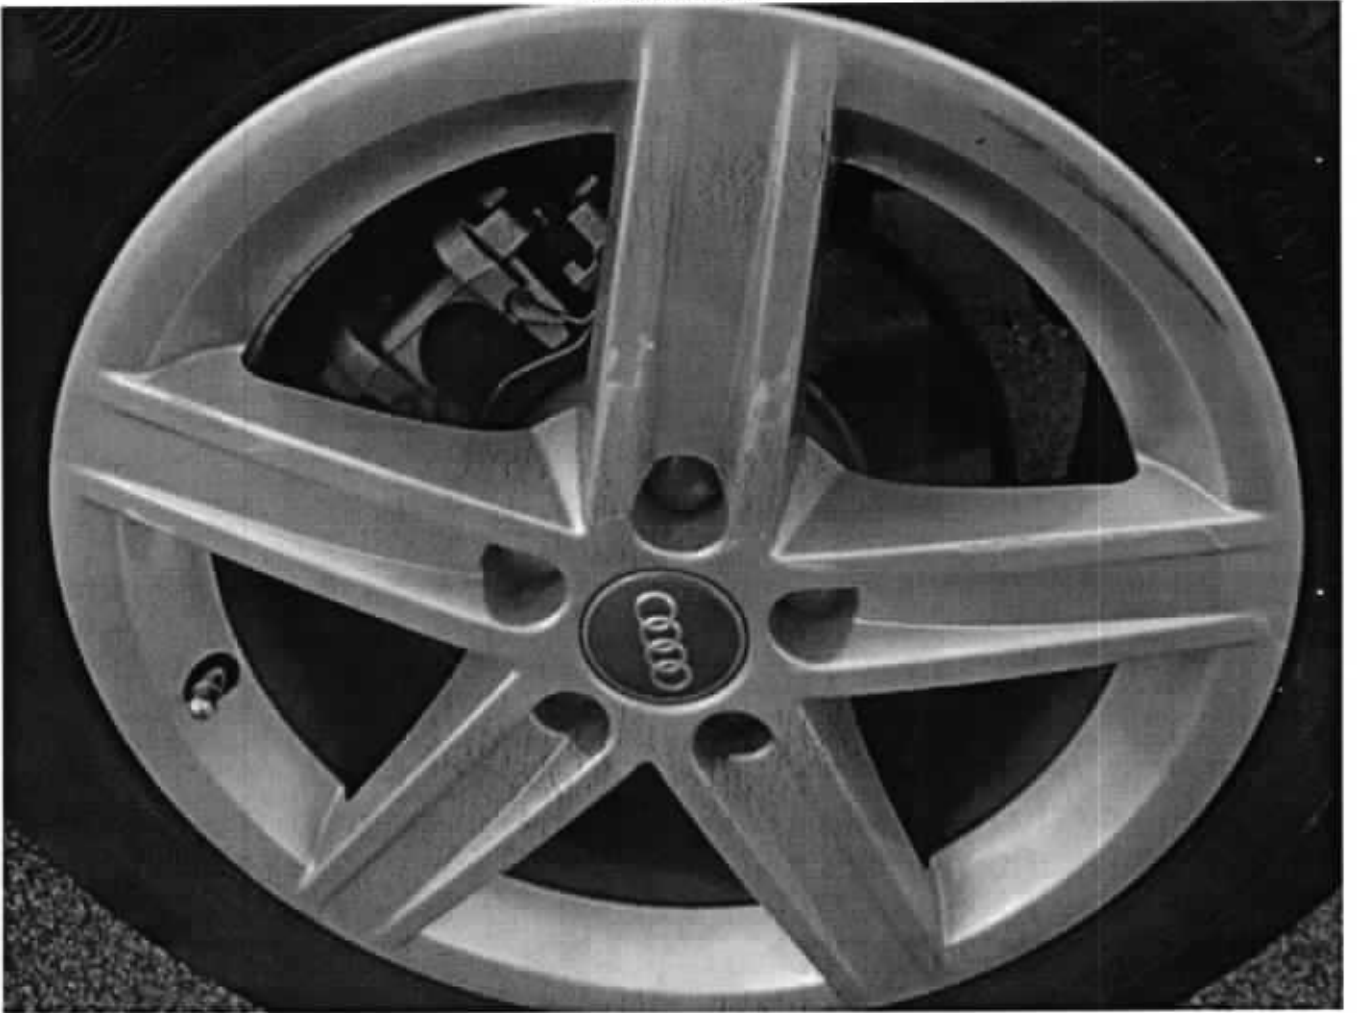
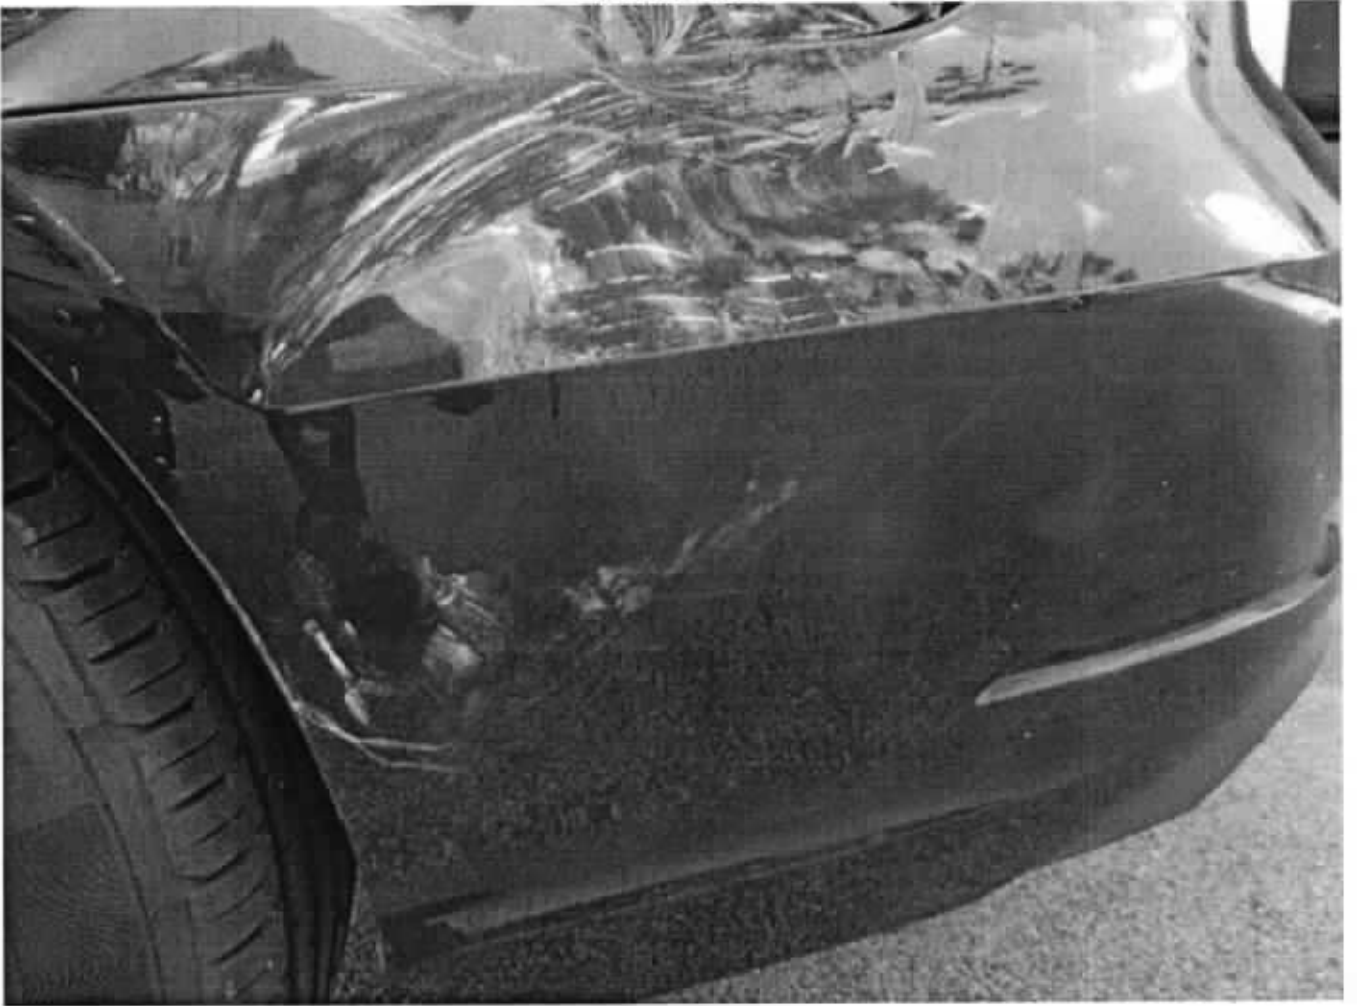
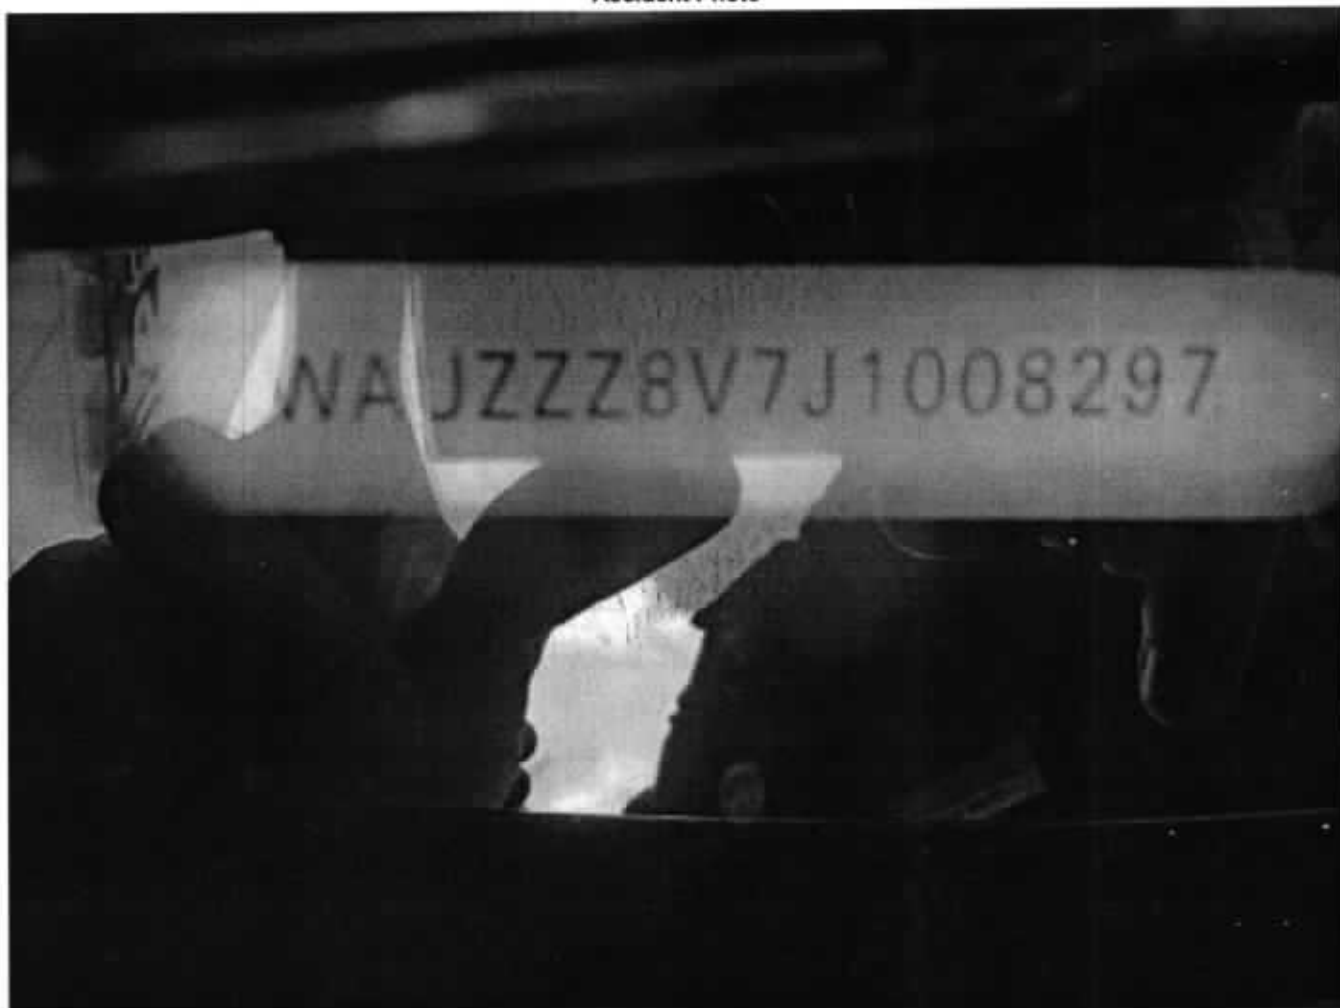
Accident Photo

The UIC / Chassis frame / Body Structure affected due to collision.

The vehicle sustained impact / damages n/s body and parts claimed are consistent to the accident.

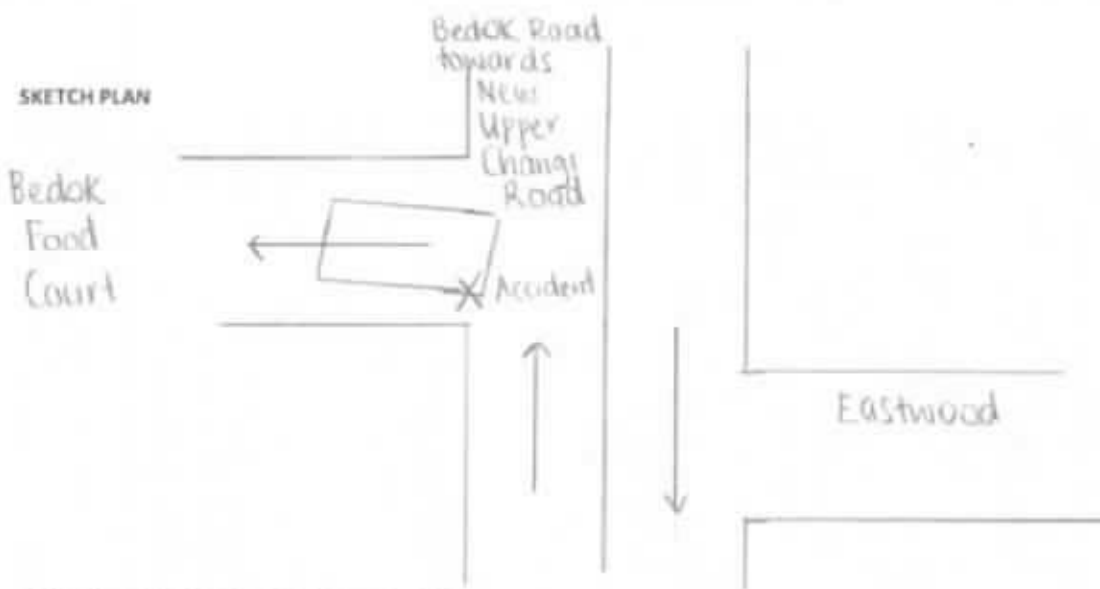
Sketch Plan #2

On 10/02/2019 at about 17:5hrs along Bedok Road towards New Upper Changi Road, I was travelling in my vehicle SLS 2279H and was turning left into the carpark of Bedok Food centre. I slowed down before the turn and signalled early before making the turn. After making the turn into the carpark entrance and while waiting for the barrier to open in 3-5 seconds, I heard a bang on the left rear of my vehicle. I then stopped out to check and saw a male rider of motorcycle (BD) 9221 A on the ground. The road was clear and the road conditions were dry with light traffic.
