Preliminary Advice

Insured Vehicle No : GBE2967Y

TP Vehicle No : SJB7118U

VEHICLE DAMAGE INSPECTION REPORT

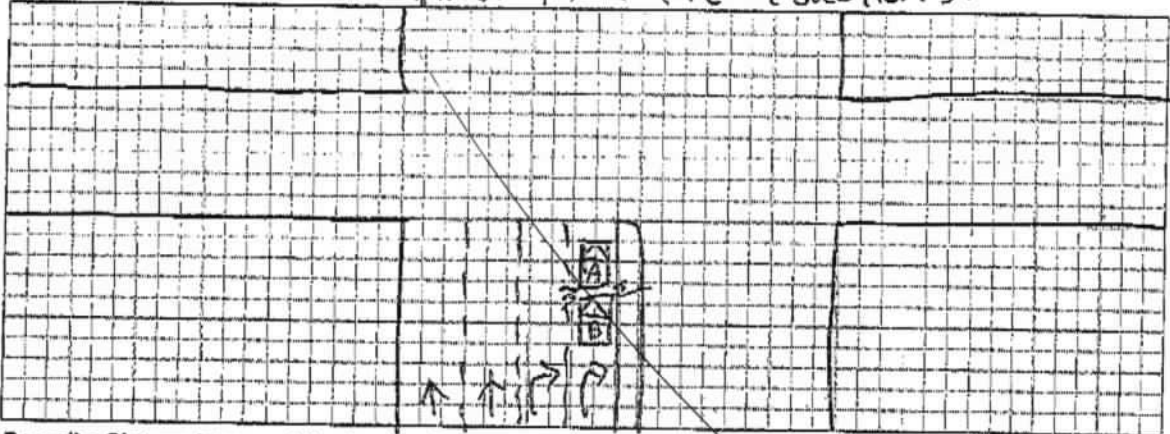
Sketch Plan

TAMPINES RD → KPE (JUNCTION).

I WAS TRAVELLING TAMPINES ROAD TOWARD KPE (JUNCTION). SOMEWHERE BEFORE KPE JUNCTION. I WAS THE 2ND VEHICLE DUE TO THE TRAFFIC RED LIGHT. ONCE THE TRAFFIC LIGHT CHANGED TO GREEN, VEHICLE AHEAD OF ME SUDDENLY STOPPED AND I ALSO APPLIED BRAKE AND MANAGED TO STOPPED. OUT OF SUDEN VEHICLE (B) CAME FROM THE REAR AND COULD NOT STOPPED IN TIME. THUS COLLIDED ONTO REAR PORTION OF MY VEHICLE.

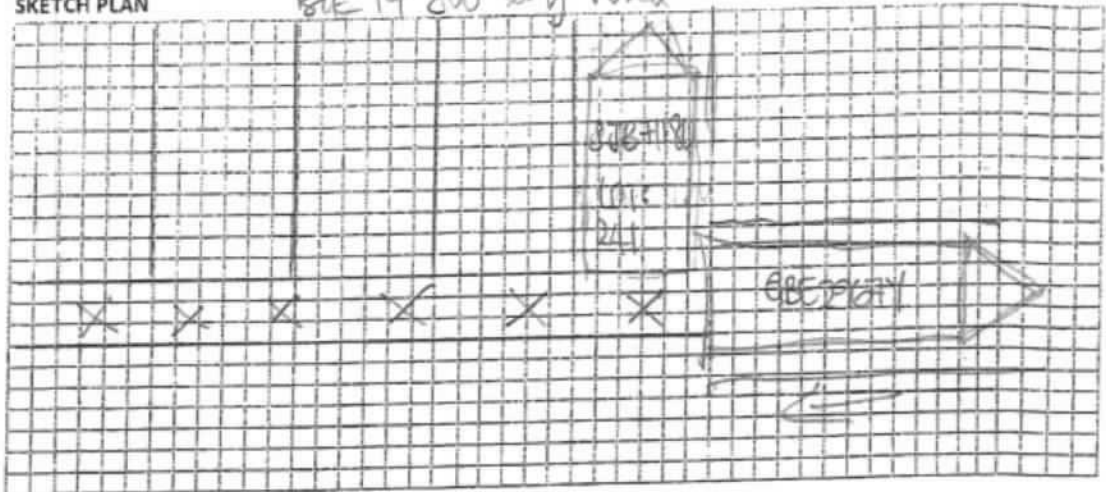
Sketch Plan #2

But 19 800 Lang Road
