SLK 8942D

Honda Vezel

The U/C / Chassis frame / Body Structure affected due to collision.

VEHICLE DAMAGE INSPECTION REPORT

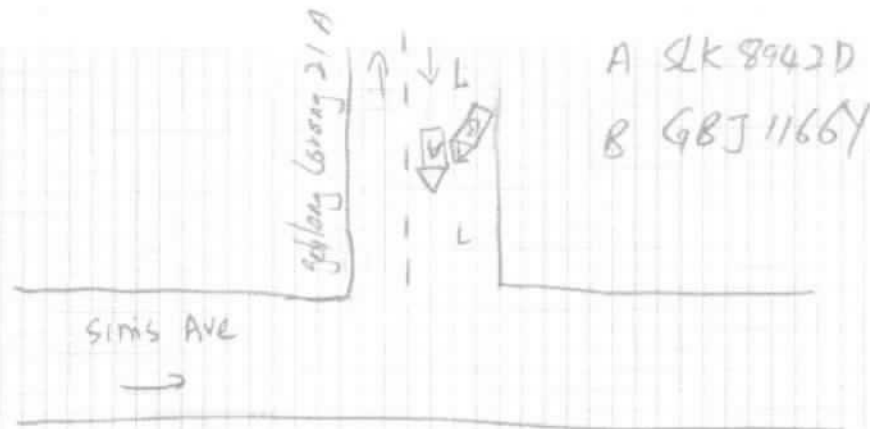
Sketch Plan #2

On 25th Friday about 8:30 am in this morning
 When I driving across straight on Gaylang Lwy ~~21A~~ 21A.
 Suddenly a Lorry from my left side come out and
 Know my left hand side door
