DAMAGE ASSESSMENT REPORT

Ref: CS3/SPF19003101/Gvd3e2

4. Description of Damages

ADJUSTMENT ON REPAIR COST FOR VEHICLE NO. SDR 828L

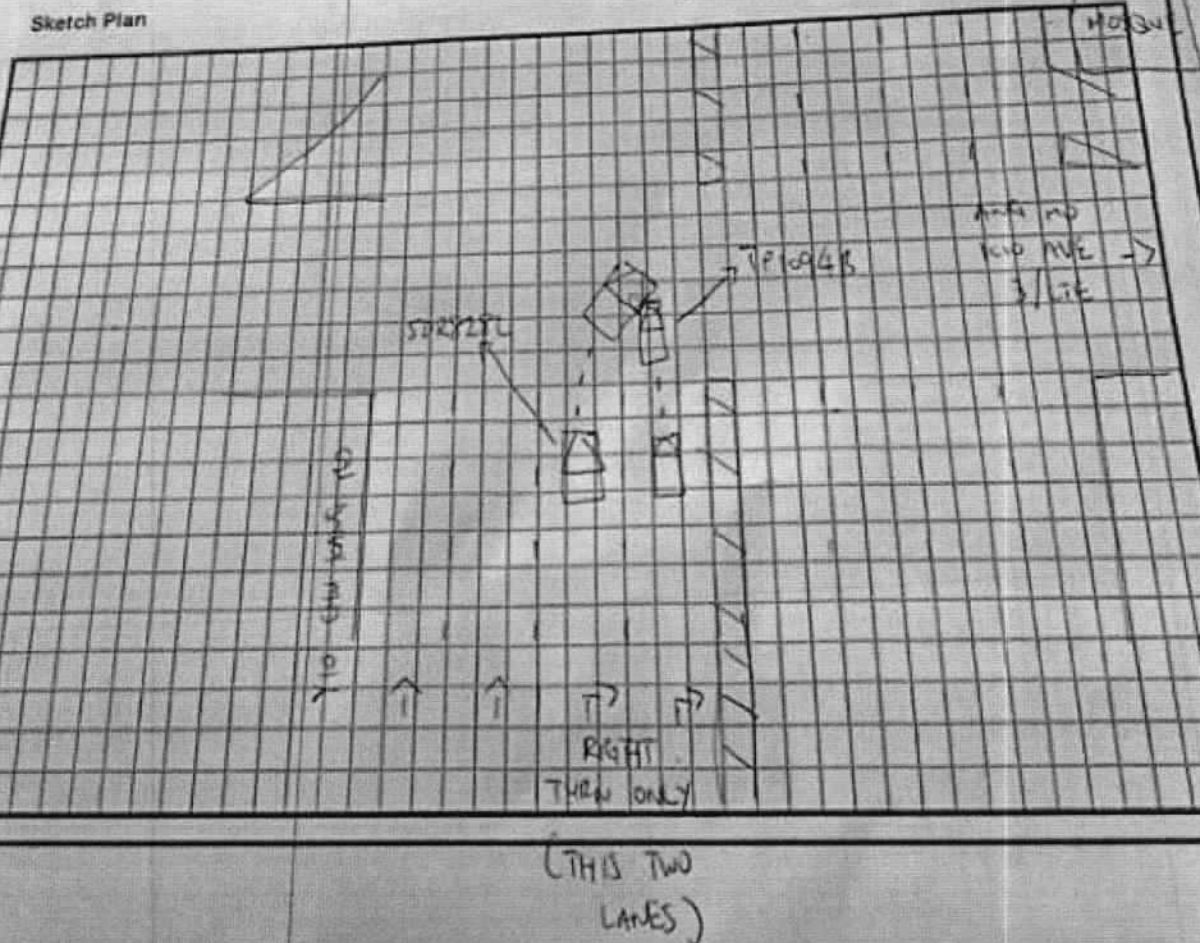
Sketch Plan

REFER TO POLICE REPORT NO: T/20190215/2209(LODGED AT HOUGANG N.P.C) ON THE 15/02/2019 AT 1939HRS, I WAS ON THE OUTER LEFT LANE OF A 2 RIGHT TURN ONLY LANE(TURNING RIGHT LANE TO ANG MO LIO AVENUE 3)ALONG YIO CHU KANG ROAD, AND HAD SIGNALLED TO TURN RIGHT. THERE WERE 2 TRAFFIC POLICE BIKES(TP1094B AND TP1097T) ON MY RIGHT SIDE OF A RIGHT TURN ONLY LANE. TRAFFIC LIGHT WAS RED. ON MY LEFT THERE IS A YELLOW/GOLD COLORED BMW. WHEN THE TRAFFIC LIGHT TURNED GREEN WITH ARROW SIGNALLED GREEN TO TURN RIGHT, THE BMW ON MY LEFT ROARED ITS ENGINE AND SPED STRAIGHT AHEAD. MY VEHICLE MOVED OFF SLOWLY TO TURN RIGHT. THE TRAFFIC POLICE BIKE TP1094B ON MY RIGHT SIDE OF MY VEHICLE HAD SPED STRAIGHT ON A RIGHT TURNING ONLY LANE. I HEARD A LOUD BANG AND REALIZED HIS BIKE HAD DIRECTLY IMPACT AND COLLIDED ONTO MY CAR DRIVER SIDE DOOR AND THE FENDER, AS WELL AS THE BUMPER, I IMMEDIATELY JAMMED BRAKE. DUE TO THIS IMPACT, THE TRAFFIC POLICE OFFICER HAD FELL OFF HIS BIKE AND ROLLED OFF TO THE OPPOSITE RIGHT SIDE(ON THE OPPOSITE ONCOMING TRAFFIC), THE TRAFFIC POLICE OFFICER ROLLED AND LIED IN FRONT OF VEHICLE SJU6979H ON THE 1ST RIGHT LANE, AND HIS BIKE HAD SKIDDED TO THE EXTREME LEFT SIDE IN FRONT OF SJS3127E(NOTE:DRIVER OF SJU3127E MR JEREMIAH, INFORMED THAT HE DO DO HAVE A IN-CAR CAMERA BUT HE DID NOT WANT TO GIVE HIS IN CAR FOOTAGE TO ME, BUT ONLY TO THE POLICE UPON REQUEST)AND COULD HAVE COLLIDED TO THE FRONT AREA. THE TRAFFIC POLICE OFFICER WHOM HAD FELL OF HIS BIKE, ROLLED AND HIT BESIDE THIS VEHICLE SJU6979H. I THEN WENT OUT OF MY VEHICLE TO CHECK ON THE OFFICER AND HE IS STILL CONSCIOUS, I MADE A CALL TO 995. THE OTHER POLICE BIKE TP1097T WHICH HAD CROSSED OVER, MANAGED TO TURN BACK TO THE SCENE. PLEASE REFER TO ATTACHMENT
