VEHICLE DAMAGE INSPECTION REPORT

Our File No: CS/AIG19003215/KQD3Q2
Date: 04/03/2019

Handling Insurer: AIG Asia Pacific Insurance Pte. Ltd.	Policy No: 0999994822	
Claimant Vehicle No : GBE7002Z	Insured Vehicle No : SLB5907Z	
Date of Loss: 18/02/2019	Nature of Claim: TP	Claim No: 5920353618SG

Reg No: GBE7002Z		Engine No: 1KD2590536
Make & Model: TOYOTA HIACE, 3.0 (A)		Chassis No: JTFHT02P400189862
Reg. Date: 01/03/2016 (Man. Year: 2016)		Odometer: 102939 km
Colour: Metallic Silver		
Engine Capacity: 2982 cc		
Market Value/New Car Price: N/A		
Sum Insured (S\$): Market Value/New Car Price

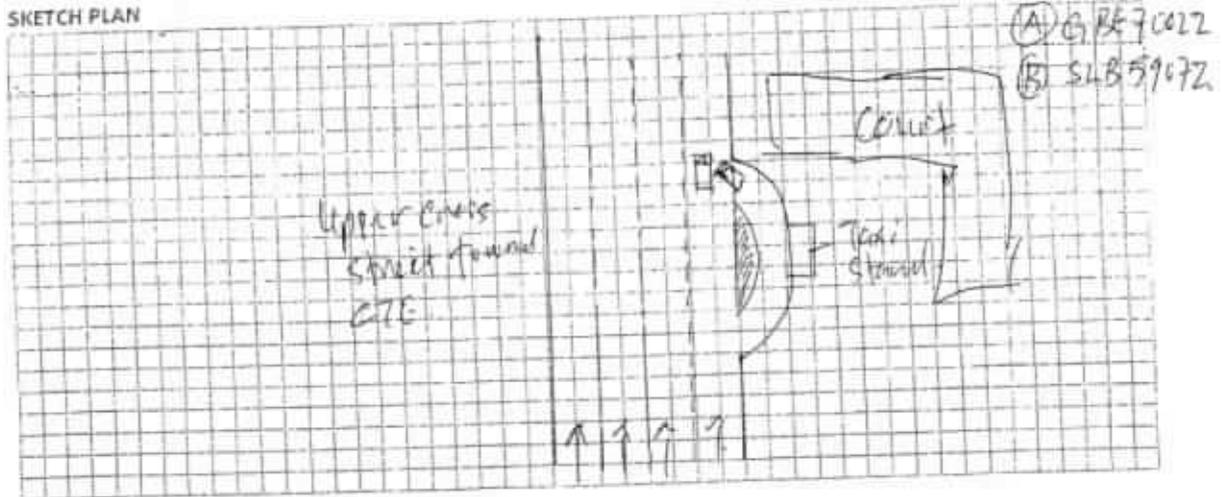
SKETCH PLAN

I was travelling along Upper Cross St towards CTE on the extreme right lane of 4 lanes road. Approaching the front of court, a vehicle SLB 59072 suddenly came out from the slip road without stopping and collided against my right side of my van. My right side of my van was damaged.
