Ref : CS/TP19003242/Utd3n2

ON BEHALF OF BALAKRISHNAN S/O
RAJAMANICKAM

1. Policy Particulars :- THIRD PARTY CLAIM

ADJUSTMENT ON REPAIR COST FOR VEHICLE NO. SMD 2601C

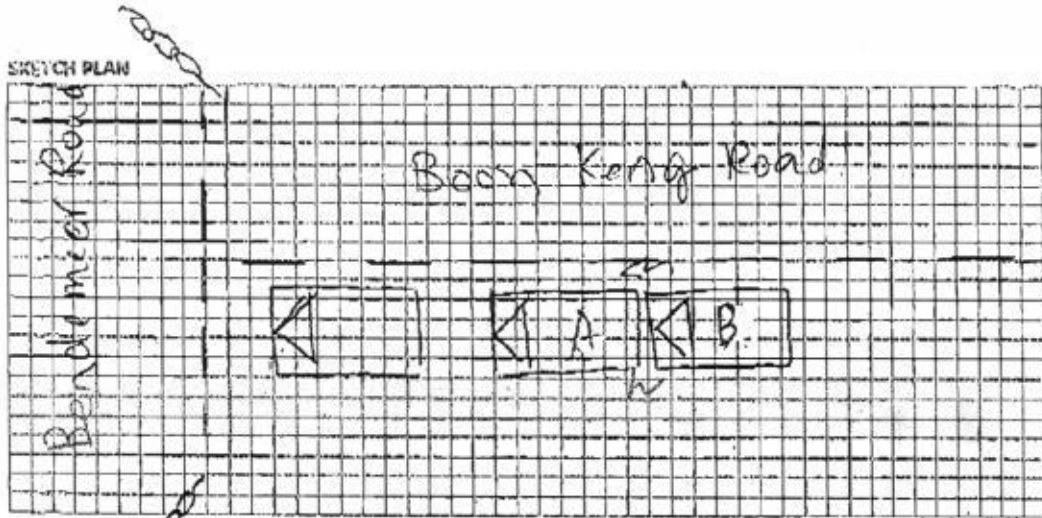
Sketch Plan #2 Pg. 1

On 16/2/19 at about 5:05 pm, I stopped due to red light for about 1 min when suddenly car B moved and hit the rear of my car (A).
