Vehicle No	: SLE5601P	Accident Date	: 18/02/2019
Make	: AUDI A3	Policy No.	: 2100476156-02
Assignment Date	: 21/02/2019	Excess	: S\$0.00
Date of Inspection	: 20/02/2019	Est. Duration of Repair	: 12.00
Inspection At	: PREMIUM AUTOMOBILES PTE LTD (UBI) 55 UBI ROAD 1 SINGAPORE 408699

Point of Impact / General Description of Damages

VEHICLE DAMAGE INSPECTION REPORT

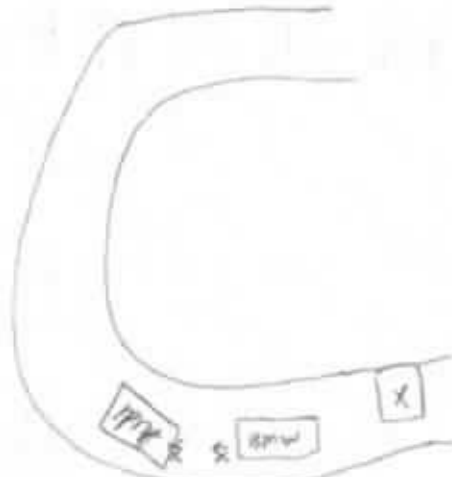
SKETCH PLAN

A car skidded and my front vehicle stop to allow the skidded car to reverse. As it was at a bend, I could not see that the front vehicle had stopped. When I see it I tried to brake but floor is slippery and the ~~brake~~ could not brake in time.

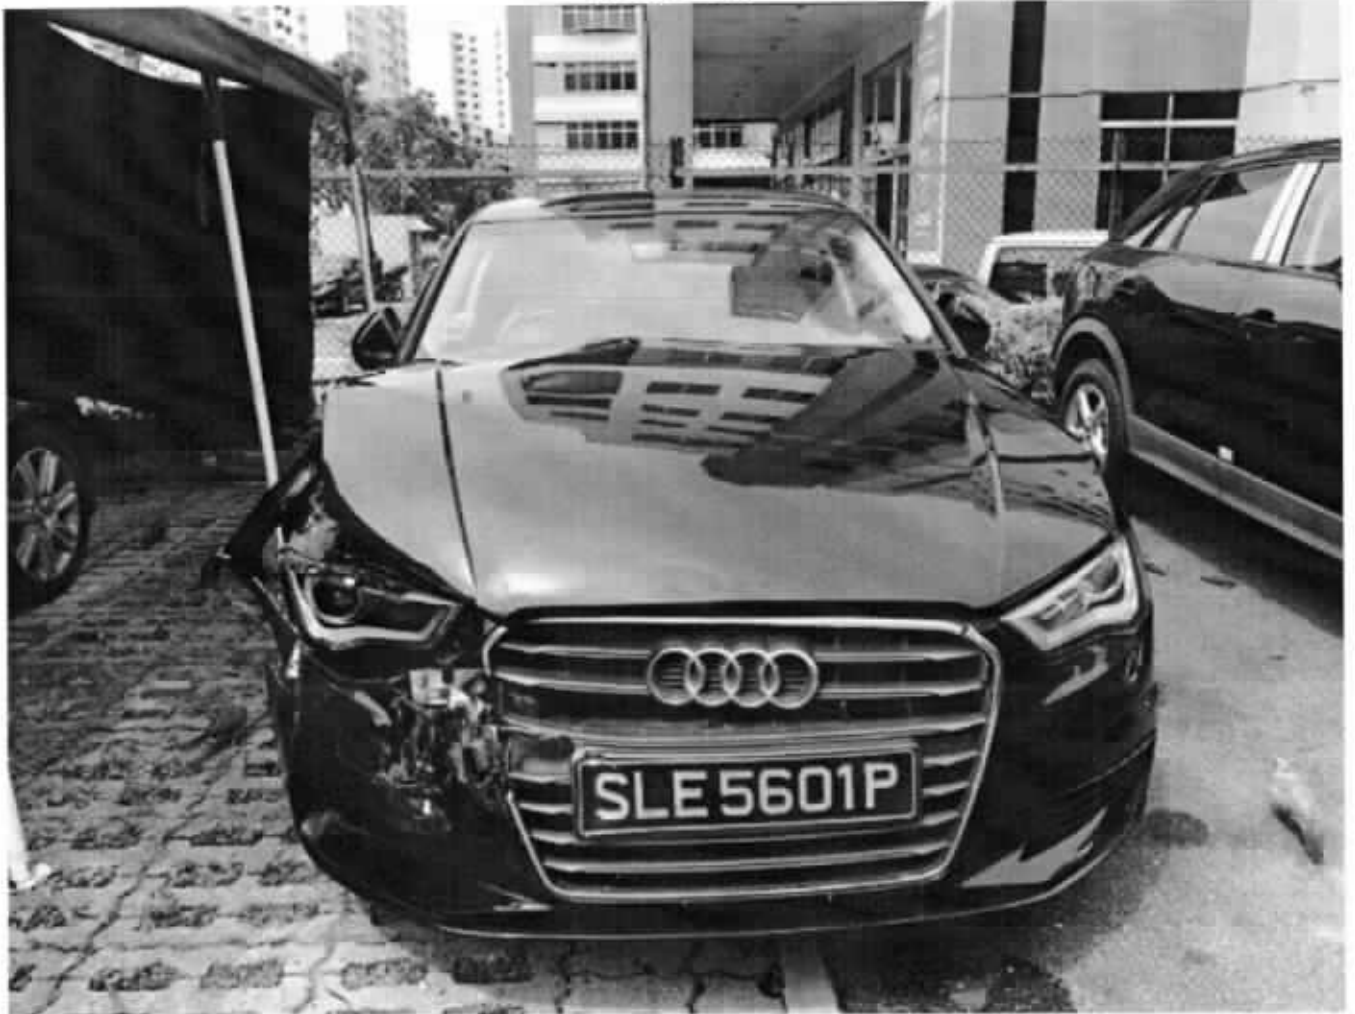
Accident Photo

The vehicle sustained impact / damages front portion and parts claimed are consistent to the accident.
