SLP 7163R

SINGAPORE ACCIDENT STATEMENT

VEHICLE DAMAGE INSPECTION REPORT

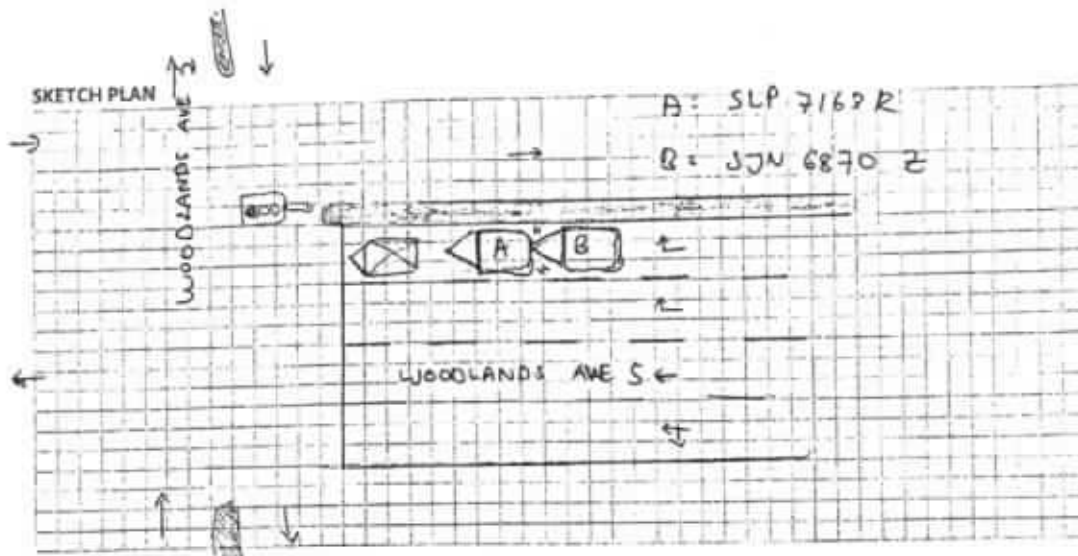
Sketch Plan #2 Pg. 1

waiting for traffic light to turn green

My vehicle is stopped at the traffic light (Woodlands Ave 5, turning into Woodlands Ave 2) when the other party (SJN 6870Z) hit into ~~the~~ rear of my vehicle (SLP 7163R)
