To inspect Vehicle No: PC 5799R

DAMAGE ASSESSMENT REPORT

THE VEHICLE SUSTAINED DAMAGES AT THE O/S REAR PORTION.
DAMAGES SEE DETAILS.

ADJUSTMENT ON REPAIR COST FOR VEHICLE NO. PC 5799R

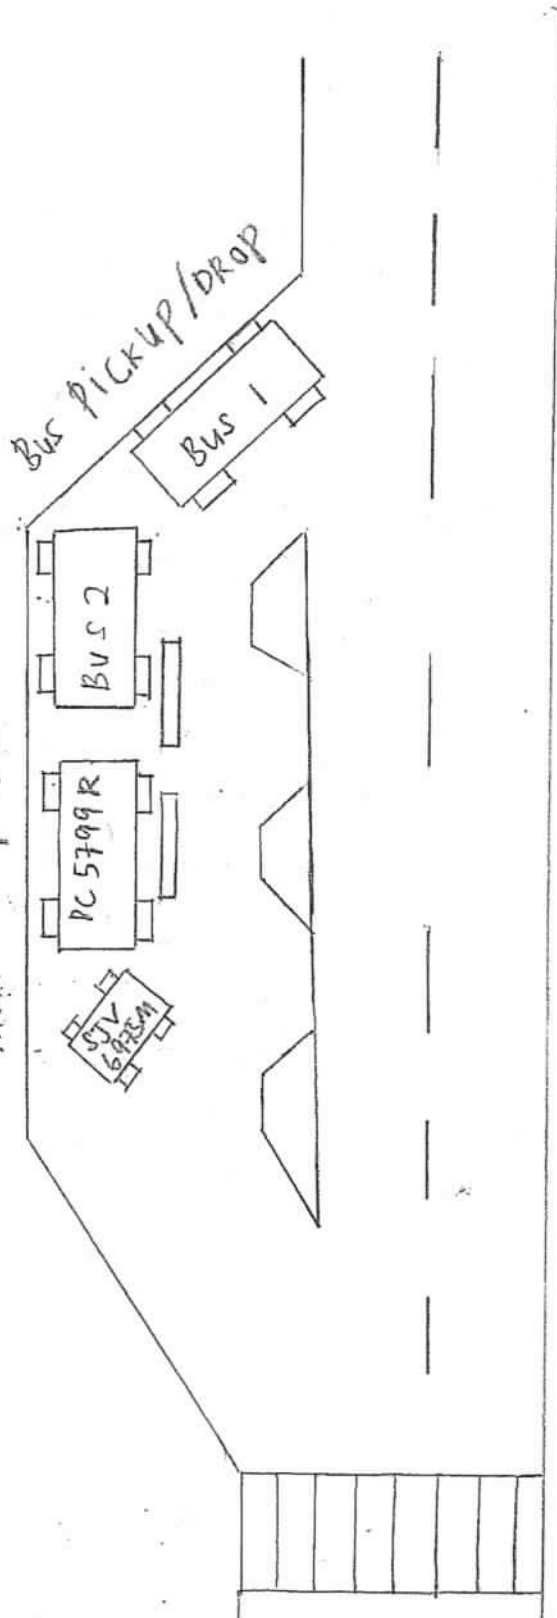
SKETCH PLAN

MY BUS WAS STATIONARY AT SGH BLOCK 3 WAITING TO ALIGHT PASSENGERS. WHEN SUDDENLY, ONE PRIVATE VEHICLE, SJV6975M FROM BEHIND TRIED TO OVERTAKE MY BUS AND IN THE PROCESS, THE LEFT PORTION OF THE SAID VEHICLE GRAZED AGAINST THE REAR RIGHT PORTION OF MY BUS. THERE WERE 4 PASSENGERS IN MY BUS AND NO INJURY WAS REPORTED AT THE MATERIAL TIME. THIRD PARTY PROPOSED FOR PRIVATE SETTLEMENT & I INFORMED MY COMPANY TO CALL HIM FOR NECESSARY FOLLOW UP

SGH BLOCK 3

MAIN ENTRANCE
