FBC2762G

Date: 25/2/19	Veh No: FBC 2762G	Reg: 01-08
Estimated Cost:	Type: M/Car / <u>M/Cycle</u> / Bus / Van / Lorry / Taxi / Prime Mover /	
OD / TP / WS / TP RES / OD RES / EVA / MV / MY	Truck / Trailer or	
To Insured Vehicle No: FBC 2762G	Make: Yamaha	XIR CC 135
at Workshop no: complete VMS	Colour: Multi Colour	A/C Insured / Std / Nil / NA
of: 176 Sin Ming Drive #03-14	Sp Reading: 46P3	I/Radio: Insured / Std / Nil / NA
Insured:	Eng No: 4S	3001787
Policy No:	C/Nr:	
Claims No:	Gen. Cond: <u>Good</u> / Fair / Poor / Burnt	
Sum Insured:	Steering: <u>In order</u> / Jammed / Leaked / Burnt or	
(Client's Record)	Brake: <u>In order</u> / Jammed / Leaked / Burnt or	
Make of Veh:	Modl: Nil / S/Rim / STD / <u>Alum</u> or	
(Policy Condition)	Tyre Size: F: 80/180R17	
Remark: The veh had commenced its repair at the time of inspection.	R: 80/180R17	
	BS / DUN / EXNOVA / GY / FS / LIZA / <u>MMC</u> / OHTSU / PIR / SUMI /	
	TOYO / YOKO or

Insured:	LIM ENG HONG, ID: S6918148A		
Main Claimant:	OOI BON SEONG		
Vehicle Reg. No.:	FBC2762G	Date of Loss:	21/02/2019 08:00 - :59
Claim Type:	TP / CMTD1901032	Policy/Cover Note No.:	D18MTPV01014323 (Comprehensive)
Vehicle Reg. No. (Insured):	SFU2580Y	Polic

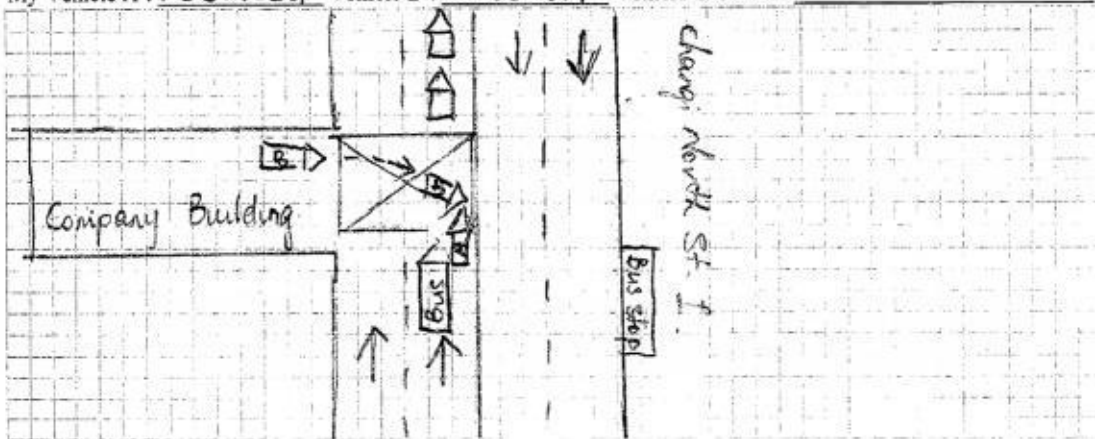
SKETCH PLAN

Date of Accident: 21/02/19 Time: 08.40am Location: Changi North Street one
 My Vehicle A: FBC2762G Vehicle B: SFU2580Y Vehicle C/Others: _____

I was driving along Changi North Street 1. I slowed down upon approaching the yellow box as the front vehicles after the yellow box are stationary.
 Suddenly vehicle B making a right turn and not noticing me and knocked into my bike.
