## ACCIDENT DAMAGED VEHICLE INSPECTION REPORT

Date of Accident : 18 June 2018  
Date of Inspection : 21 June 2018

Registration No : SGN8209G  
Make : TOYOTA  
Model : VIOS 1.5E A  
Year : 2006

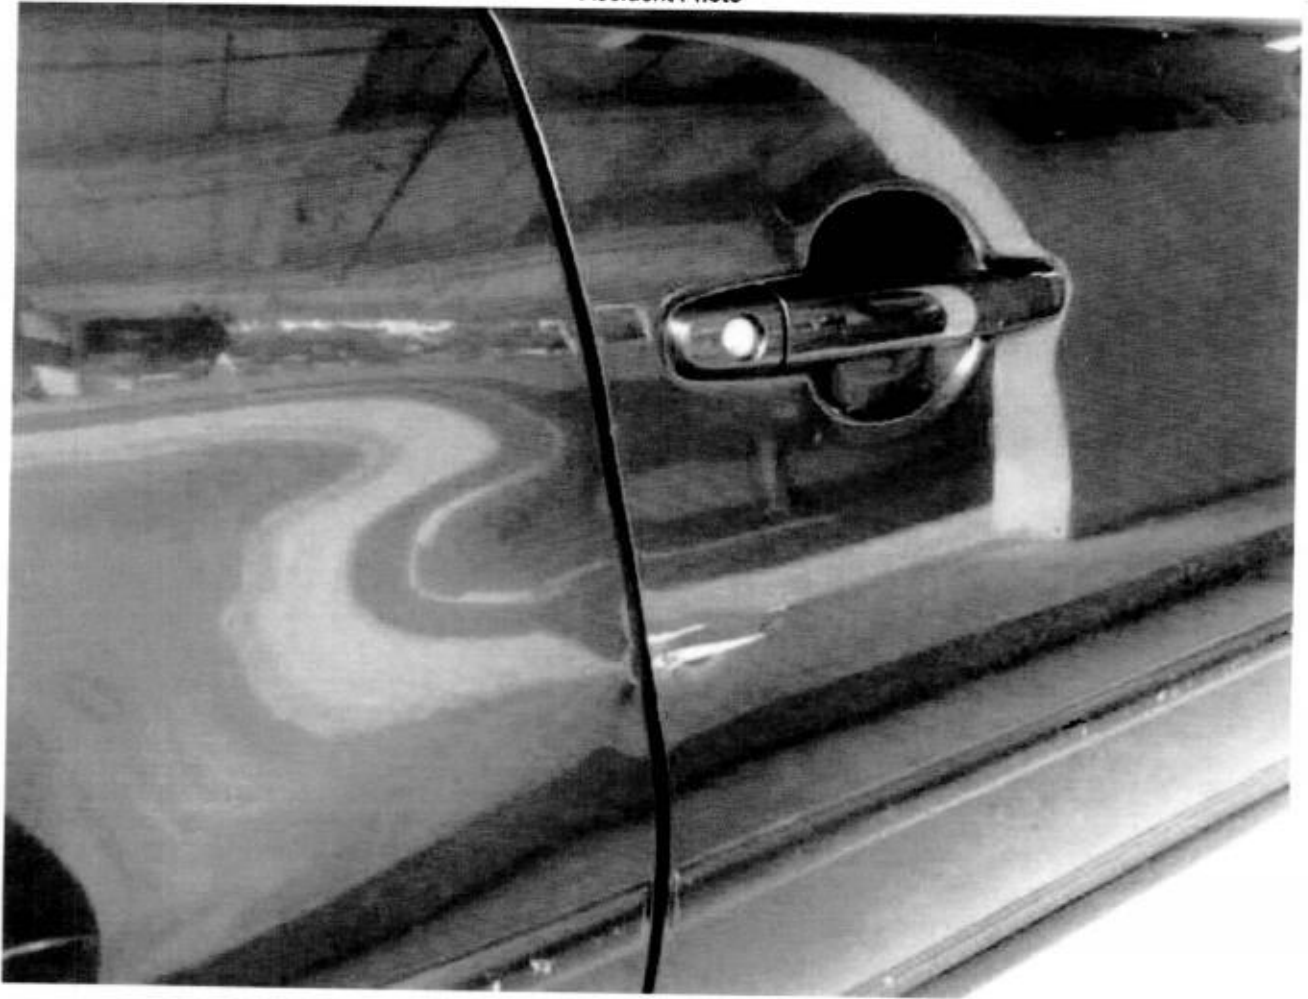
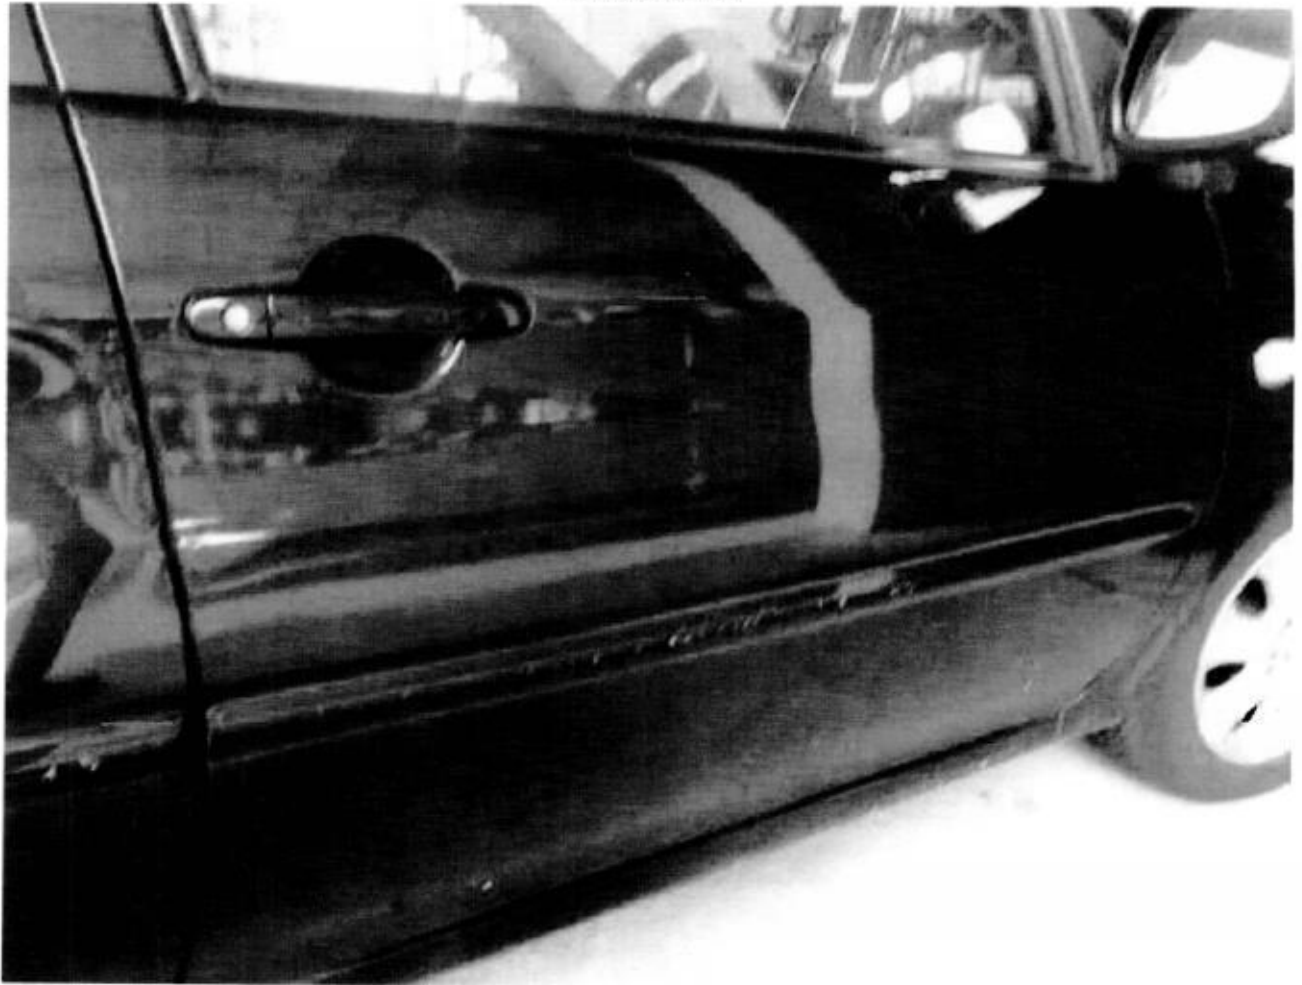
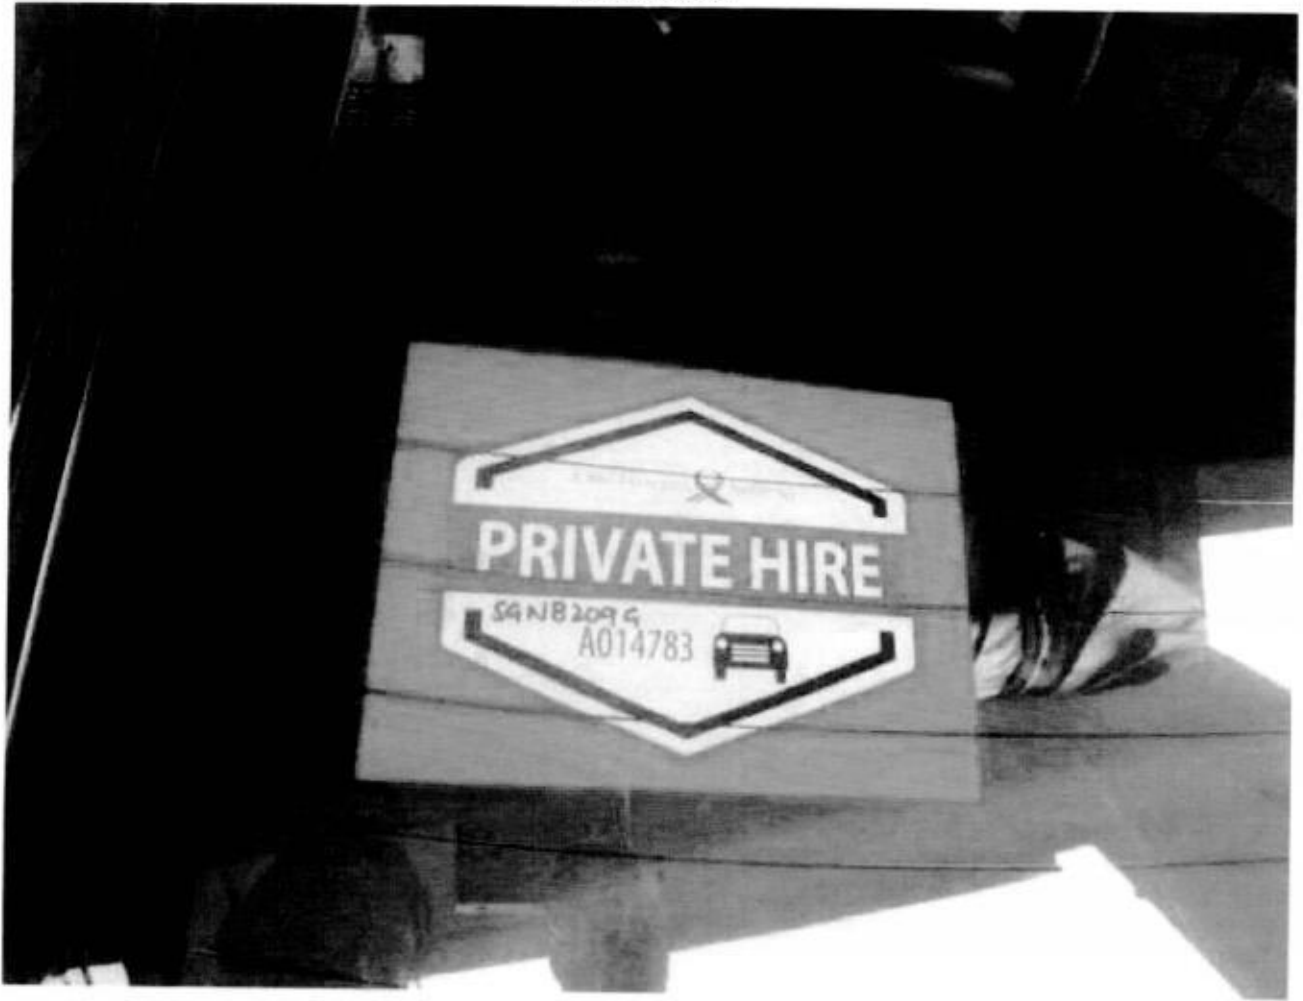
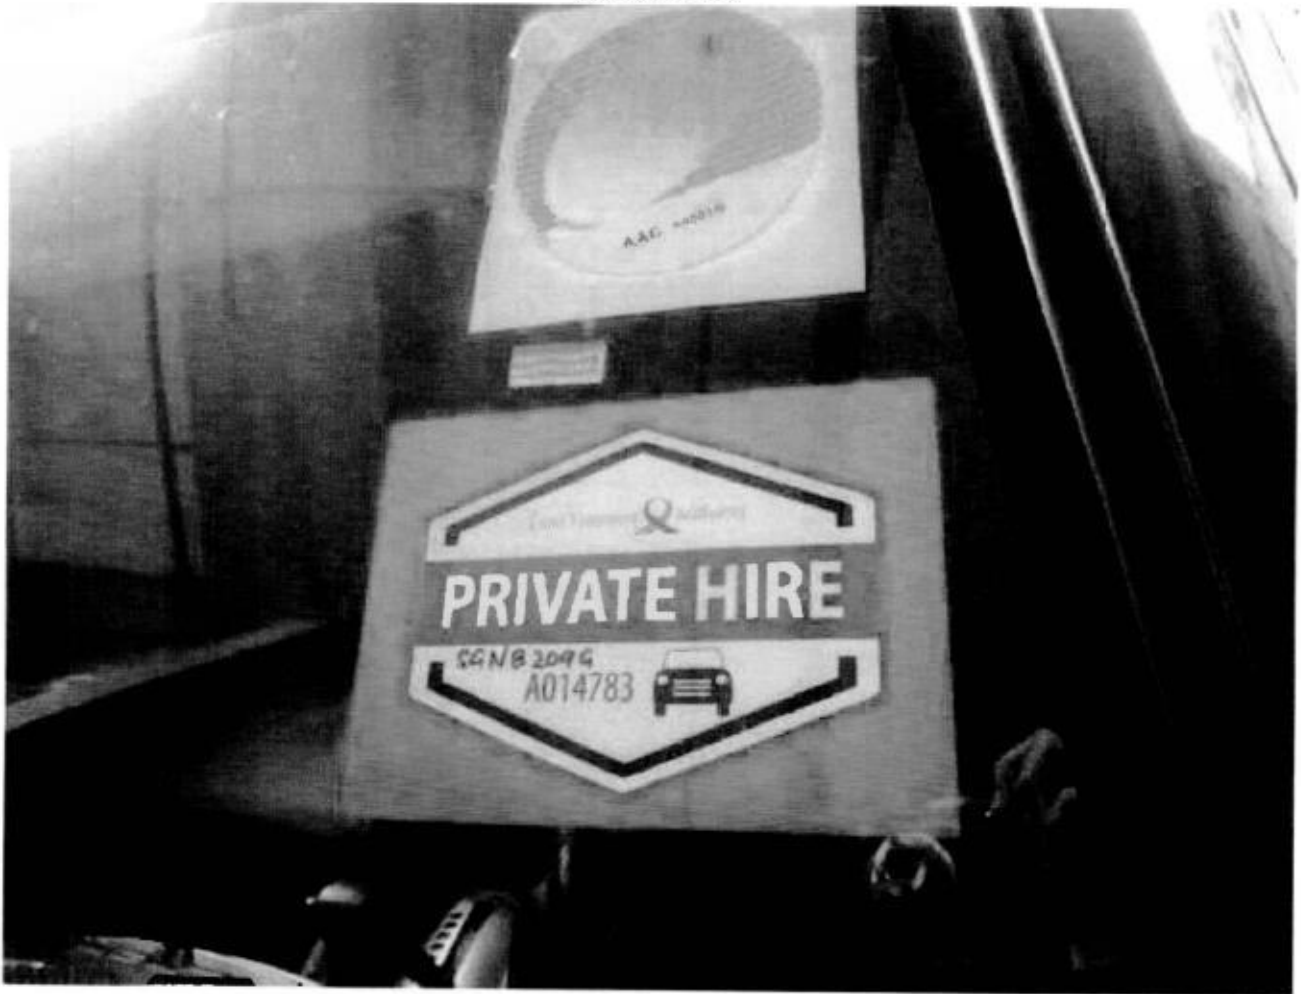
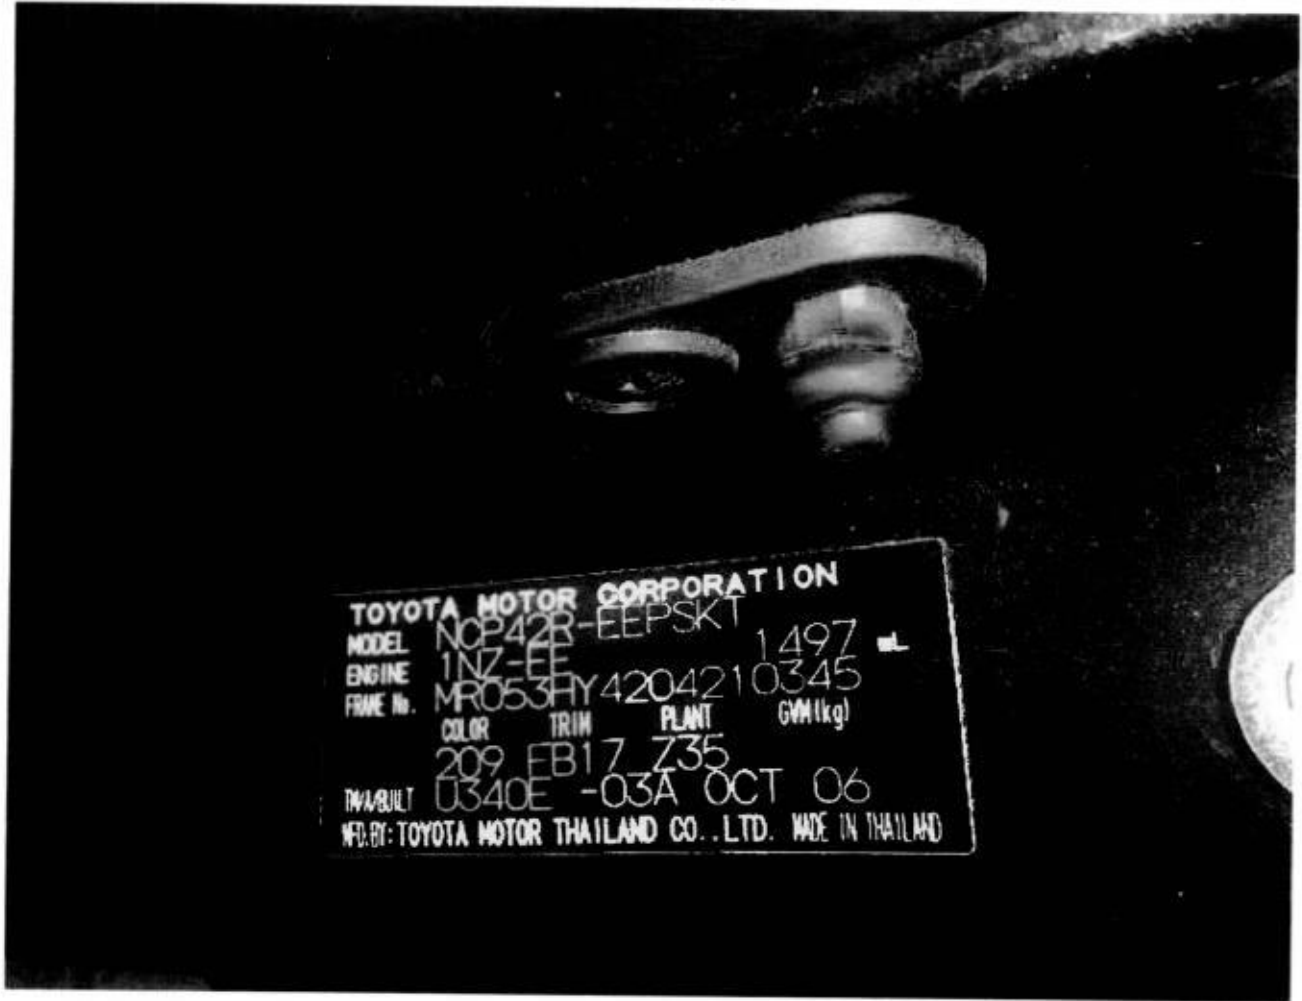
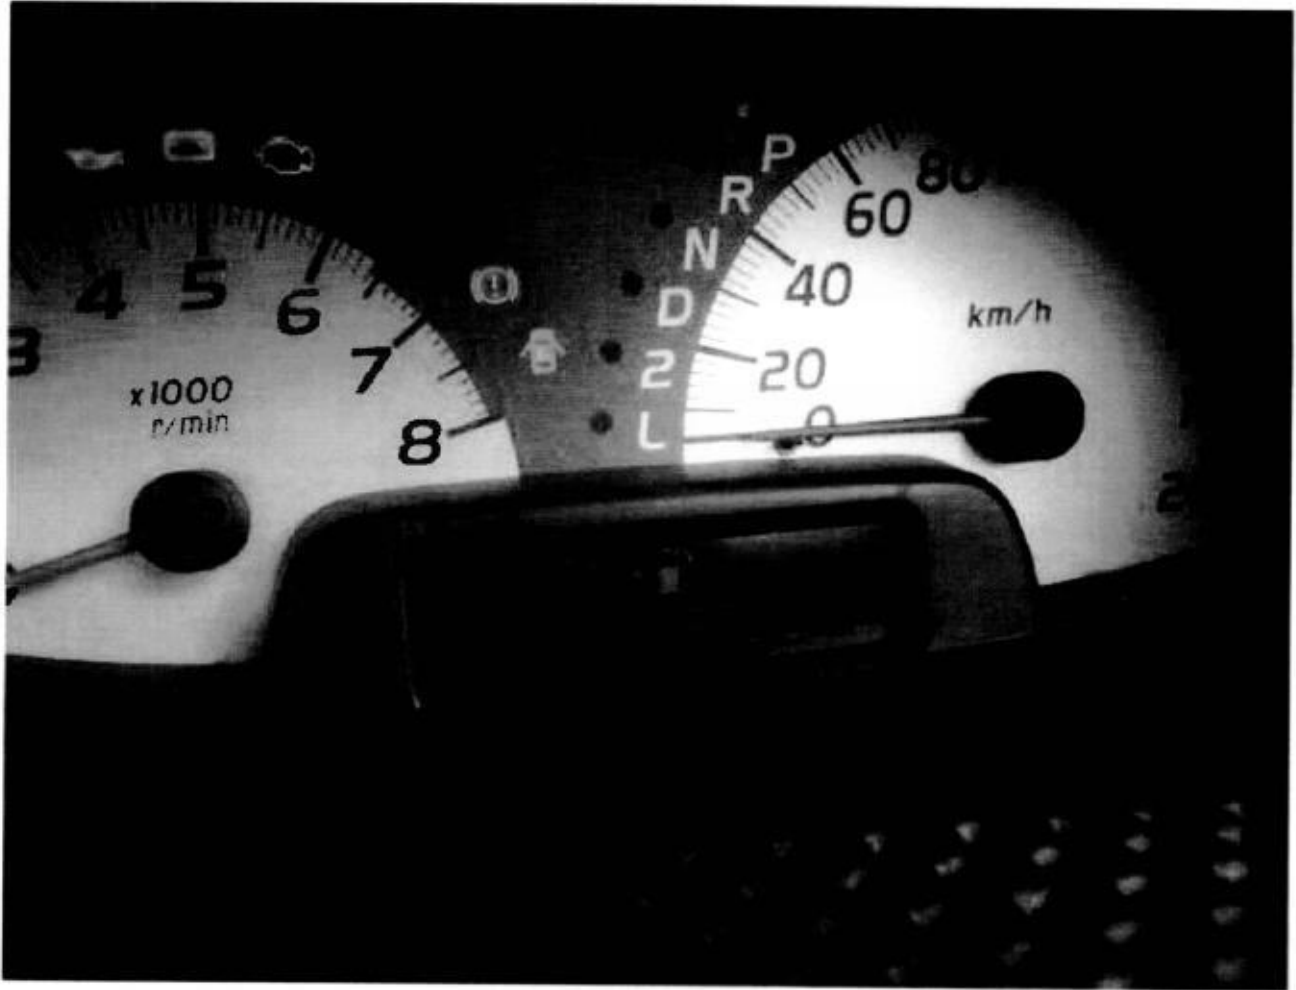
Accident Photo

The vehicle sustained damage at the right side portion.  
For details, refer to assessment for repairs and photographs attached.

The impact was confined to the right side portion of the vehicle.  
The damages appeared to be consistent as per the accident report statement.  
Please refer the attached schedule and photographs for details.

Our assessment of the repair costs to pre-accident condition was **S\$9,500.00** nett at lump sum basis. (Subject to GST if applicable)  
Under normal circumstances, estimated period required for repairs : Twelve ( 12 ) working days.
