**Preliminary Advice**

Vehicle No	: GBH9935C	Accident Date	: 31/01/2019
Make	: TOYOTA DYNA 150 D	Policy No.	: DMCVSN1837681800
Assignment Date	: 25/02/2019	Excess	: S\$350.00
Date of Inspection	: 06/03/2019	Est. Duration of Repair	: 4 days
Inspection At	: Asm Automotive Services Kwong Min Rd (HQ) No. 2 Kwong Min Road Singapore 628705

## VEHICLE DAMAGE INSPECTION REPORT

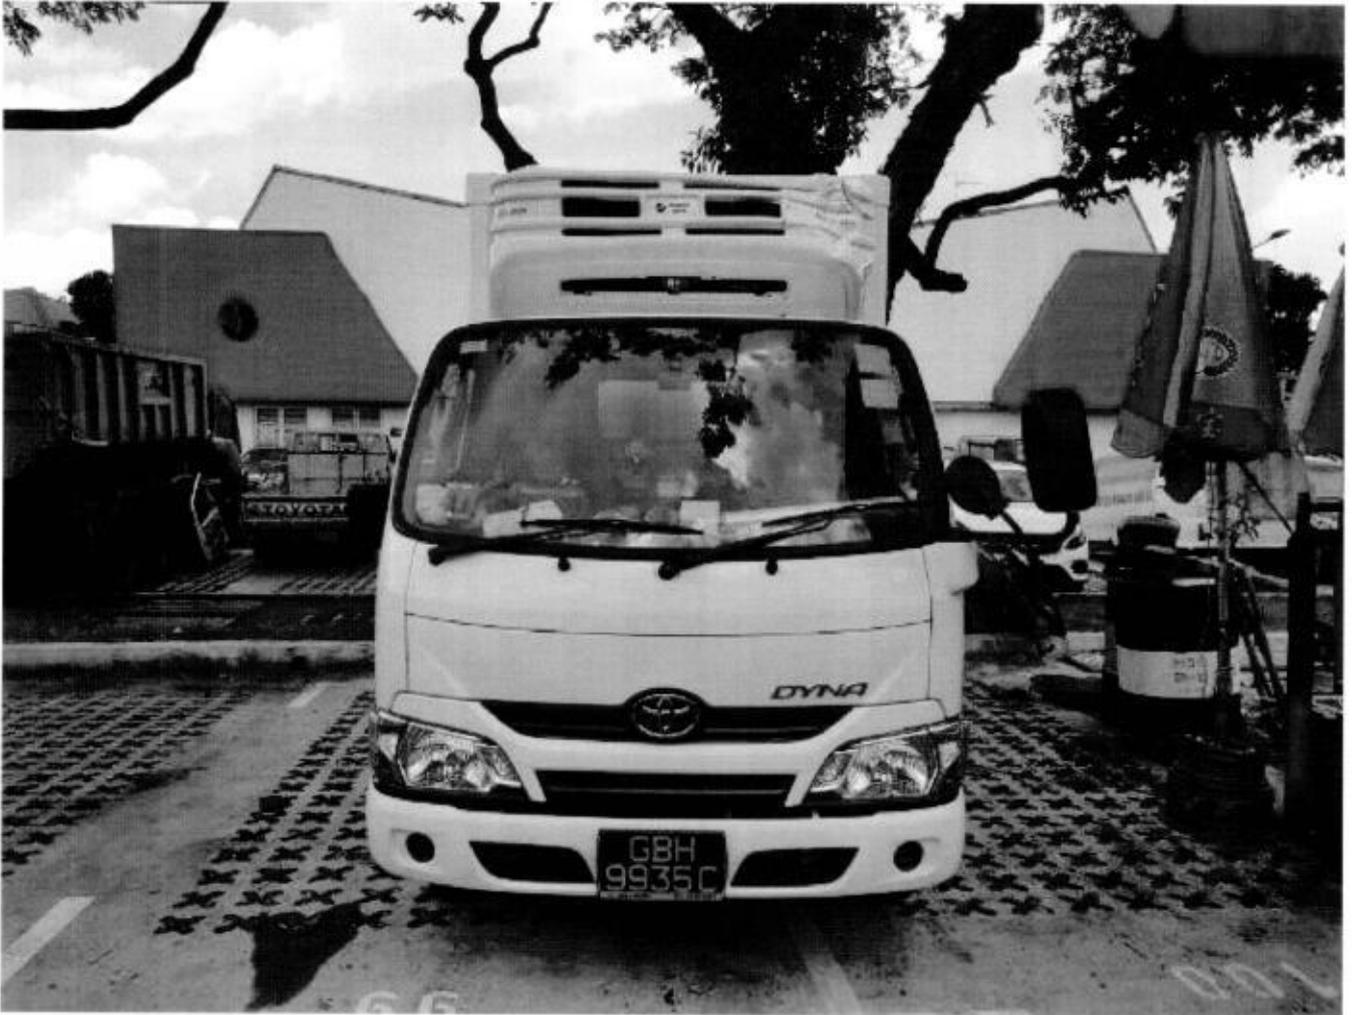
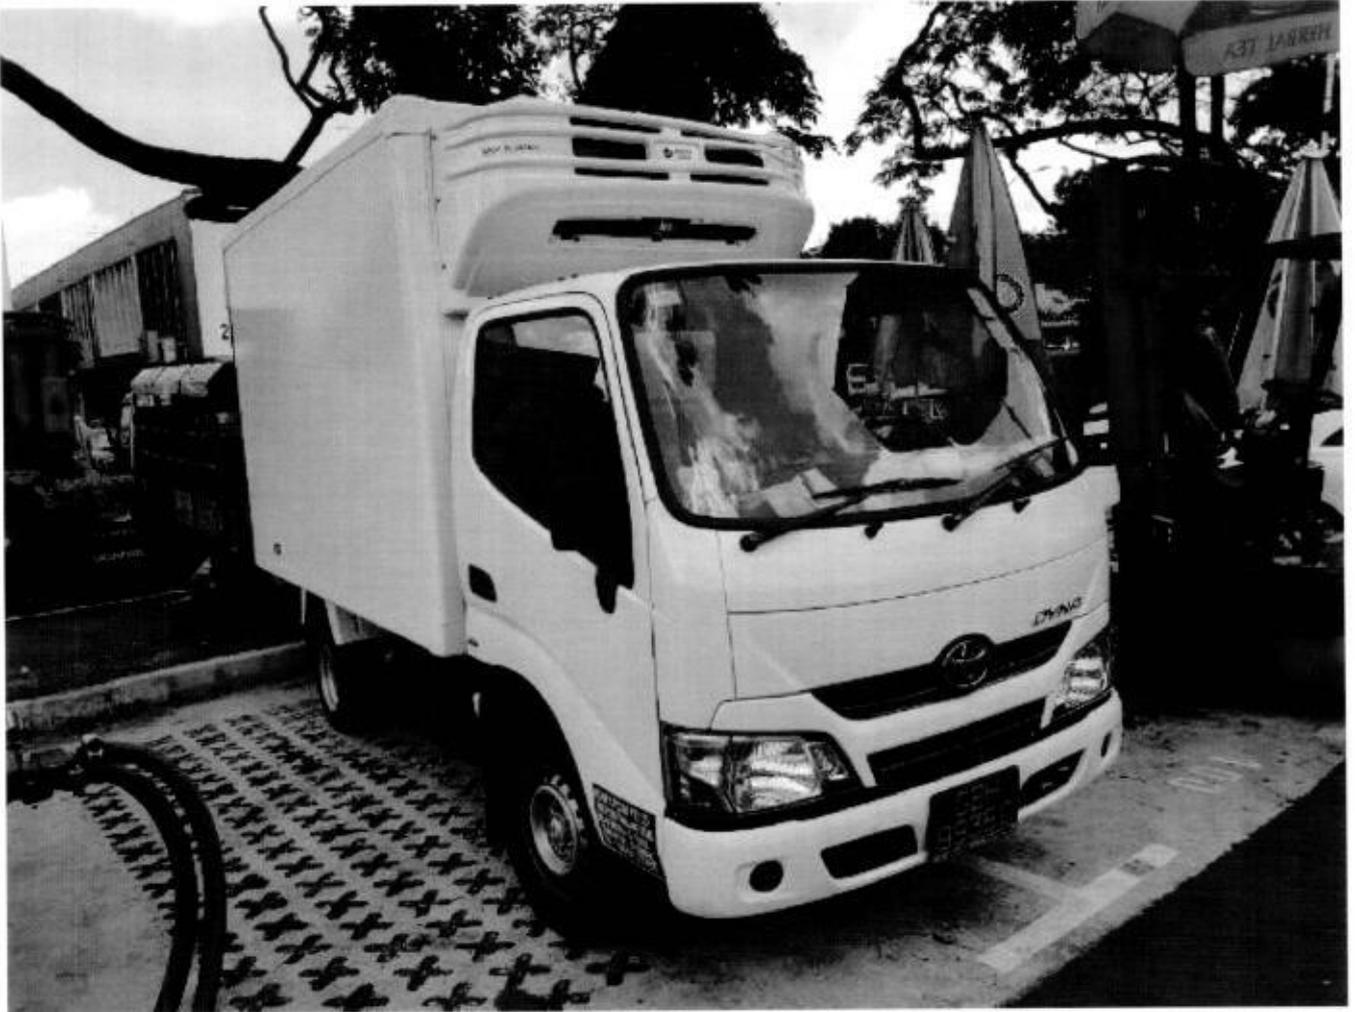
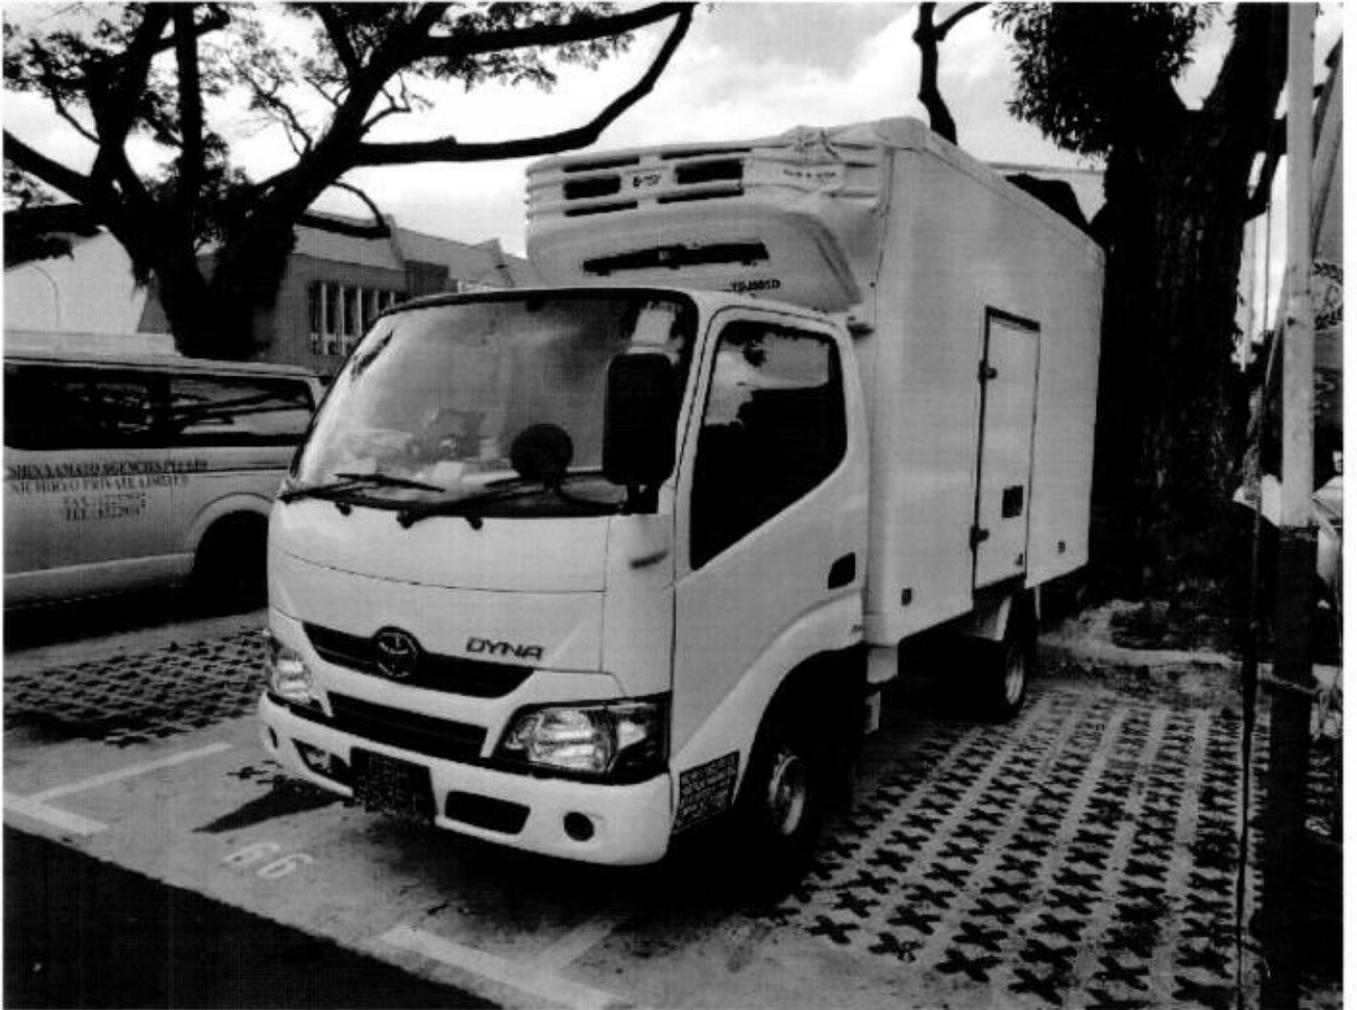
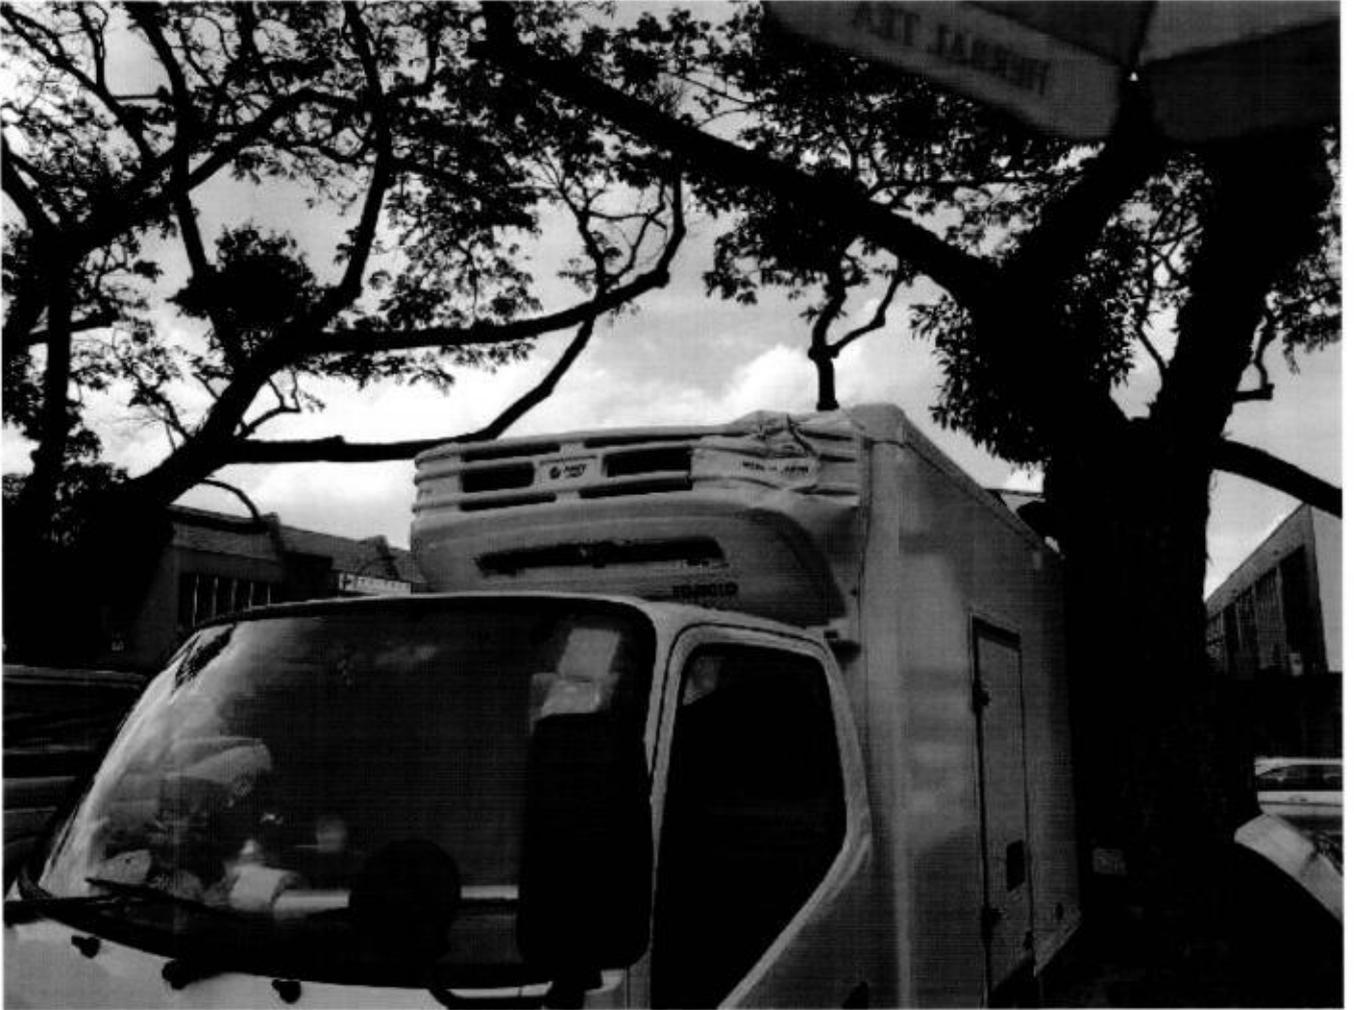
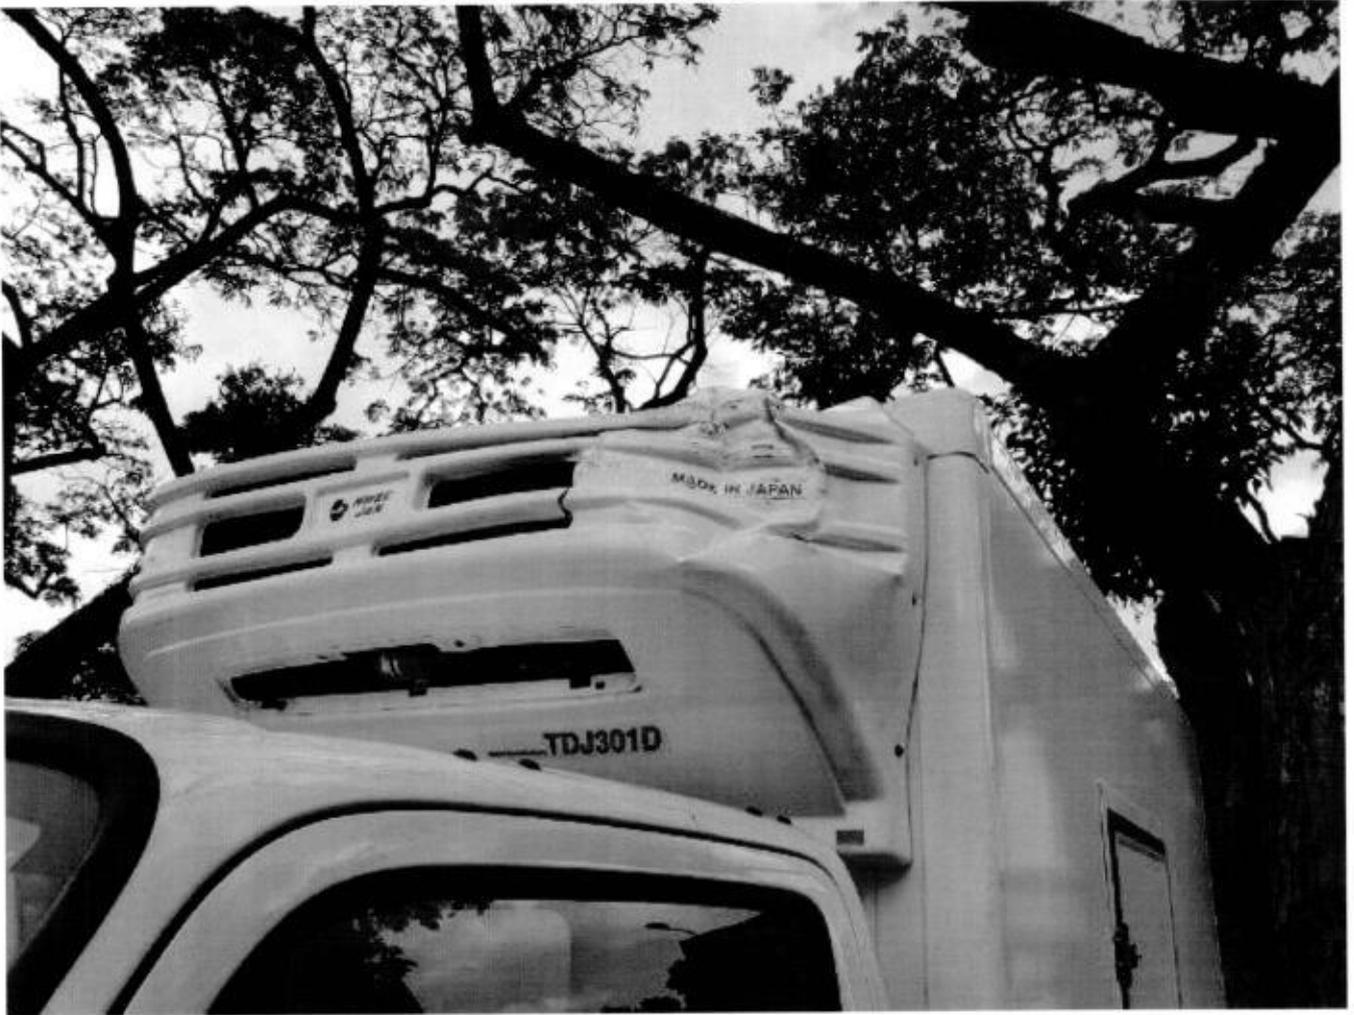
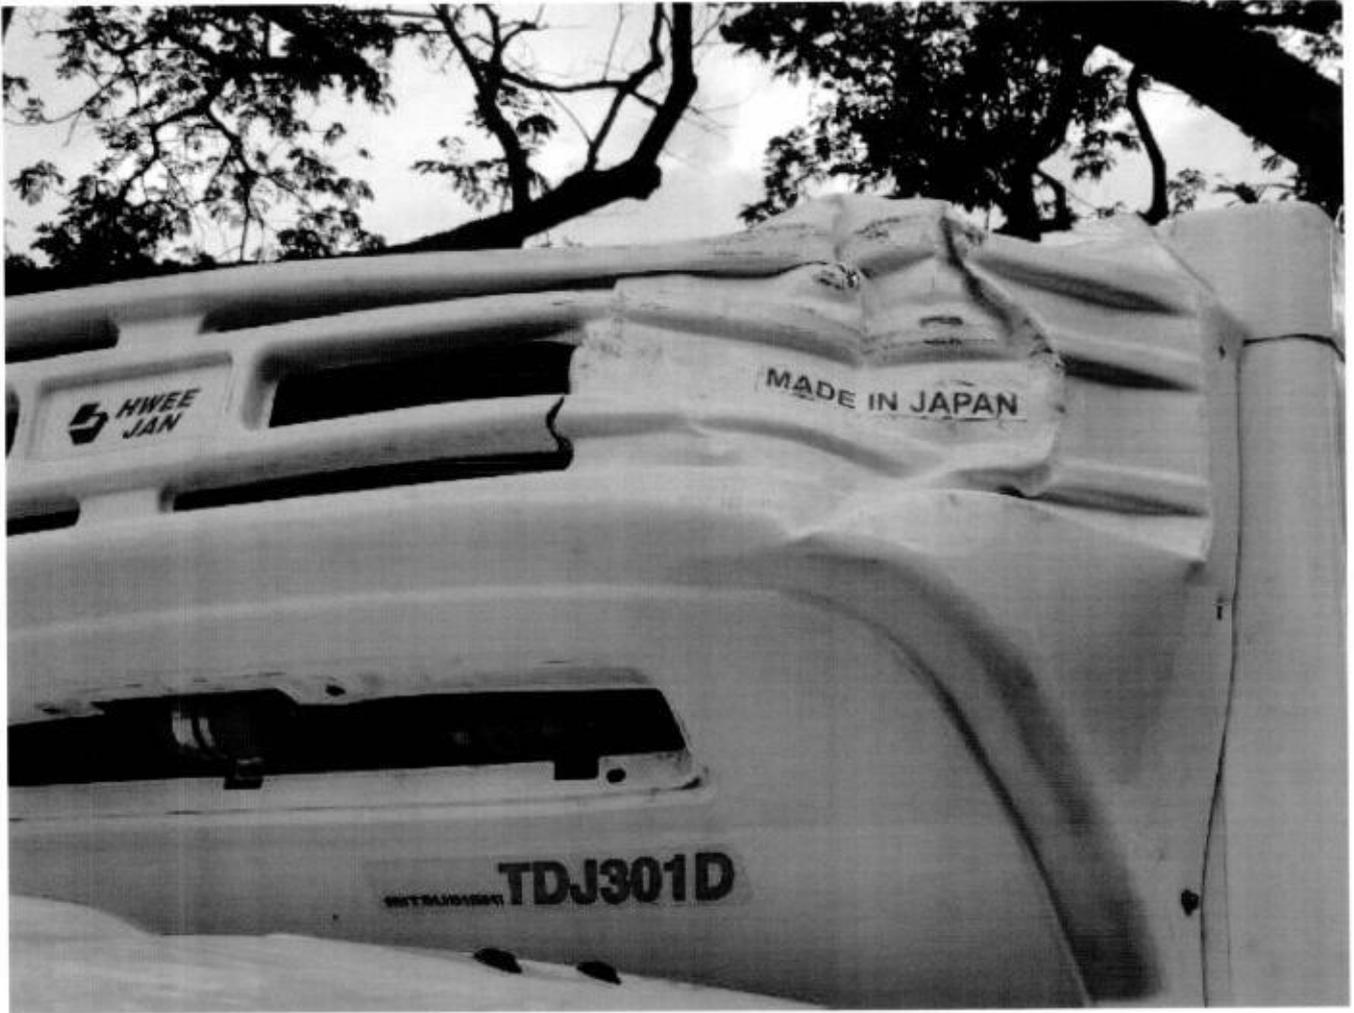
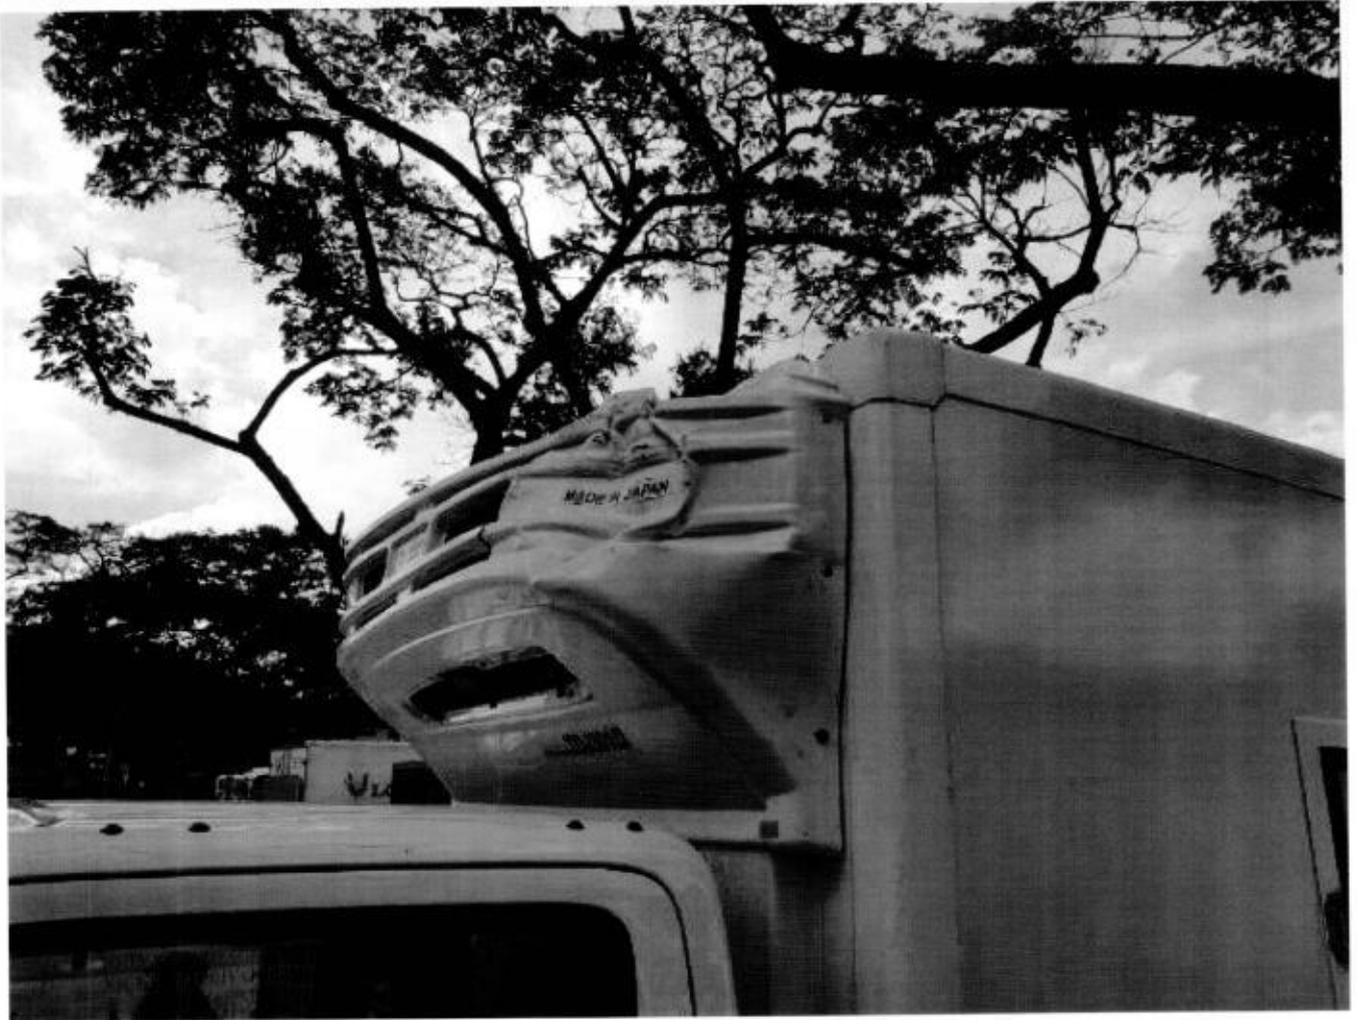
Accident Photo

The vehicle sustained impact / damages front n/s portion and parts claimed are consistent to the accident.

On 31 01 2019 at 1350 hrs. I was driving out of the open space carpark of Blk 726 Clementi West Street 2. During the exit, the top of my lorry GBH9935C collided onto the height limit railings. I wish to state that the entrance of the carpark has no height limit railings. There are also two exit points located at two different locations within the carpark. The exit point which I use to maneuver is erected with height limit railings. After the collision, the front top area of my lorry was damaged and the refrigerate compartment air-con and fan is not in working condition.

To dismantle and replace new sets refrigerated unit, reconceal unit on interior and exterior with sealant. Including reconnect wiring, refix all piping. Conduct final test run and perform gas leakage test.  
 Touch-up paint  
 Refilling of gas-R404A (TDJ301)
