## SINGAPORE ACCIDENT STATEMENT

## AUTOMOBILE ASSESSMENT REPORT

Assessment of Vehicle No : SJV 3340P  
Date of Accident : 26/12/2018  
Date of Inspection : 02/01/2019

## VEHICLE DAMAGE INSPECTION REPORT

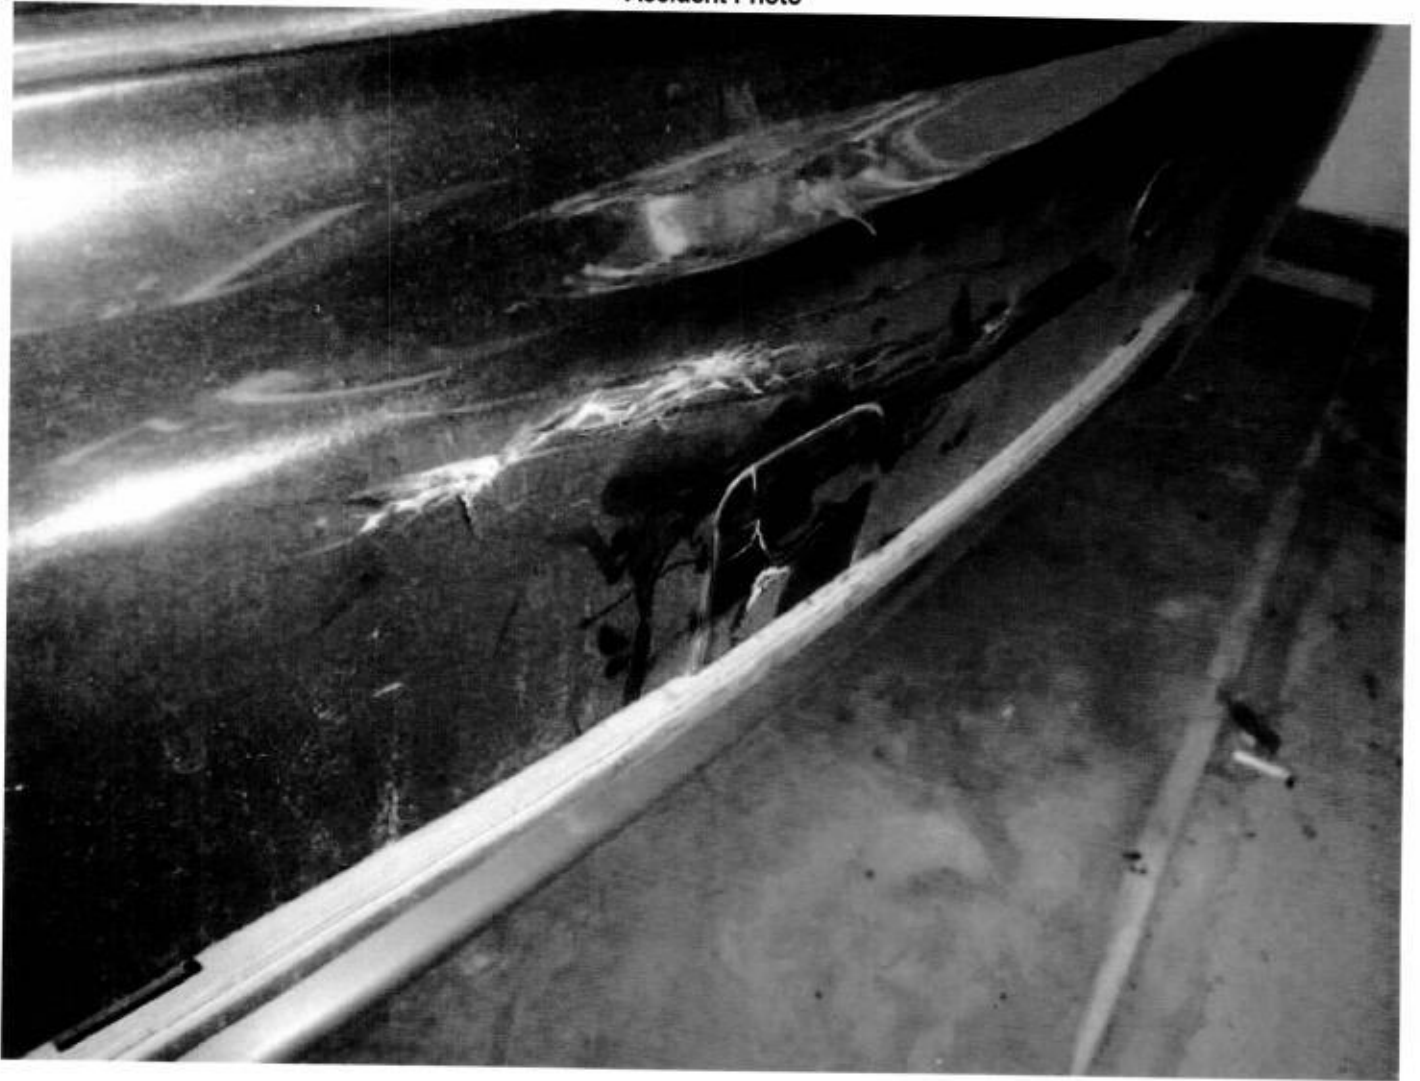
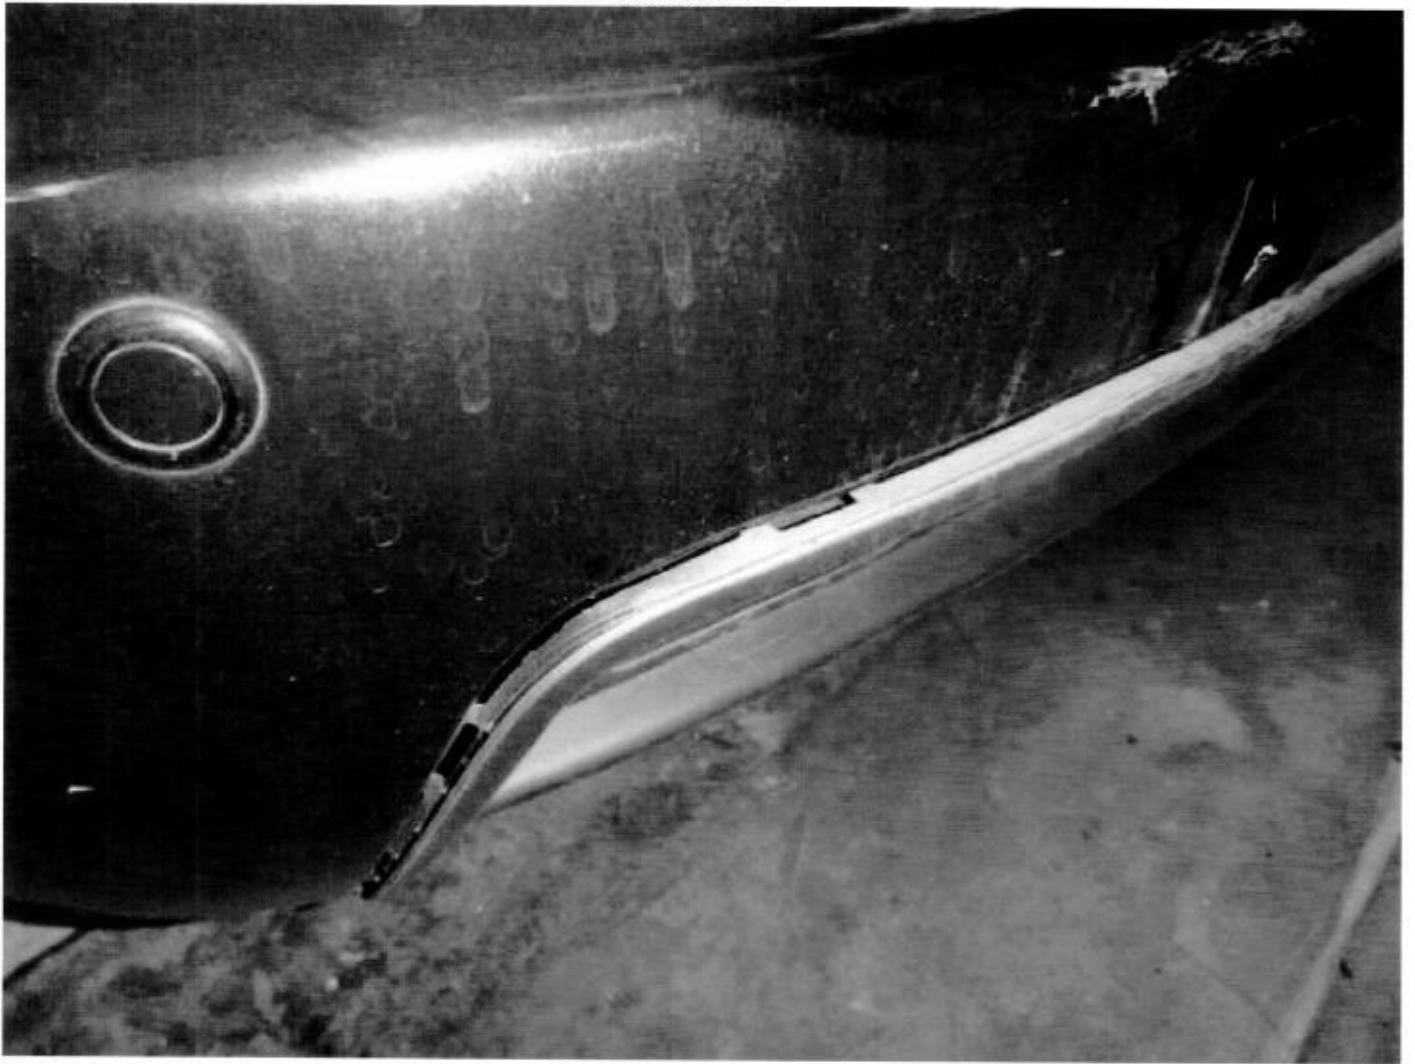
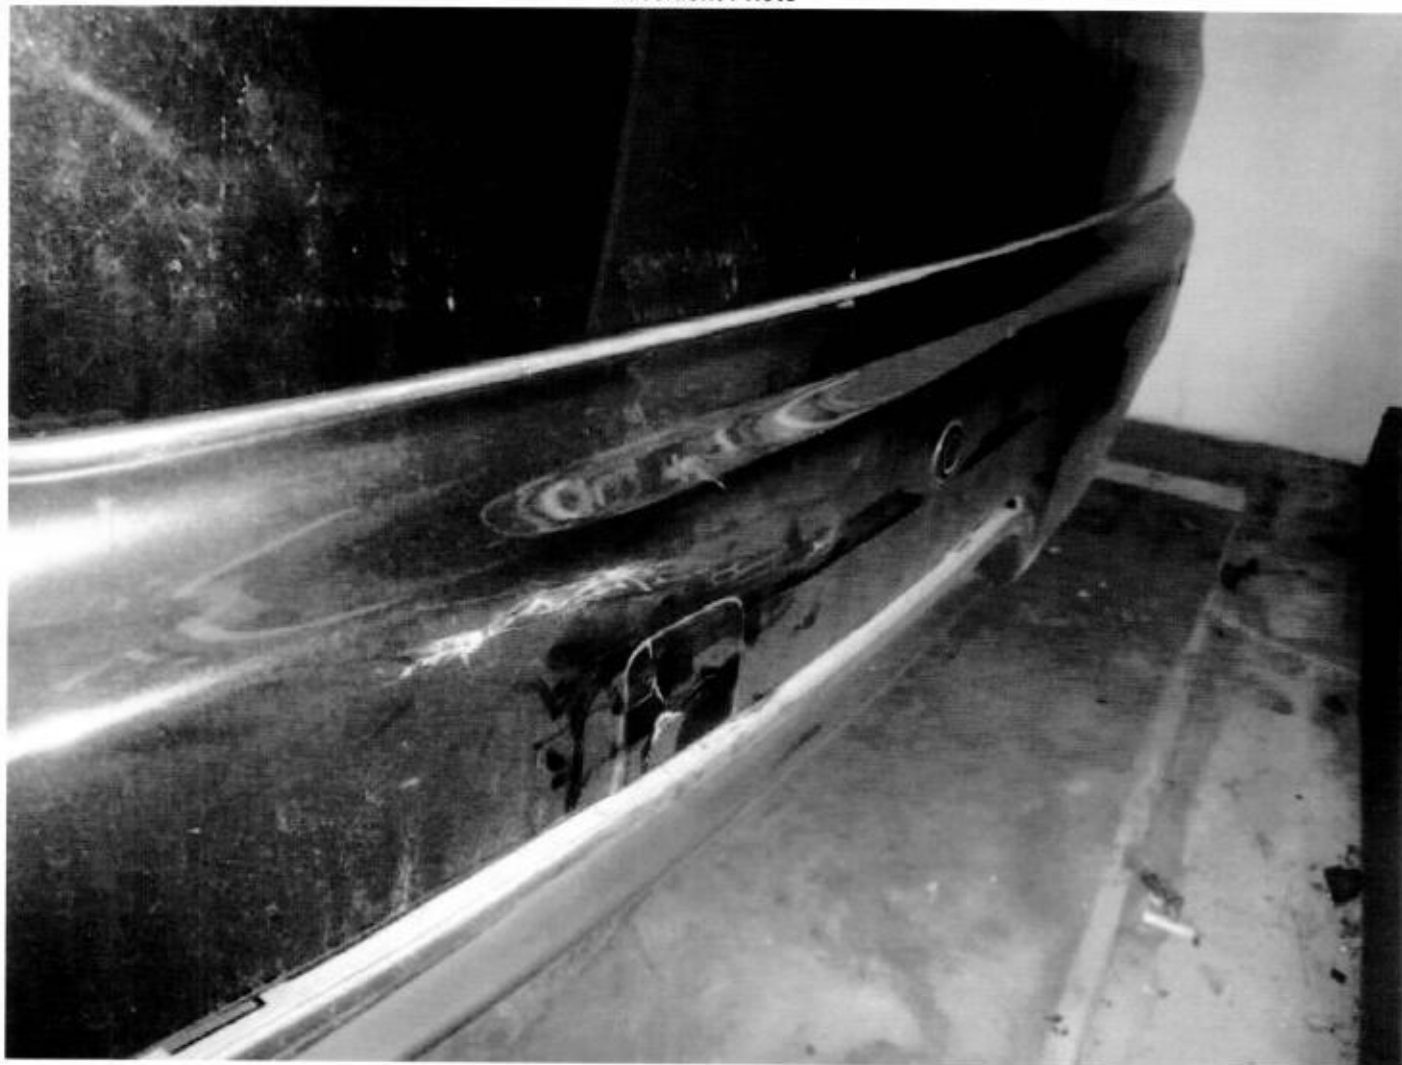
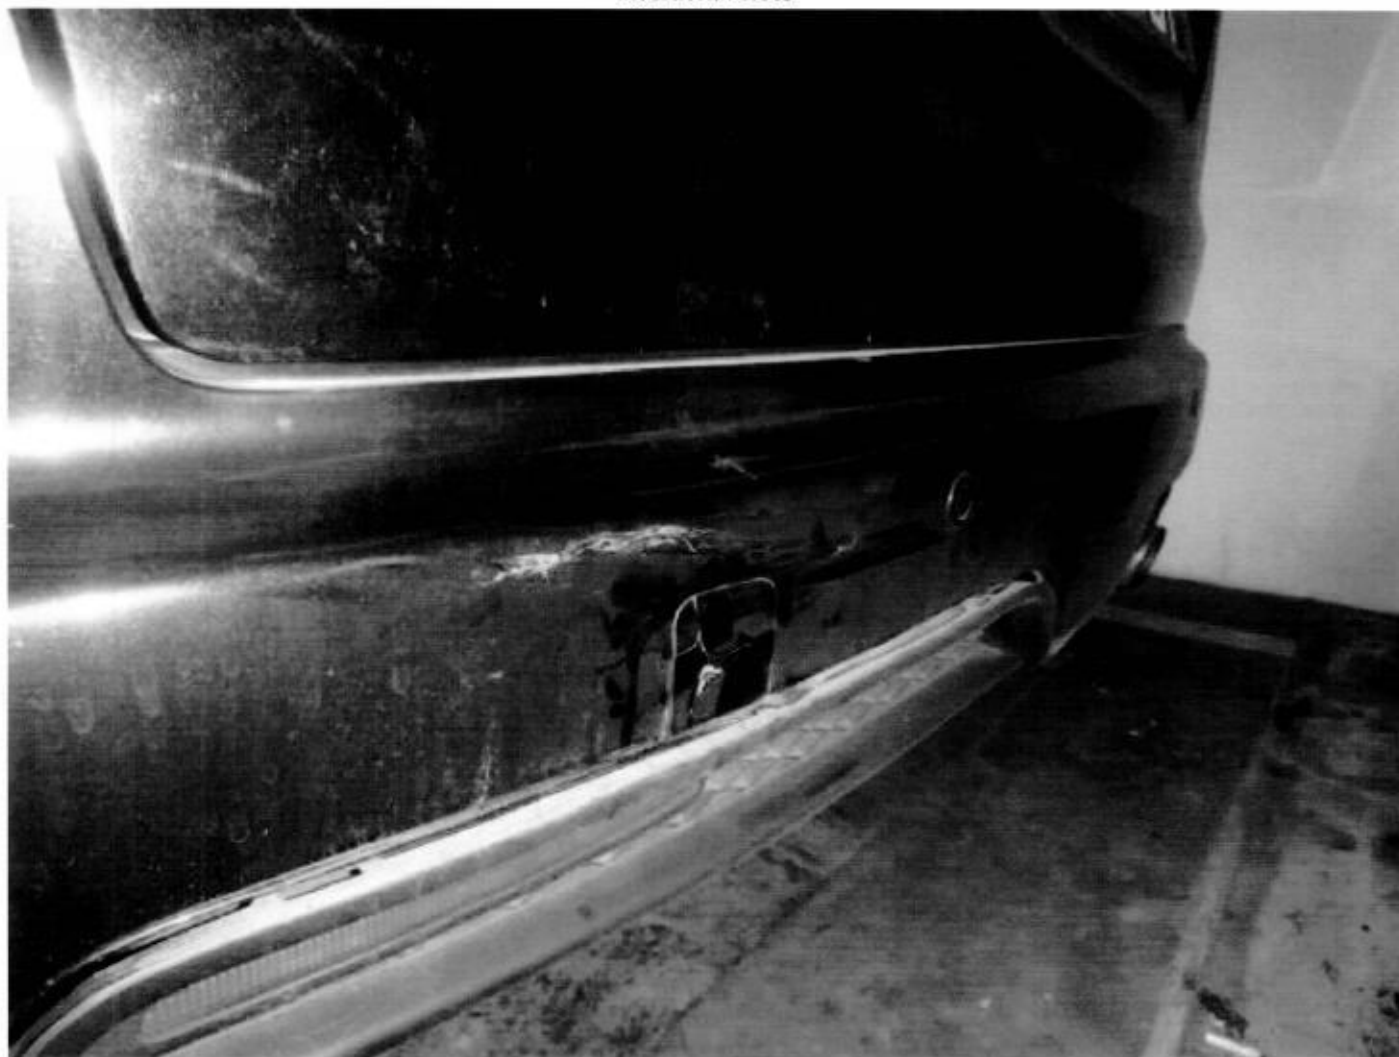
Accident Photo

At the time of inspection observed that this vehicle had sustained damages to the Rear portion

Pursuant to your instruction, we have **NOT AUTHORIZED** repair.  
The assessment was conducted on a "**Without Prejudice**" basis.

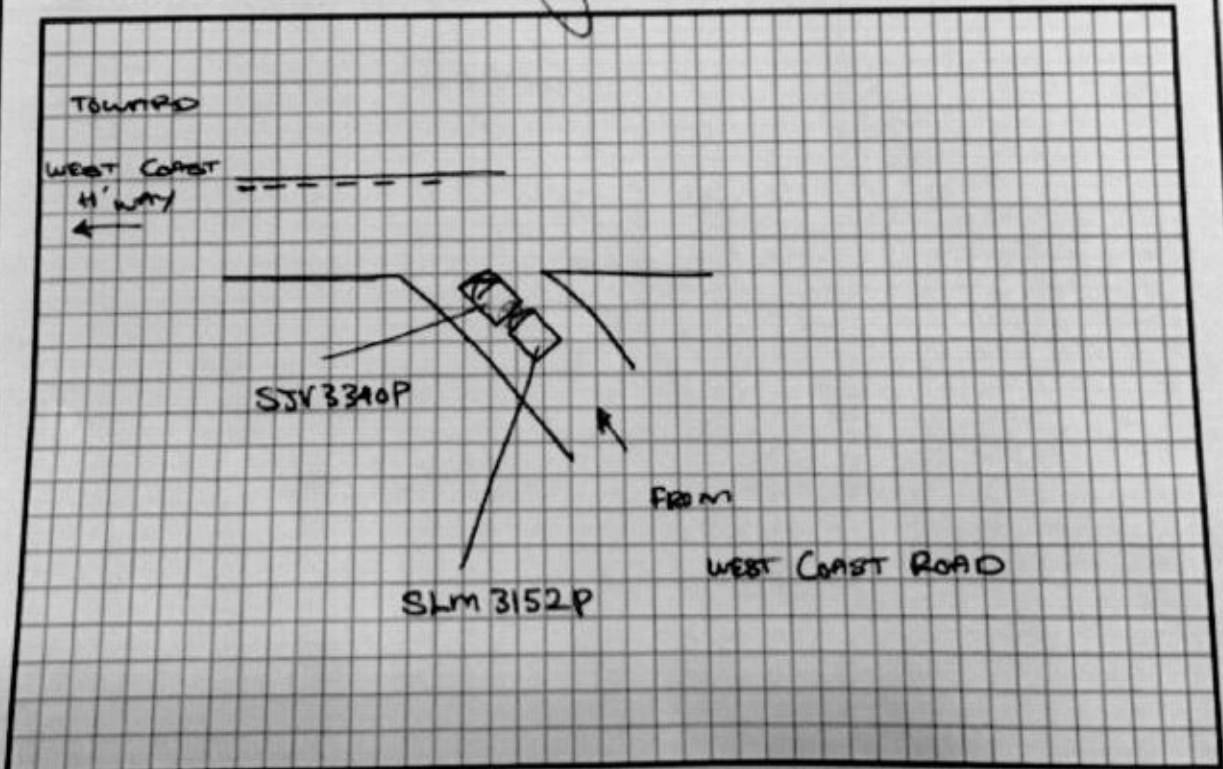
Sketch Plan #2

I was travelling from WEST COAST ROAD toward WEST COAST H'way, while I was checking for oncoming traffic, I didn't notice that the front car was not moving, my car SLM3152P hit onto rear of car SJV3340P. No injuries to me & my passenger. That's all.
