**DAMAGE ASSESSMENT REPORT**

NTUC INCOME INSURANCE CO-OPERATIVE LTD Ref: CS/INC19003574/Utd3e2

Insured Veh.	SJY 5952U	Veh. Inspected	SLN 2120H
Policy No.		Coverage (\$)	0.00
Claim No.	MT/1032907-002	Excess (\$)	0.00
Assign From	CYNTHIA ANG	Assign Date	26/02/2019

## ADJUSTMENT ON REPAIR COST FOR VEHICLE NO. SLN 2120H

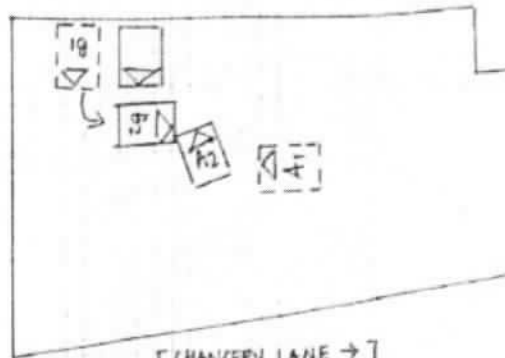
# Accident Sketch Plan

VEHICLE A: SLN2120H

VEHICLE B: SJY5952U

DESCRIBE CIRCUMSTANCES OF THE ACCIDENT

Refer to Police Report
