**INITIAL INSPECTION REPORT OF VEHICLE NO. SLP 3002Z .**

Please be informed that we had conducted the inspection of the abovementioned vehicle on 05/03/2019 at the premises of M/s BH AUTO. and have the following to report:-

ACCIDENT REPAIR ON: SLP3002Z

## ADJUSTMENT ON REPAIR COST FOR VEHICLE NO. SLP 3002Z

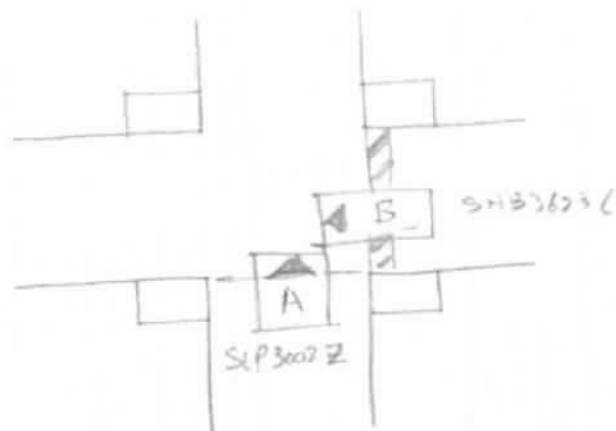
## SKETCH PLAN

A - SLP 3002 Z  
B - SHB 3623 C

At 1:30 pm park green condominium basement car park, visibility was clear and road was dry. At a cross junction I stopped at the stop line, driver of Taxi plate SHB 3623 C ONG HAI SOON License Number SO 633636A stopped at hump also, suddenly he moved ahead past the hump towards my car, I honked to warn him but he struck the front of my car SLP 3002 Z, after he realized he had struck the front of SLP 3002 Z he suddenly reversed back again but I stayed put. Damages to my car include the front right light and bumper, SHB 3623 C damage was limited to front left bumper. We took pictures and exchanged particulars, he offered to pay me \$1.8k for the damages because he was afraid to lose his license to drive if we report the accident. But I said the damages would not cost \$1.8k and decided to file for insurance claims. refer to SHB 3623 C video recording device. 5008143 for details.
