REF: CSI/ALG19003650/R9d302

OD/TP Re-inspection / Evaluation

To Inspect Vehicle No: GBC 24464 Insured: 8KX 25305

## ADJUSTMENT ON REPAIR COST FOR VEHICLE NO. GBC 2446U

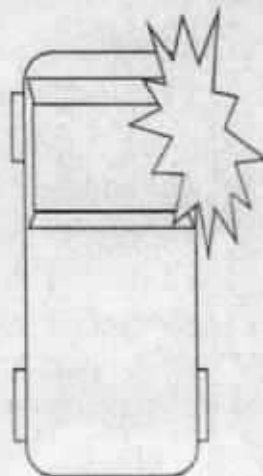
At the time of the inspection, the vehicle sustained damages to the FRONT portion.

Pursuant to your instruction, we have **NOT AUTHORISED** repair.

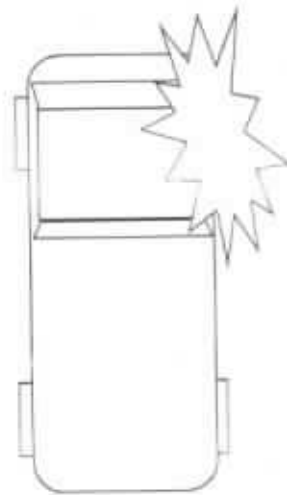
At the time of the inspection, the vehicle sustained damages to the FRONT portion.

Pursuant to your instruction, we have **NOT AUTHORISED** repair.  
The assessment was conducted on a **"Without Prejudice"** basis.  
If we are not notified of anything to the contrary within **14 days** from the date hereof, this report shall be treated as correct.
