RE: ACCIDENT INVOLVING GBH 1869 M / SLB 4331 R / SHC 8665 T / SLK 5790 U ON 22nd FEBRUARY 2019 ALONG AYE (AFTER LOWER DELTA)

***GBH1869M (5467430747SG)**
[SLB4331R]

VEHICLE DAMAGE INSPECTION REPORT

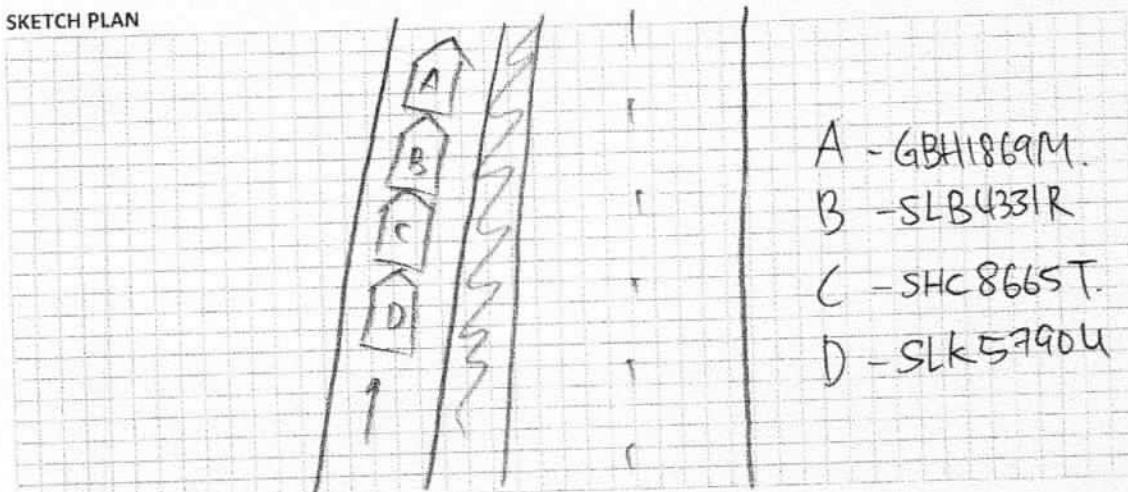
SKETCH PLAN

DESCRIBE CIRCUMSTANCES OF THE ACCIDENT

I was travelling along slip road from Keppel Rd into AYE (Tuas). When vehicle in front of me stopped, and I applied my brake and came to a stop too. Suddenly I felt a great impact from the rear. I quickly stopped at the road shoulder, and I walked back to the vehicle B, and I realized that it was a chain collision with total four vehicles involved.
