ASSIGNMENT

Preliminary Advice

VEHICLE DAMAGE INSPECTION REPORT

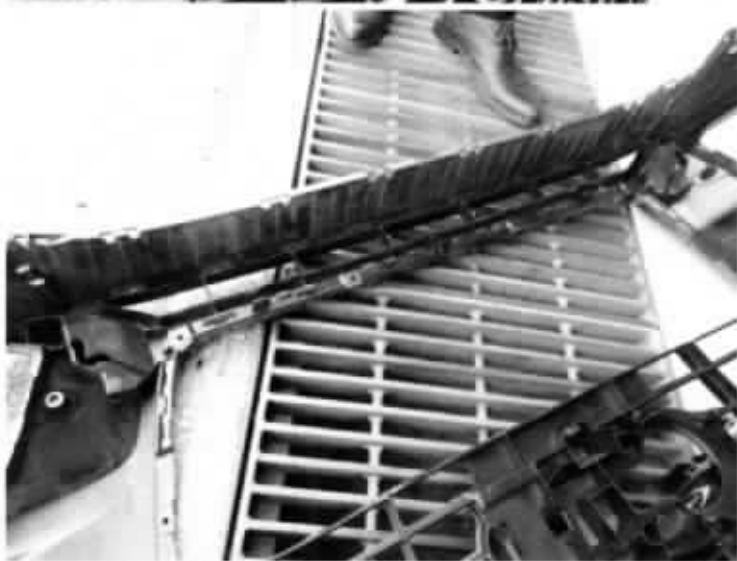
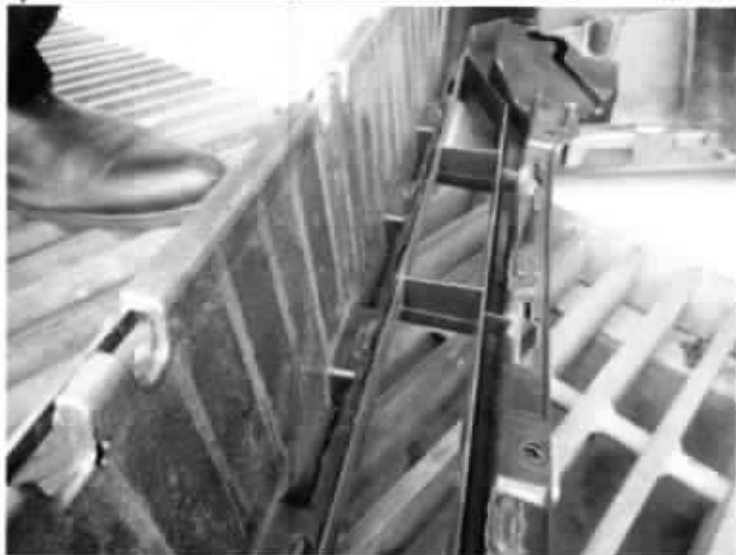
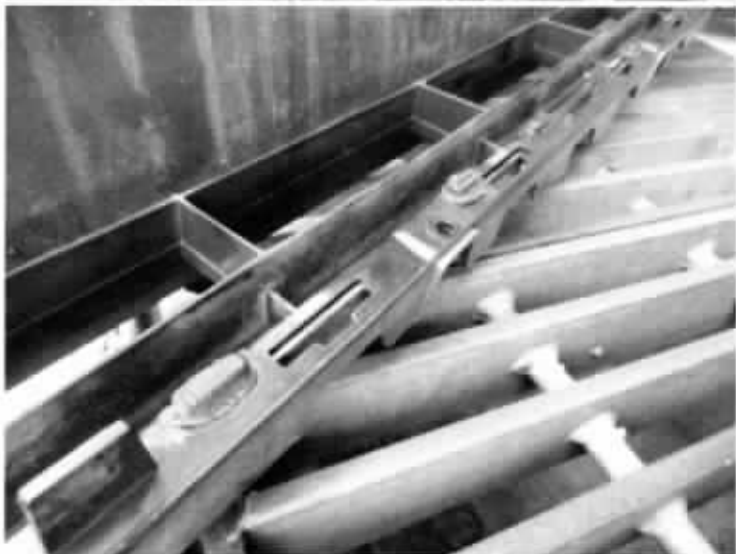
Maintained:Where is the damage of the lower grille which required to be replaced?

38-41

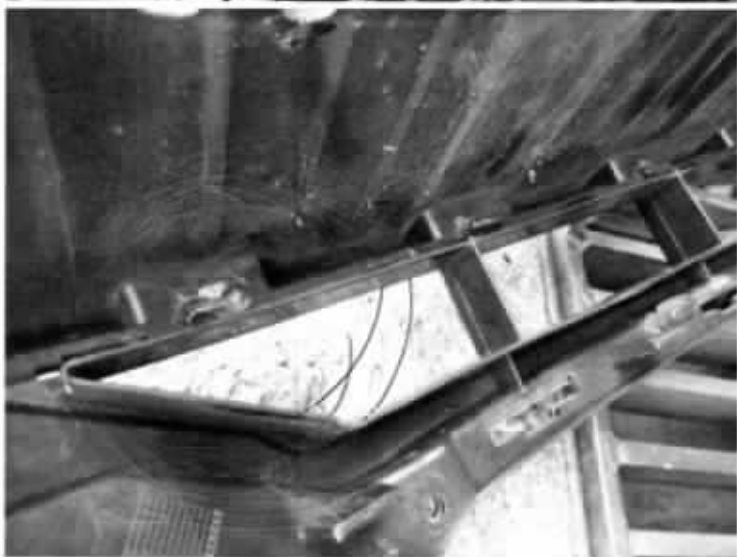
39/44: Reinspection Photo

As the bumper is being thrust backwards, the holding bracket of the lower grille gave way as seen in the highlighted picture.

17	1		*FRONT BUMPER LOWER GRILLE	Cracked	92.40 FS	*92.40 FS
18	1		*FRONT BUMPER LOCKING CLIP	Necessary	57.60 FS	*57.60 FS
19	1		*FRONT BUMPER TOP COVER	Cracked	89.20 FS	*89.20 FS
20	1		*OUTSIDE TEMPERATURE BRACKET	Cracked	16.24 FS	*16.24 FS
