To Inspect Vehicle No: *SKD36627*

Make: *Nissan Teana* c.c. *1997*

**- Pre-Repair Inspection Request - SKD3662T vs SKH3736T (OI) on D.O.A.: 02/02/2019**

## VEHICLE DAMAGE INSPECTION REPORT

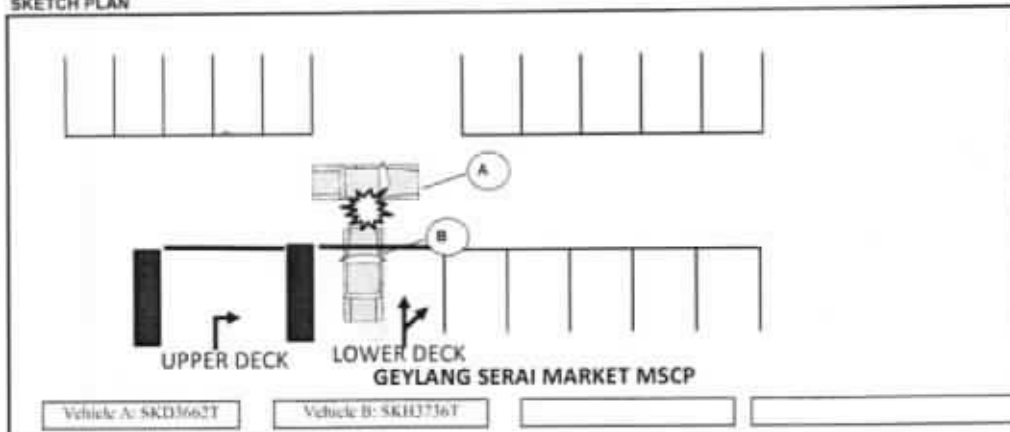
### SKETCH PLAN

MY VEHICLE WAS TRAVELLING STRAIGHT AFTER I TURN RIGHT FROM UPPER DECK. AS I WAS GOING STRAIGHT, VEHICLE B FROM LOWER DECK FAILS TO STOP BEHIND THE STOP LINE (AS HE WAS GOING STRAIGHT) AND HIT ONTO MY VEHICLE RIGHT PORTION. NO ONE WAS INJURED.
