VEHICLE DAMAGE INSPECTION REPORT

Our File No: CS/CTI19004061/KQD3N2

Handling Insurer:	China Taiping Insurance (Singapore) Pte. Ltd.	Policy No:	DMCVSN18276118000	
Claimant Vehicle No :	SGW4682B	Insured Vehicle No :	XE4258L	
Date of Loss:	02/03/2019	Nature of Claim:	TP	Claim No: SNM19D201039C02

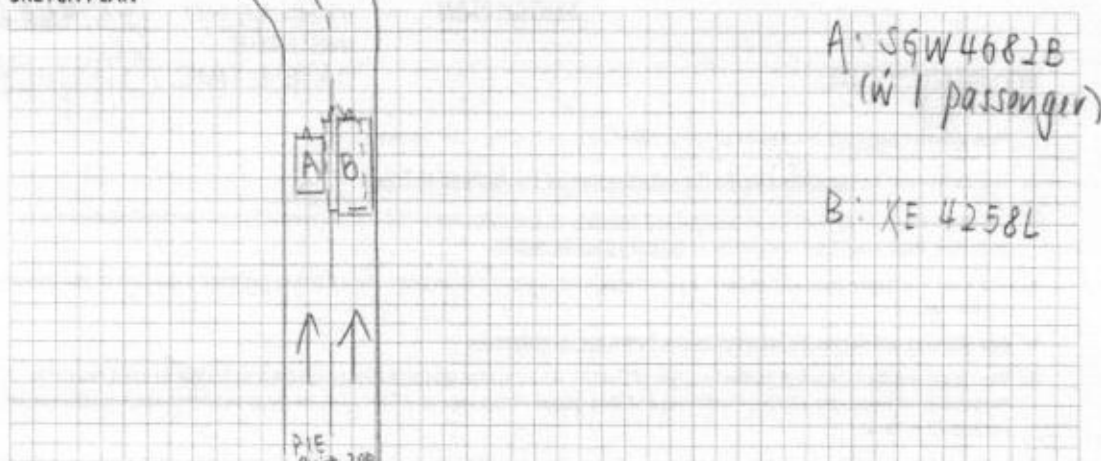
Sketch Plan #2

Rathinan was driving a sand truck and the collision occurred along the slip road of Exit 208. It was right before a left bend when his vehicle knocked into my vehicle. The place of the scene was near plastic barricades. His vehicle was parallel to my vehicle when he first moved into my lane. I came to a halt and his vehicle came into contact with the right side of my vehicle. Evidently, all damages occurred on the right side of the vehicle due to the incoming impact from Rathinan's vehicle. The car's mirror folded forward on impact, shattering the mirror. There was no room for his vehicle to make the lane change and it was a reckless decision on his part. He admitted to his fault which is supported by audio recordings provided. He had not checked his blind spot and did not see my vehicle. Damages were found on the tyre, side doors and rear wheel fender.
