ASSIGNMENT (Office)From (Person): Chong Boon Senof CAIDate/Time: 5/3/2019 09:42

Preliminary Advice

Vehicle No	: SLP9902L	Accident Date	: 28/02/2019
Make	: MERCEDES-BENZ C200 KOMPRESSOR	Policy No.	: DMPCSN1824121800
Assignment Date	: 05/03/2019	Excess	: S\$0.00
Date of Inspection	: 05/03/2019	Est. Duration of Repair	: 4.00
Inspection At	: JIN AUTO SERVICES PTE LTD (DEFU) BLK 14 DEFU LANE 10, #01-410/412 SINGAPORE 539195

VEHICLE DAMAGE INSPECTION REPORT

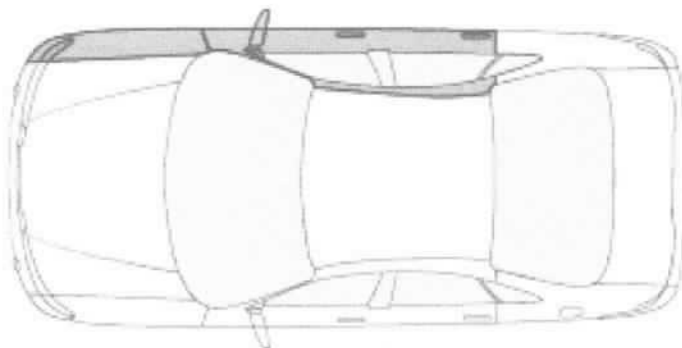
Damage Areas

The vehicle sustained impact / damages o/s portion and parts claimed are consistent to the accident.

Code	Description	Time Base 10 WU/h	Price = 42.00 SGD/h	
			WU	Price SGD
88-3956 01	RENEW R/FR WING INCLUDES: PARTITION PANEL R CPL REMOVE-- REFIT R/SIDE MEMBER TRIM DETACH/ATTACH		10.0	42.00
72-1515 01	RENEW R/F DOOR INCLUDES: R + R DOOR, CONVERT ATTACHED PARTS, RENEW IF NECESSARY		33.0	138.60
72-1682 01	ADDITION TO RENEW R/DOOR (1ST DOOR) (VEHICLE WITH LOWER MOULDING)		1.0	4.20
72-2692 01	RENEW R/F DOOR HINGE/S		14.0	58.80
72-1691 01	ADDITION TO RENEW R/DOOR (1ST DOOR) (VEHICLE WITH DOOR SPEAKERS)		2.0	8.40
54-7989 02	R + R BATTERY EARTH CABLE (WHEN DISCONNECTING ELECTRIC PLUG AND SOCKET CONNECTIONS)		2.0	8.40
