Veh No: SJJ1964R Yr Regn: 2008 / Sept
 Type: M.Car / M.Cycle / Bus / Van / Lorry / Taxi / Prime Mover /
 Truck / Trailer or _____
 Make: honda Fit c.c 1339
 Colour: Red AC: Insured / Std / NI / NA
 Sp.Reading: 120032 Tr/Radio: Insured / Std / NI / NA
 Eng/No: _____
 C/No: GE61096434
 Gen. Cond: Good / Fair / Poor / Burnt
 Steering: In order / Jammed / Leaked / Burnt or _____
 Brake: In order / Jammed / Leaked / Burnt or _____
 Mod: Nil / STD A/Rim / STD A/Rim or _____
 Tyre Size: F: 195/55R15
 R: 195/55R15
 BS / DUN / EXNOVA / GY / FS / LIZA / MIC / OHTSU / PIR / SUMI /
 TOYO / YOKO or _____

From: Catherine Chong (LKK Auto) <admin-d@lkkauto.com>
Sent: Wednesday, 6 March, 2019 11:10 AM
To: 'Shu Pei (LKKAuto)'; 'assignments'
Cc: 'sur@lkkauto.com'
Subject: RE: Urgent: PRE-REPAIR INSPECTION: Your Vehicle: SKT 1881 G; Leang Auto's Vehicle: SJJ 1964 R; ACCIDENT INVOLVING SJJ 1964 R & SKT 1881 G ON 1 March 2019

VEHICLE DAMAGE INSPECTION REPORT

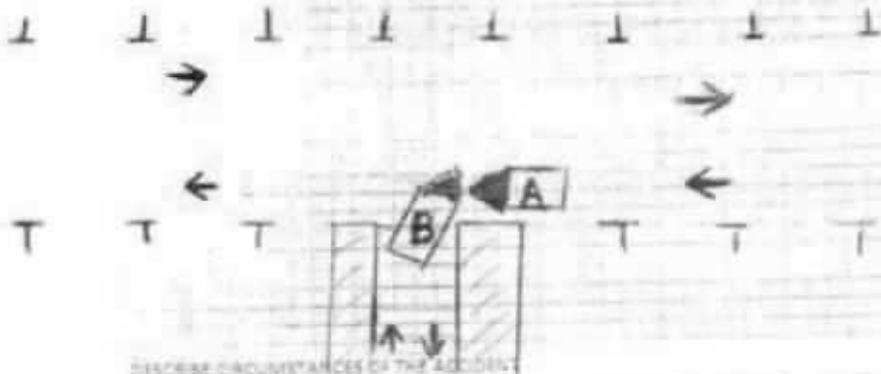
Sketch Plan #2

DESCRIBE CIRCUMSTANCES OF THE ACCIDENT:

I was in the multi-story concrete going straight, when I saw a vehicle turning up the ramp. I stopped my car and honked, but the other vehicle continued moving and collided into my car.
