REF: CS/CT/19004128/Bsd302

To Inspect Vehicle No:

SKA 1235Y

VEHICLE DAMAGE INSPECTION REPORT

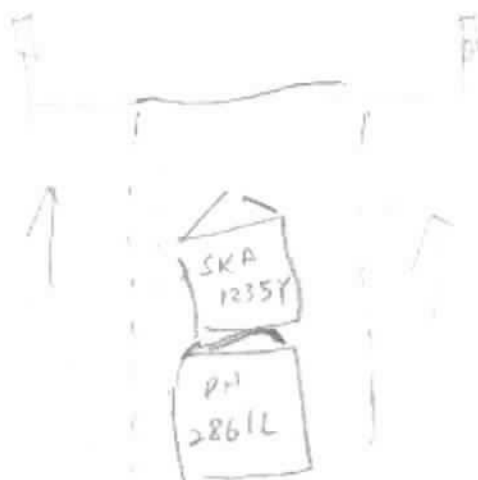
SKETCH PLAN

I was driving along Upper Serangoon Road. My car was stationary stopping at the traffic light. An excursion bus no PH2861L came from behind and hit directly onto the rear of my car SKA1235Y.
