FW4135B

FW4135B - ESTIMATED REPAIR BILL
MODEL : SUZUKI GSX1300RZK3
YEAR OF MANUFACTURE:2002 [17-03-2013]

VEHICLE DAMAGE INSPECTION REPORT

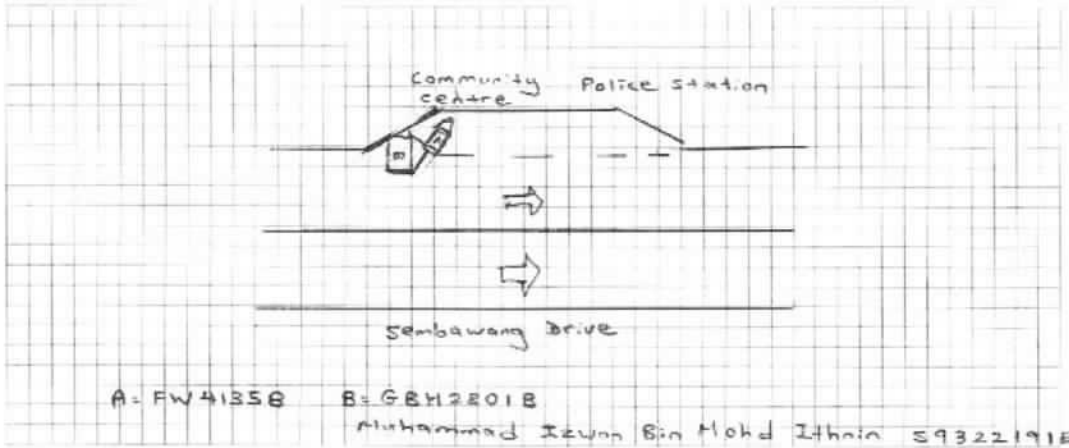
SKETCH PLAN

x At 1250hrs, I went to drop off my colleague at Sentulawang Neighbourhood Police centre to make a report. I stopped my bike by the roadside to escort my colleague in, as he is not local. When I entered, I noticed everyone was looking outside. As I looked towards the direction of my bike, my vehicle was on the ground. I rushed towards my vehicle, noticing it was damaged and was leaking of my engine oil. Behind my vehicle was a ST Logistics van which was ready to move off. But the driver came out, and apologized to me for hitting my bike from the back. And he has accepted that he didn't notice my bike while moving off, thus the result of this accident. We exchanged particulars and parted ways. I called his company and they asked me to proceed with an insurance claim.
