## VEHICLE DAMAGE INSPECTION REPORT

Our File No: CC3/TMI19004184/KTD3N2

Handling Insurer:	Tokio Marine Insurance Singapore Ltd	Policy No:	MK000195
Claimant Vehicle No :	SHD850Y	Insured Vehicle No :	SLQ8091C
Date of Loss:	05/03/2019	Nature of Claim:	TP
		Claim No:	M1901430

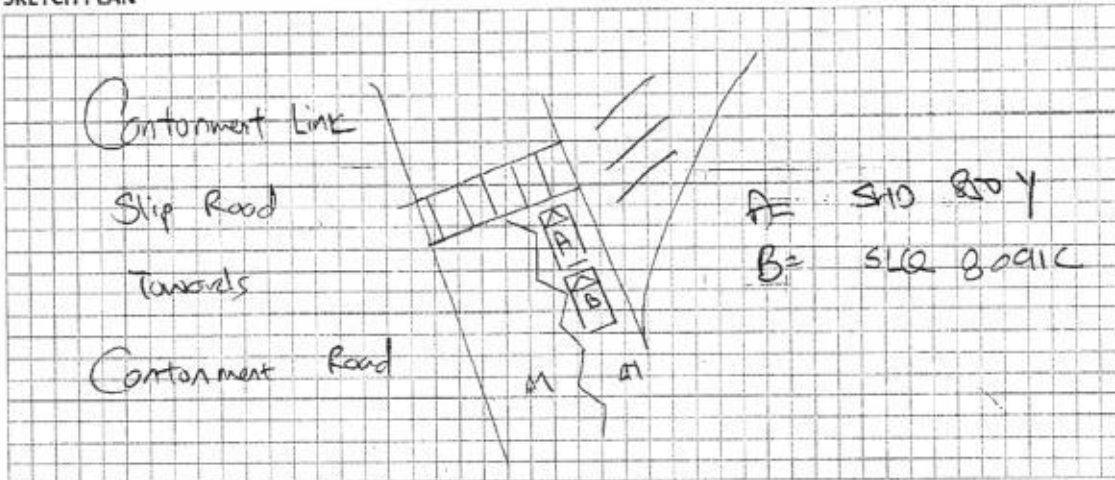
## SKETCH PLAN

On 05.03.2019 at about 0925hours, I was travelling straight on the extreme right lane along Cantonment Link slip Road towards Cantonment Road. I slow down and made a stop when I saw pedestrian crossing. While stationary, suddenly I felt an impact. Vehicle B (SLQ8091C) hit onto my taxi's rear portion.
