Veh No: SLA 525E at Regn: 2016 Feb

Toyota Camry

* Pre-Repair Inspection Request – SLA525E vs SMF6999T (OI) on D.O.A.: 04/03/2019

VEHICLE DAMAGE INSPECTION REPORT

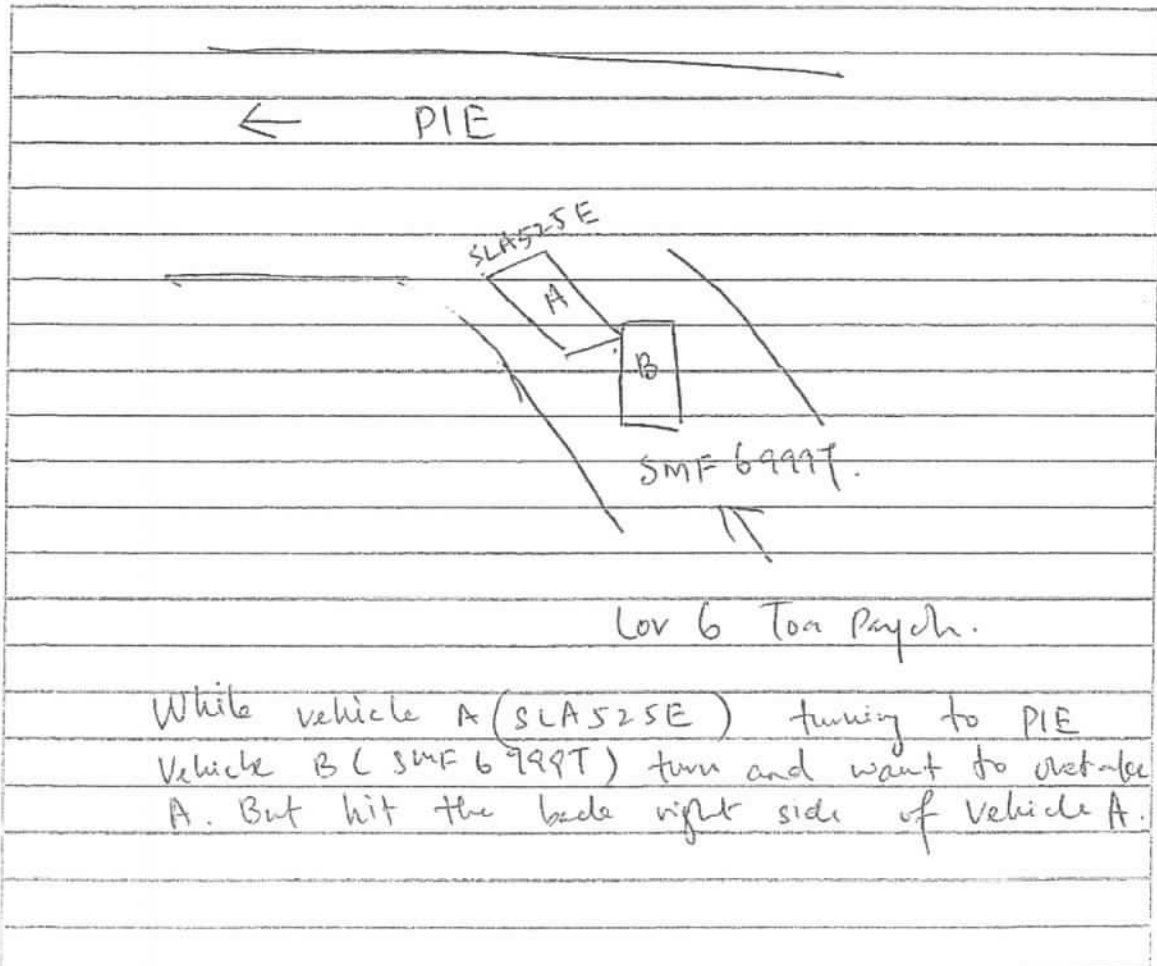
SKETCH PLAN

White vehicle A (SLA525E) turning to PIE
Vehicle B (SMF 6999T) turn and want to overtake
A. But hit the back right side of Vehicle A.
