REF: CS3/SM017020609/Evd3+

To Inspect Vehicle No:

YM 8287Y

CM7D1703793 / AGC

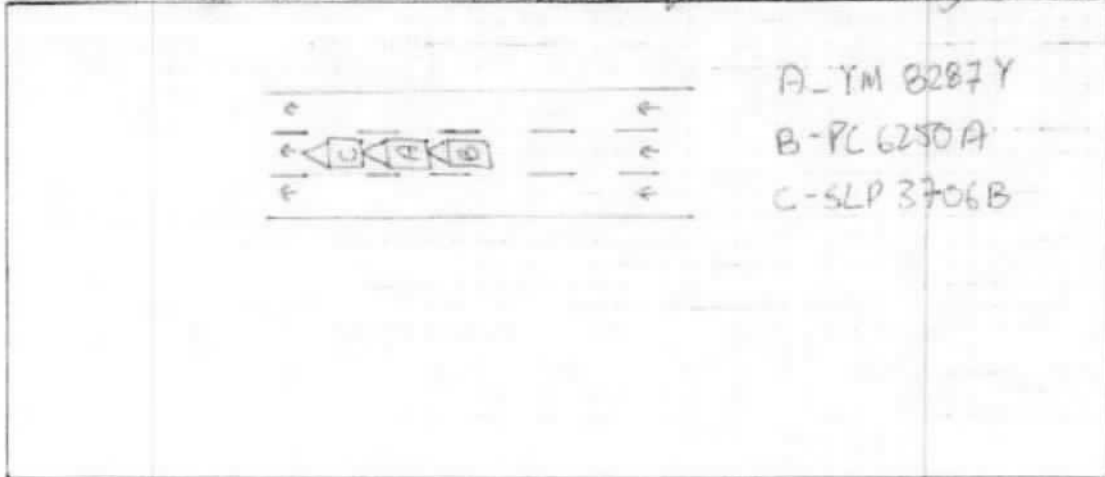
Sketch Plan #2

SKETCH PLAN Woodlands Ave 3 Toward Woodlands Square Before Marsiling MRT Station.

On the above date and time, I was driving along Woodlands Ave 3 toward Woodlands Square on the 2 line of a 3 lanes road. Some where before Marsiling MRT station, vehicle C (SLP 3706B) ahead of me slowed down and stopped due to the red light. As such I applied brake and stopped completely behind vehicle C (SLP 3706B). Out of the sudden, vehicle B (PC 6250A) came from the rear and collided directly onto the rear portion of my vehicle. Upon the impact, my vehicle surged forward and collided onto the rear portion of vehicle C (SLP 3706B). After the accident, I alighted and realised that I was involved in a chain accident of 3 vehicle.

A - YM 8287Y, B - PC 6250A, SLP 3706B

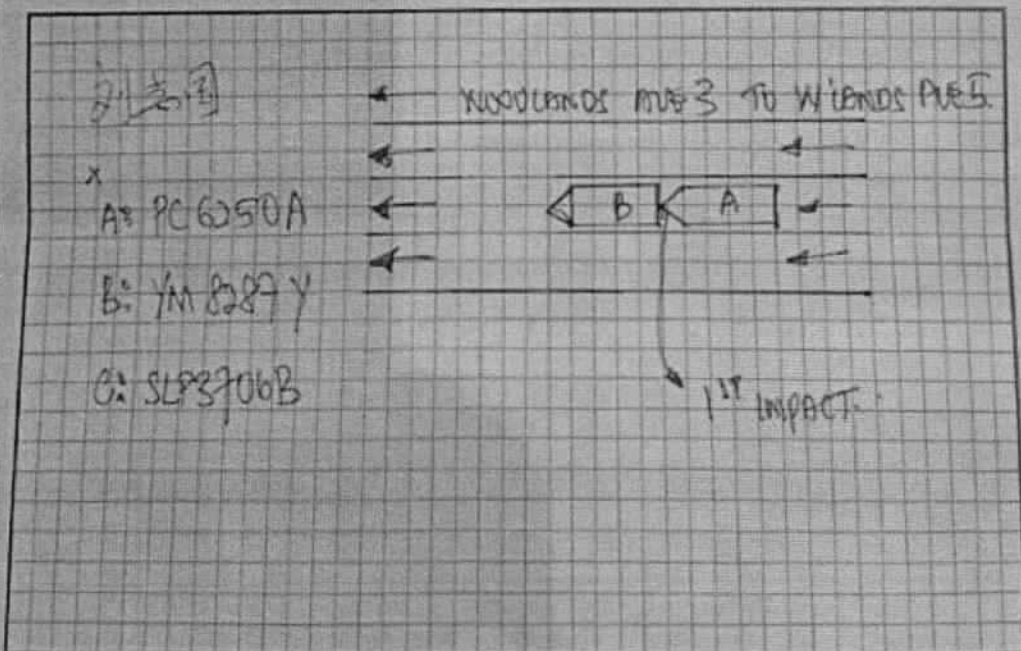
Sketch Plan

ON THE DATE AND TIME MENTIONED, I WAS DRIVING ALONG THE SAID MENTIONED ROAD, WHEN MY HANDPHONE EARPIECE FELL OFF. WHEN I ATTEMPTED TO PICK IT UP, MY VEHICLE SURGED FORWARD AND HIT THE REAR OF VEHICLE B.
