To Inspect Vehicle No:

SKD 8097S

Estimate Repair Cost for Vehicle No :SKD8097S

VEHICLE DAMAGE INSPECTION REPORT

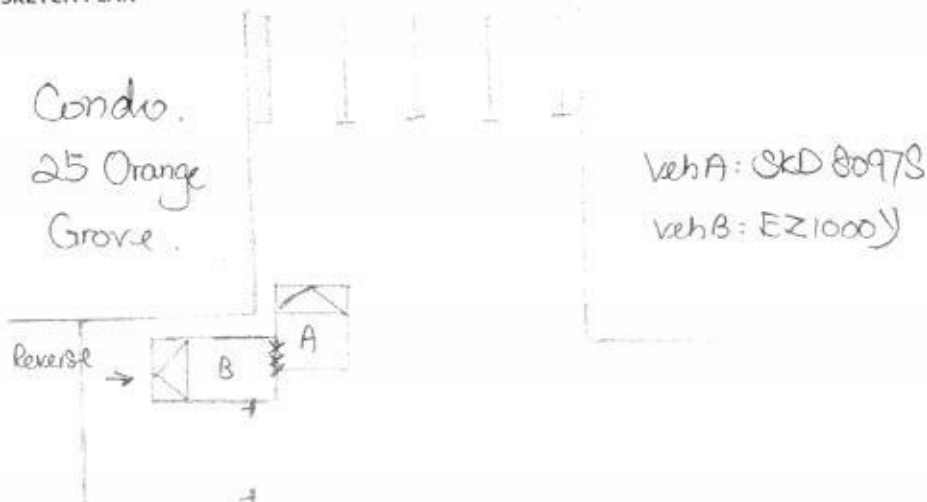
SKETCH PLAN

On 24/02/19, time about 9.40pm. I was driving my vehicle. SKD 8097S inside 25 Orange Grove drop a passenger to this area, before passenger alight. Suddenly vehicle B (EZ1000Y) reversing hit onto my vehicle left hand side rear portion. After I go down to check my vehicle have damage.
