SINGAPORE ACCIDENT STATEMENT

ACCIDENT STATEMENT

Date Of Report	22/06/2018 12:35
Date Of Accident	21/06/2018 15:00
Exact Location Of Accident	JALAN EUNOS.
Country/State of Loss	SINGAPORE

### SYNOPSIS OF DAMAGES

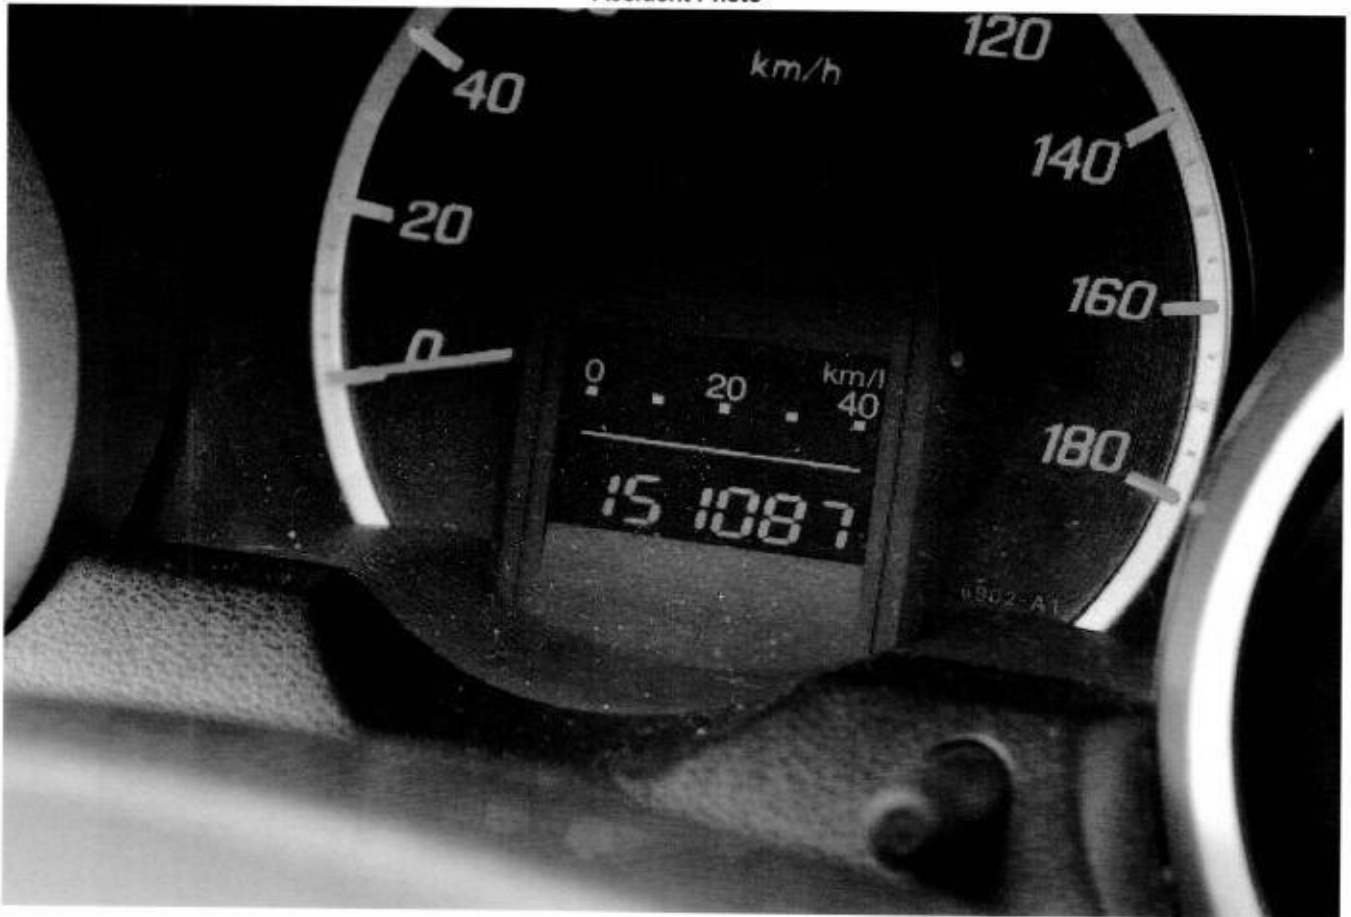
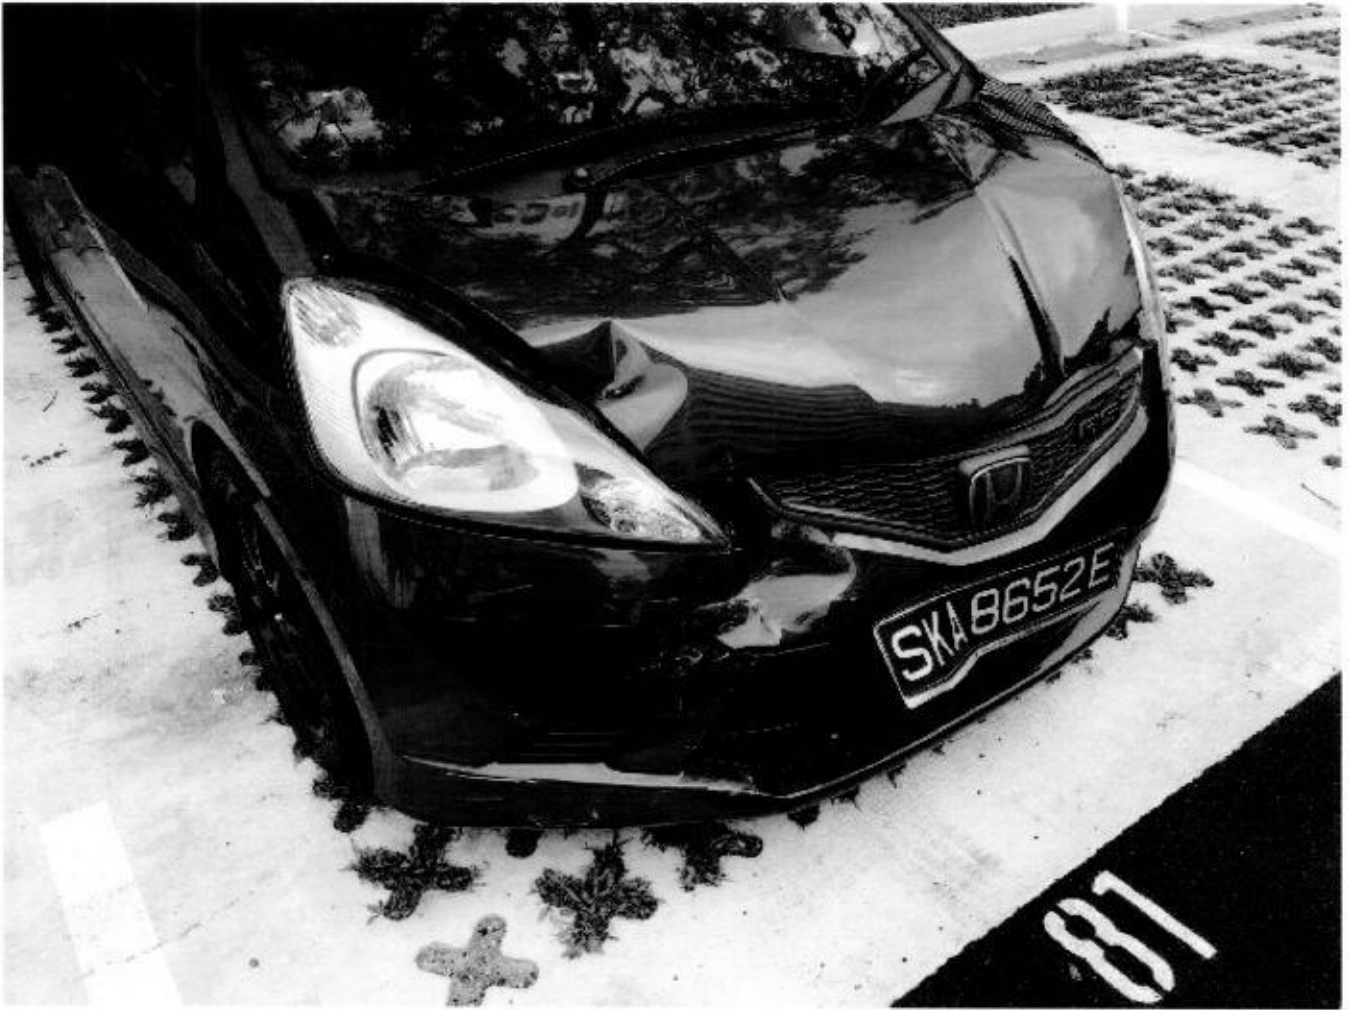
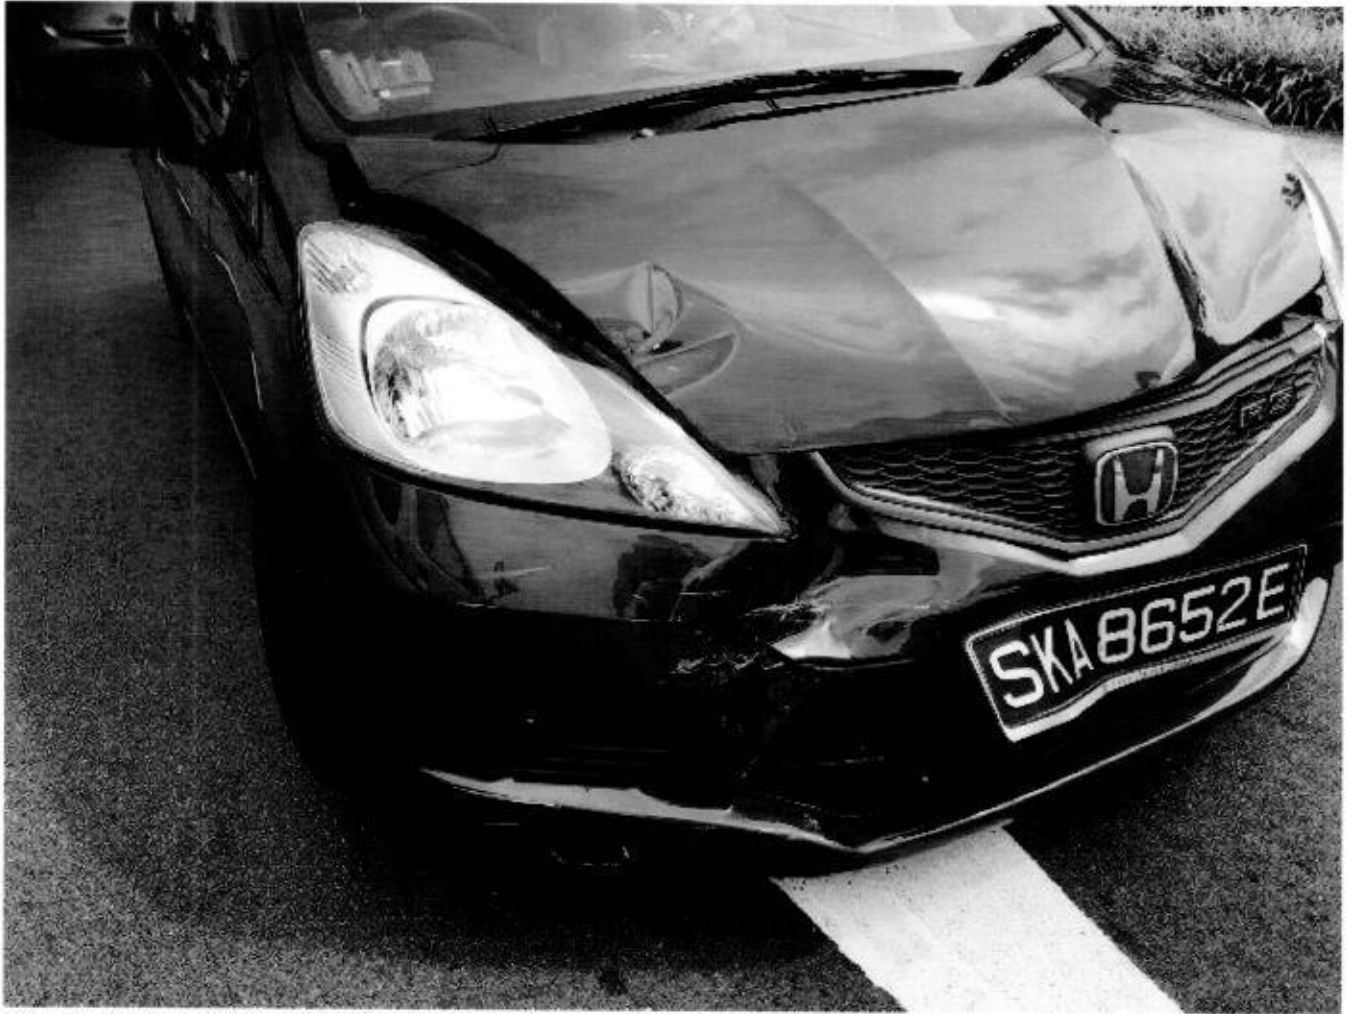
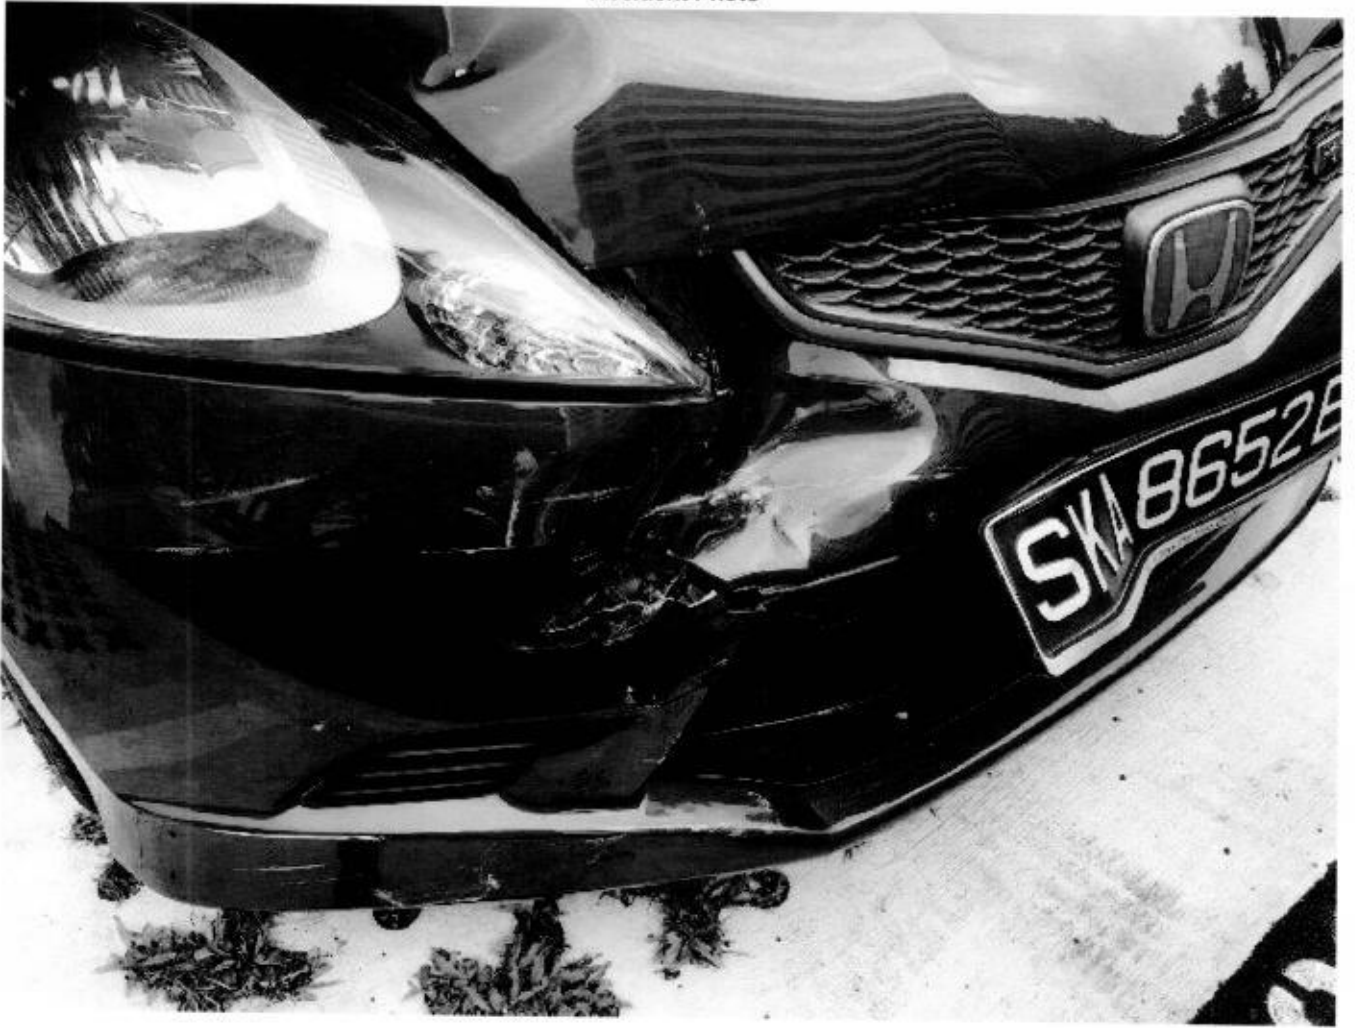
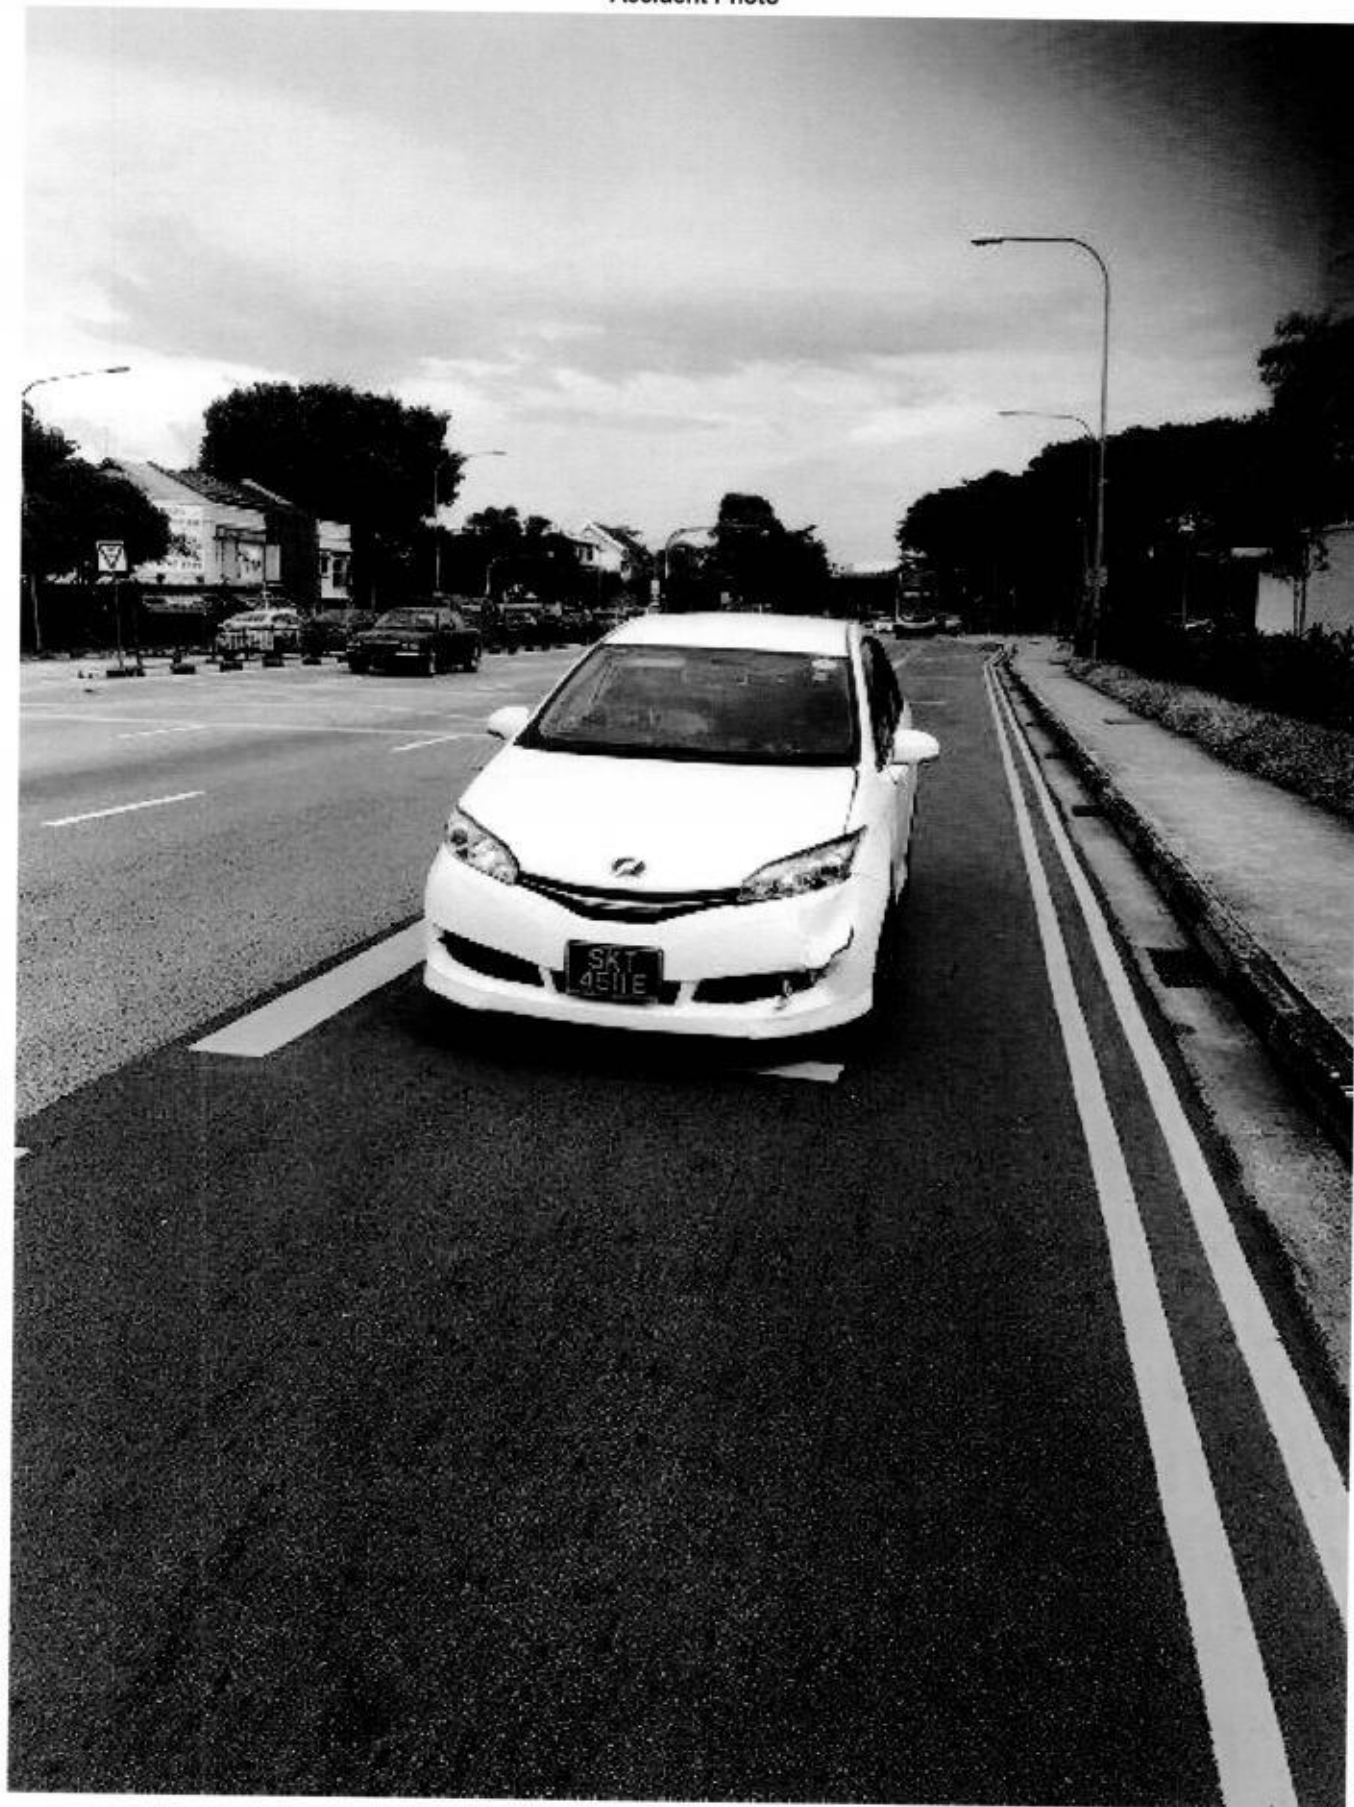
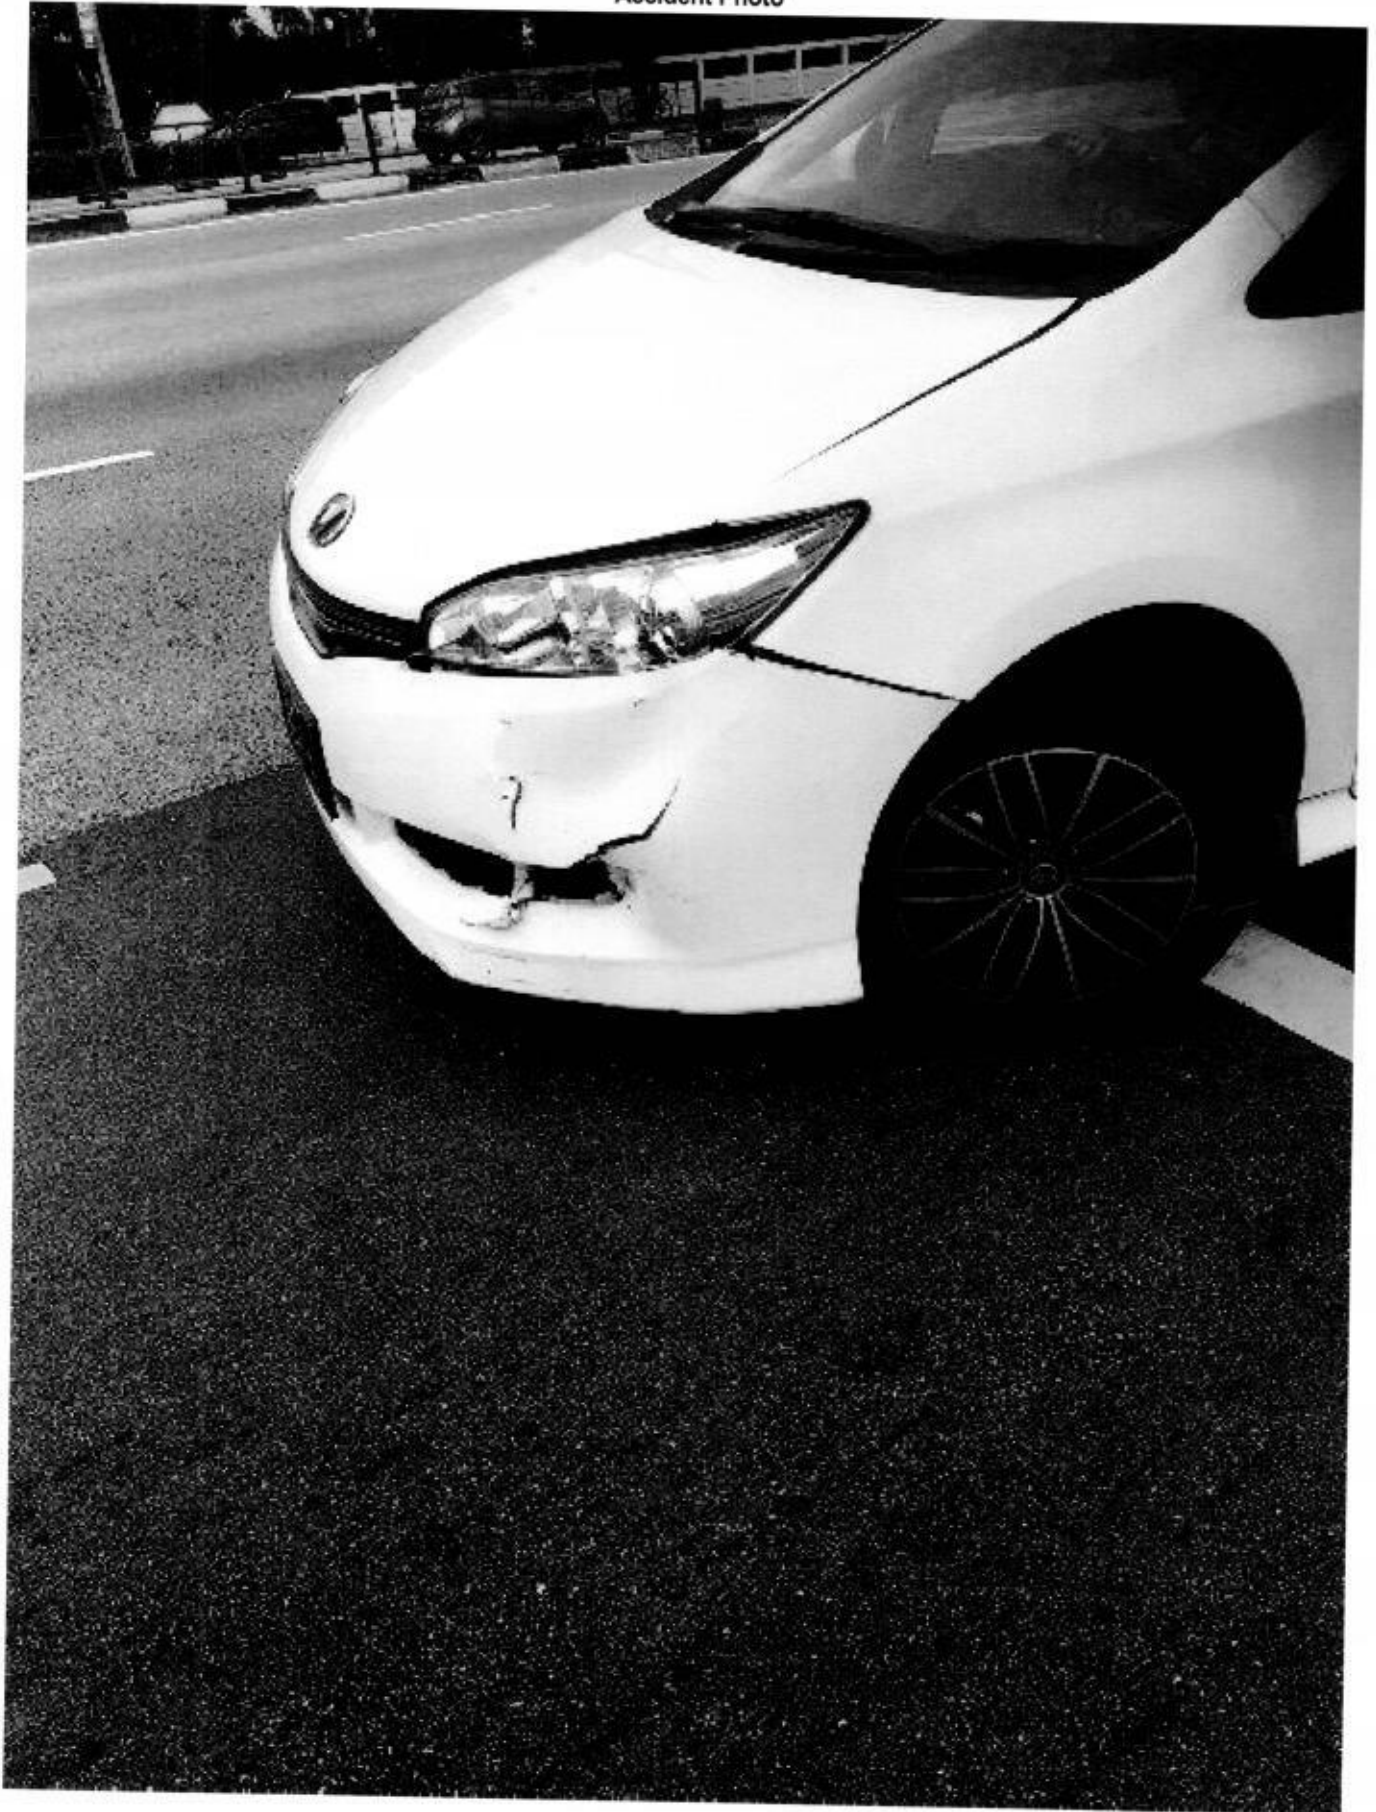
I CHECK THAT TRAFFIC IS CLEAR THUS I PROCEED TO DO A LH TURN WHEN SUDDENLY VEHICLE B CAME AT HIGH SPEED AND HIT ONTO MY VEHICLE'S FRONT LH PORTION.

At the time of survey, we noted that the vehicle has sustained an impact damages on the front portions.

A static inspection was carried out and report is enclosed for your reference. The estimated repair cost submitted by the repairer for **SGD 14,264.12** as per attached schedule has been scrutinised and revised by us against the actual damages found on the vehicle and we recommended the replacements and rectifications accordingly.

The repair cost has been revised to **SGD 11,975.16** and therefore in the consideration of the repairer giving a further 20% even discount, it was agreed that the repairs to be carried out at a contractual lump sum of **SGD 9,600.00** nett.

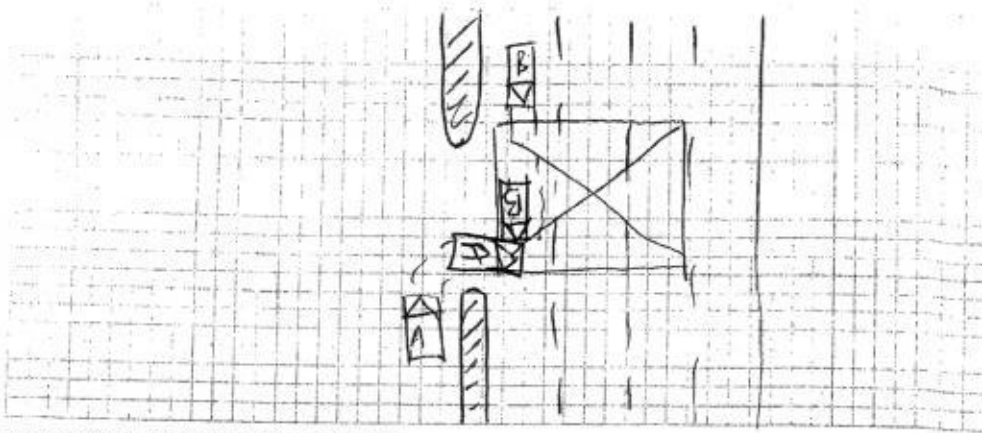
SKETCH PLAN

I check that traffic is clear thus I proceed to do a u-turn when suddenly vehicle B came at high speed and hit onto my vehicle's front LH position.
