VEHICLE DAMAGE INSPECTION REPORT

Our File No: CS/MSG19004462/AGSD3E2

Claimant Vehicle No : GBF2513T

Make & Model: TOYOTA DYNA 100, 3.0 D (M)

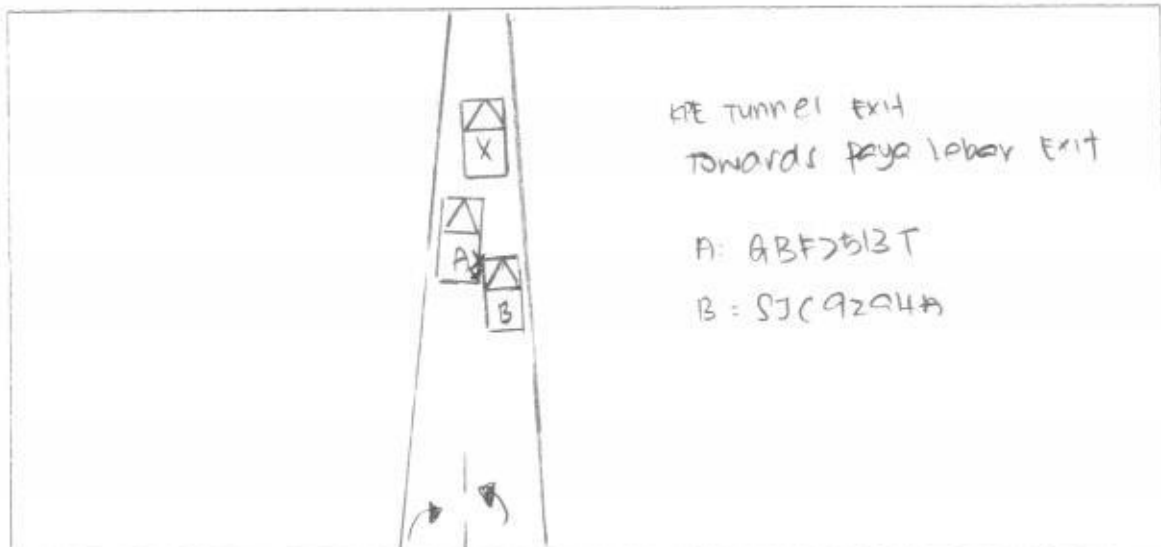
SKETCH PLAN

DESCRIBE CIRCUMSTANCES OF THE ACCIDENT

I was travelling straight along KFE Tunnel Exit towards Paya Lebar Exit. Suddenly, I saw that vehicle B trying to squeeze into the single lane that I was travelling on. Thus, I tried to avoid by moving towards my left. After which, I felt an impact. Vehicle B hit onto the rear right portion of my vehicle and caused damage.
