To Inspect Vehicle No: 811 5256P

Veh No: **SSL5256P** Yr Regn: **Dec / 2008**
Type: ☒ Car / M.Cycle / Bus / Van / Lorry / Taxi / Prime Mover /

ACCIDENT INVOLVING SJL 5256P & GBE 920U ALONG WOODLANDS DRIVE 16 ON 16 AUGUST 2018

VEHICLE DAMAGE INSPECTION REPORT

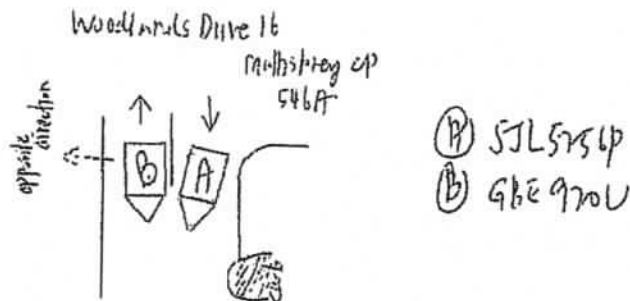
SKETCH PLAN

I was travelling along Woodlands Drive 16. Suddenly vehicle B passing from my right side with a high speed and hit into the right portion of my vehicle. I wish to stated that was a two direction road, and vehicle B was came from opposite direction.

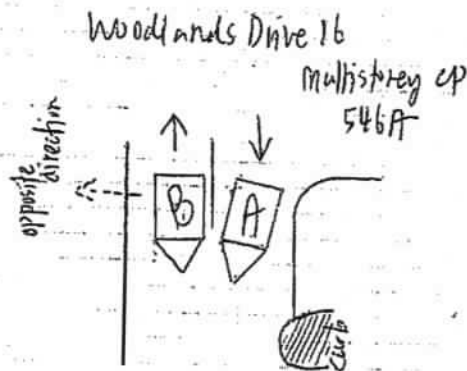
SKETCH PLAN

(A) SJL5756P
(B) GB6920U
