## VEHICLE DAMAGE INSPECTION REPORT

Our File No: CS/SMO19004632/UVD3N2  
Date: 24/04/2019

Handling Insurer:	Sompo Insurance Singapore Pte. Ltd.	Policy No:	D18MTPV01005177
Claimant Vehicle No :	SGD5778C	Insured Vehicle No :	SCW3314T
Date of Loss:	11/03/2019	Nature of Claim:	TP
		Claim No:	CMTD1901323

Reg No:	SGD5778C	Engine No:	K4MT760R075806
Make & Model:	RENAULT MEGANE, 1.5 D Sedan DCI AT EU6 (M)	Chassis No:	VF1LM0C0H34725879
Reg. Date:	20/02/2006 (Man. Year: 2005)	Odometer:	232221 km
Colour:	Grey		
Engine Capacity:	1598 cc		
Market Value/New Car Price:	N/A		
Sum Insured (S\$):	Market Value/New Car Price

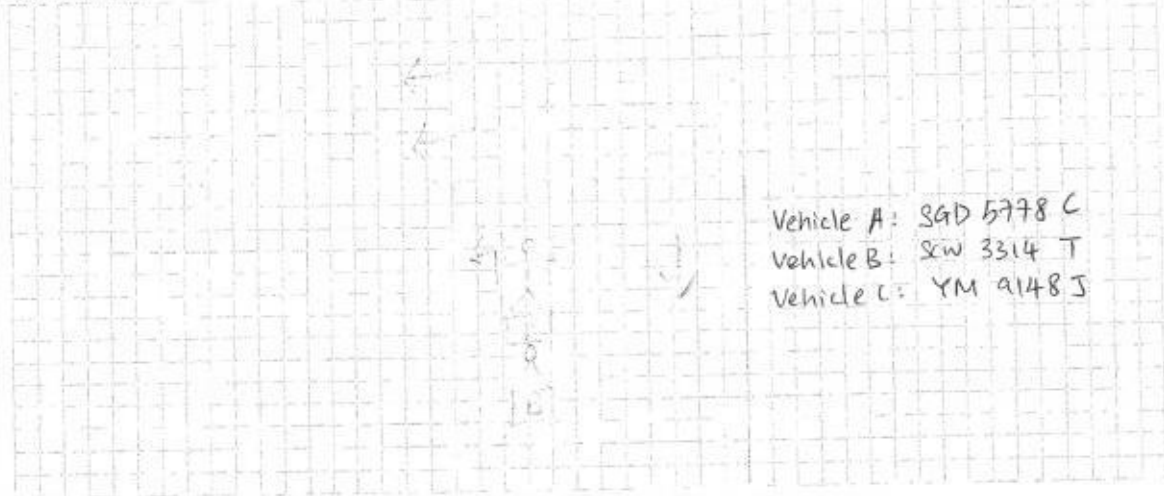
SKETCH PLAN

On 11 March 2019 at around 3:40pm, I was travelling along  
 Tai Seng Street towards Airport Road. After that, I slow down and stop  
 to checking at the stop line to check for on-coming vehicle.  
 Suddenly, Vehicle B ~~collided to~~ (SW 3314 T) collided to vehicle A (SGD 5778 C)  
 which was tow by Vehicle C (YM 9148 J).
