### VEHICLE DAMAGE INSPECTION REPORT

**Our File No:** CS/MSG19004706/UVD3Q2

Reg No: **SLK5094X**

Make & Model: TOYOTA PRIUS, 1.8 HYBRID CVT (A)

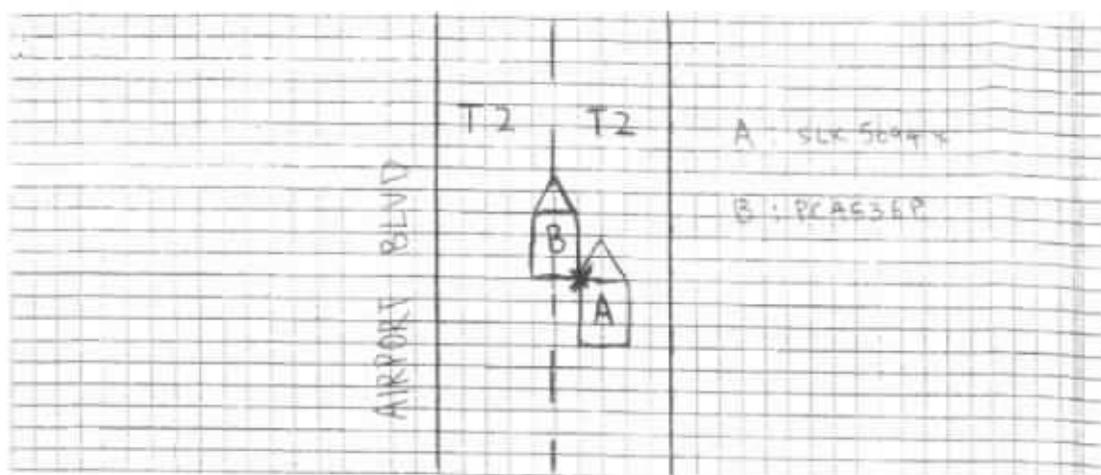
Sketch Plan #2 Pg. 1

On the above stated date and time I was travelling towards terminal 2 at airport and I was going straight when suddenly car B swerve into my lane and swing on to my front left portion. When I got hit and went to check I notice my car front left portion was damage.
