Preliminary Advice

Insured Vehicle No	: GBC8596E	Accident Date	: 23/02/2019
TP Vehicle No	: YN769X	Assignment Date	: 14/03/2019
Make	: MITSUBISHI FE83BEOSRDEA	Est. Duration of Repair	: 4 days
Date of Inspection	: 15/03/2019		
Inspection At	: Liu's Brother Auto Engineering Workshop (HQ) BLK 1 KAKI BUKIT AVE 6, #01-01 AUTO BAY @ KAKI BUKIT Singapore 417883

VEHICLE DAMAGE INSPECTION REPORT

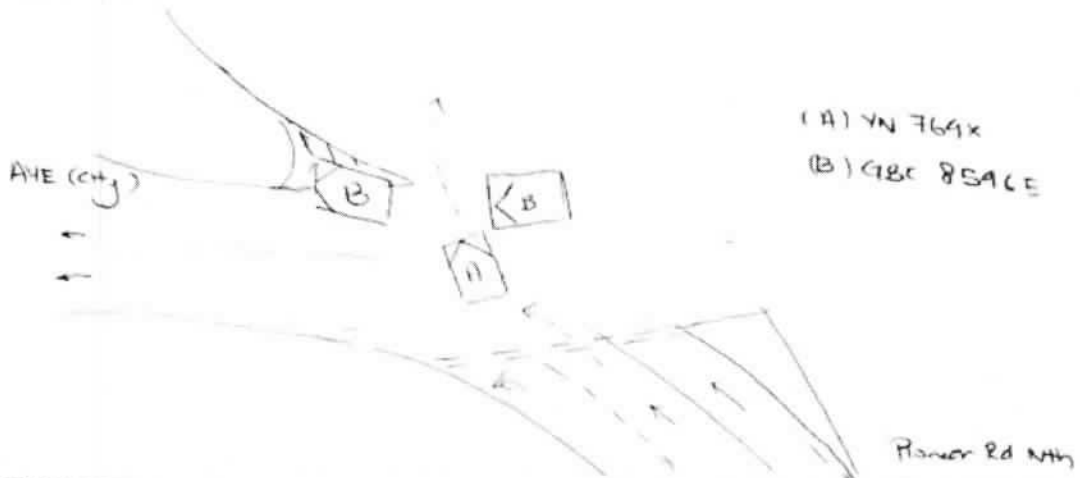
Sketch Plan #2

On 24/11 at about 8-10am, I ^{entered} the roundabout from Romer Rd North intending to travel towards PIE (city) direction. Veh B from my right intending to cut across my line of travel to enter AHE. As a result, my front right portion was damaged.
